RECALL CAMPAIGN BULLETIN

NTB11-064f

VOLUNTARY SAFETY RECALL CAMPAIGN 1996-2004 PATHFINDER IN SALT STATES FRONT STRUT HOUSING CORROSION

CAMPAIGN ID #: R1107
NHTSA #: 11V-244
APPLIED VEHICLES: 1996 – 2004 Pathfinder (R50)

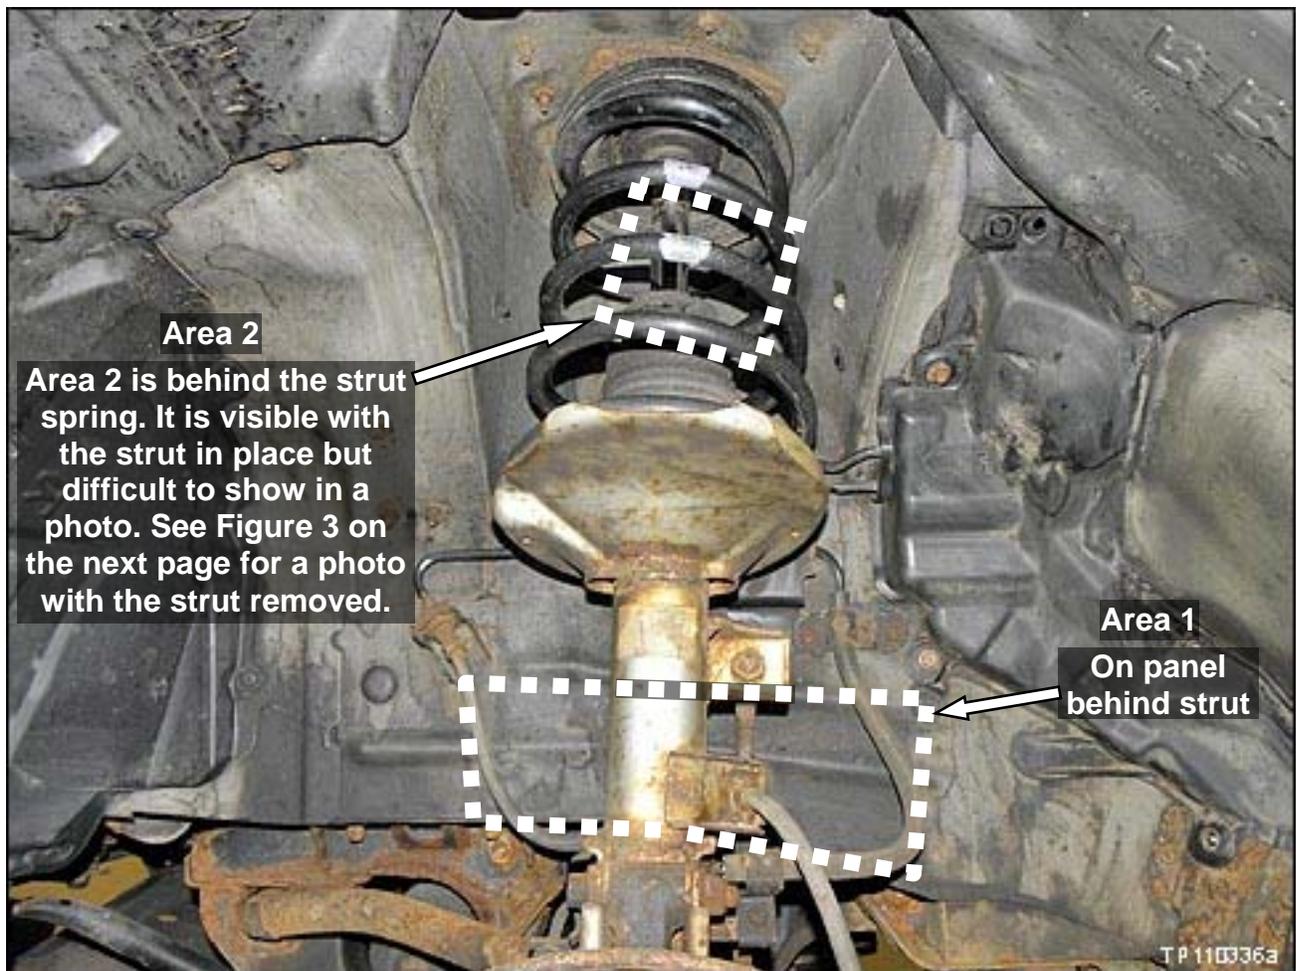
Figure 1

3. Inspect for corrosion on the driver side AND passenger side in the wheel house Area 1 and strut housing Area 2 (see Figures 1, 2, 3, and 4).

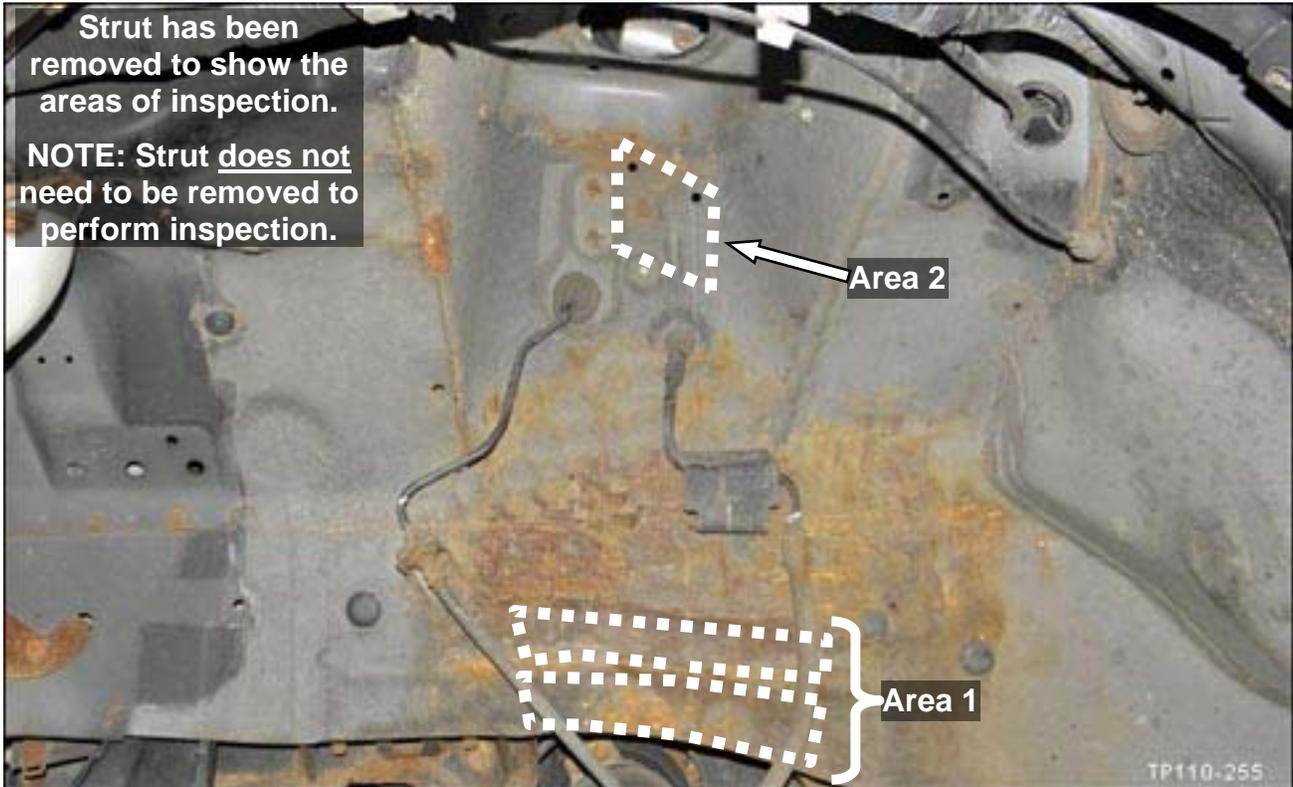
Figure 2

This example photo shows the inspection areas in relation to the repair bracket installation.

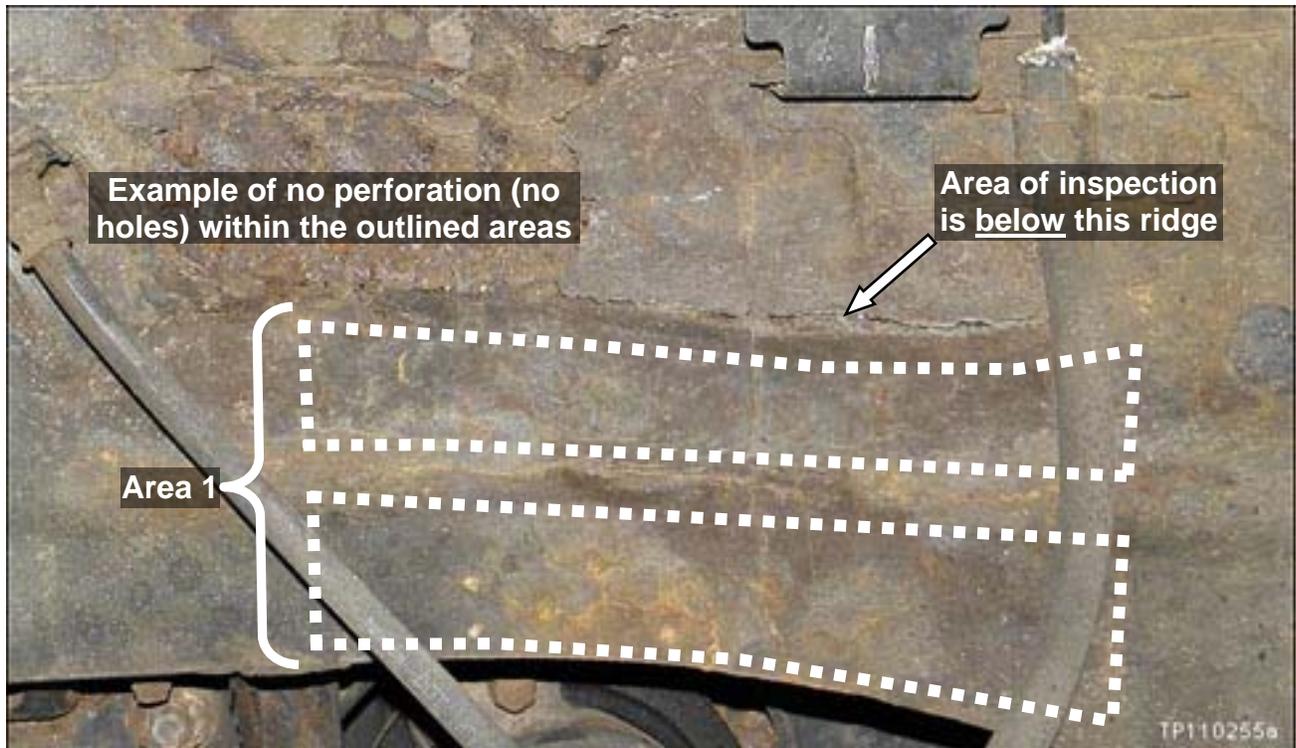
Figure 3

Area 1: Look for perforation (holes) in the metal only in the areas outlined above.

- a. Retain the vehicle at the dealer. (The vehicle is not repairable.)
- b. Supply the customer with a rental car.
- c. Fax a completed Non-Repairable Report to Morley (see page 54).

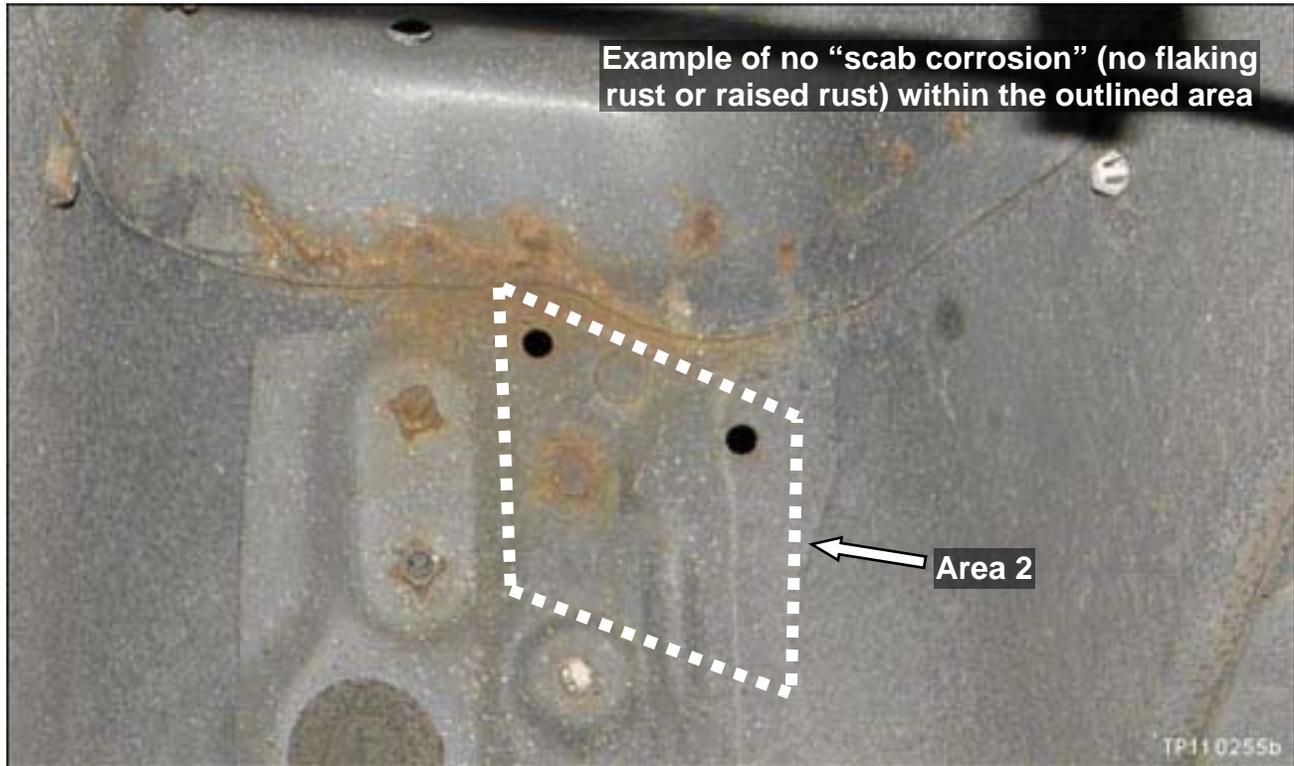
Area 2: Look for “scab corrosion” (flaking rust or raised rust) on driver side **AND** passenger side **only in the area outlined above.**

- The area shown in Figure 4 applies to driver side **AND** passenger side.
- If needed, refer to examples (additional photos) of Area 2 scab corrosion inspection on pages 46 and 47.

- a. Retain the vehicle at the dealer. (The vehicle is not repairable.)
- b. Supply the customer with a rental car.
- c. Fax a completed Non-Repairable Report to Morley (see page 54).

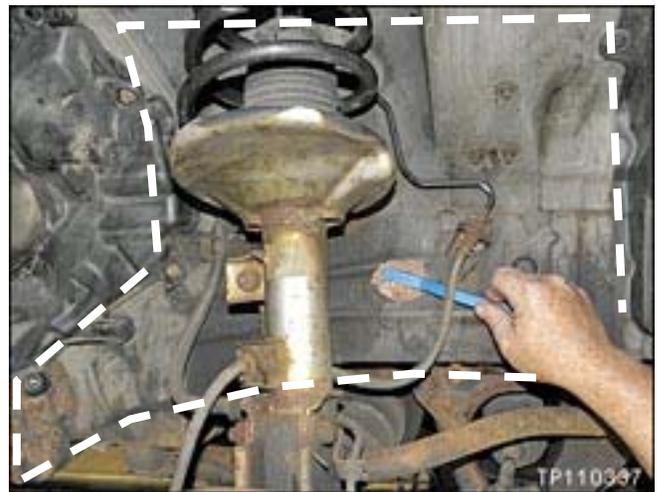
Figure 7

1. Use a wire brush to remove loose rust in the area shown with dashed line.

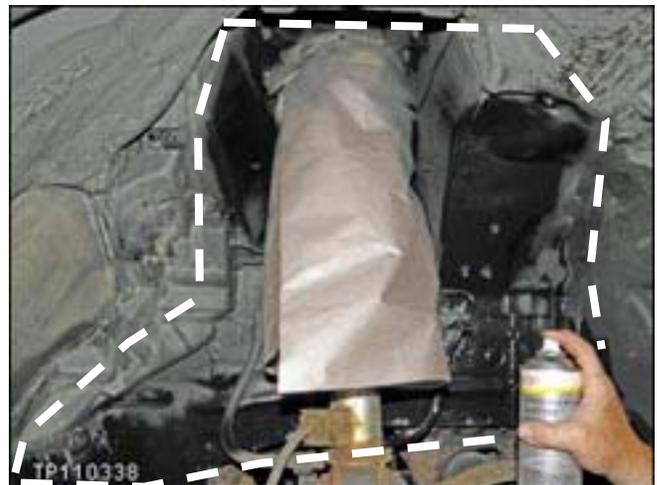
Figure 8

2. Clean dust, dirt, or other debris from the wheel housing and strut housing area.

3. Cover the strut so it is protected from overspray.

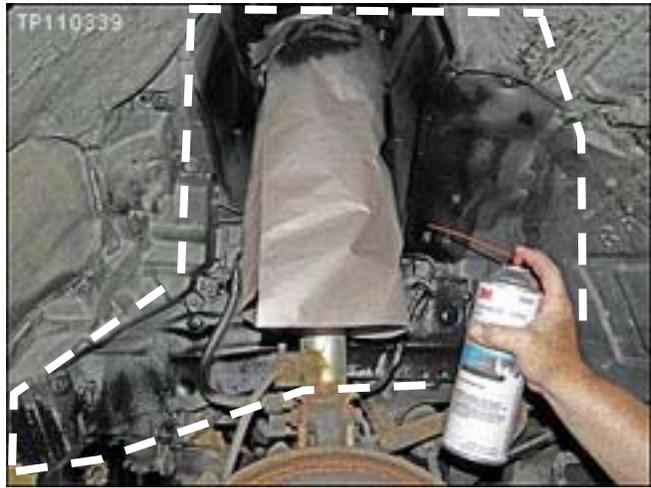
Figure 9

- Use 3M™ Rubberized Undercoating (P/N 051135 – 08883) or equivalent.
- Follow all product instructions.
- Coat all of the exposed metal areas on the strut housing and wheel house panels.
- Use a spray nozzle to spray the areas behind the strut and other hard to reach areas.

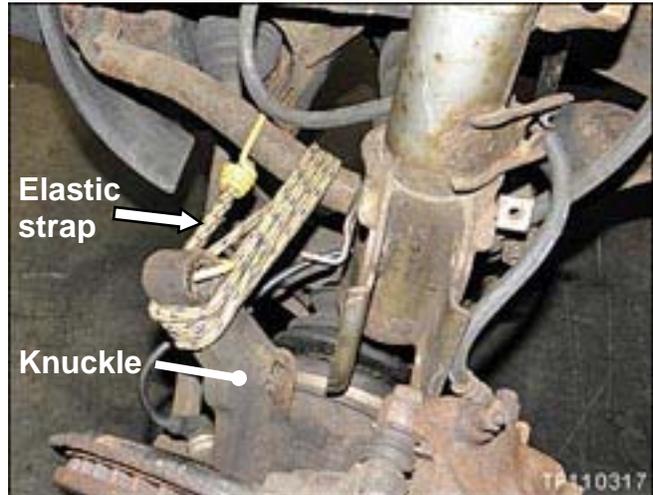
Figure SR3

NOTE: Make sure the knuckle assembly is secure. Its weight must be supported during the entire repair process.

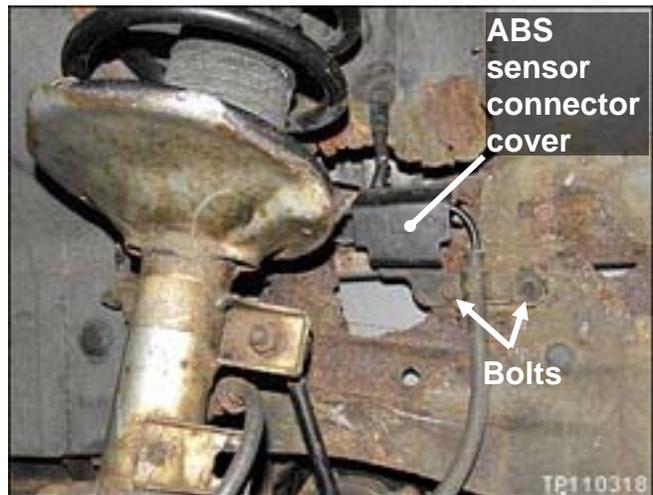
Figure SR4

5. Remove the 2 bolts for the ABS sensor connector cover.

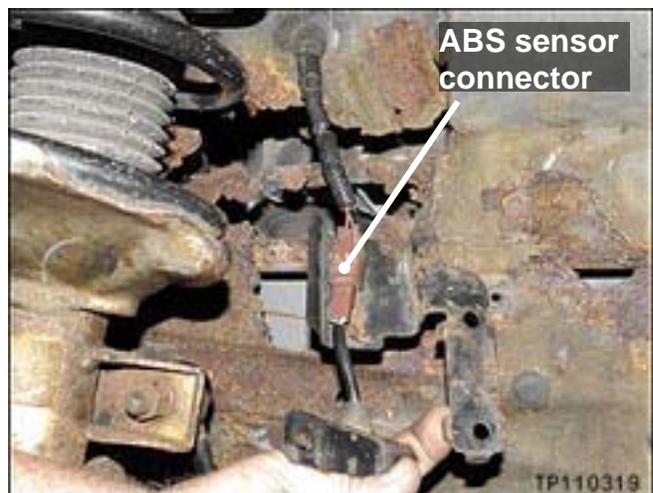
Figure SR5

- ABS sensor connector is on the back side of the cover.

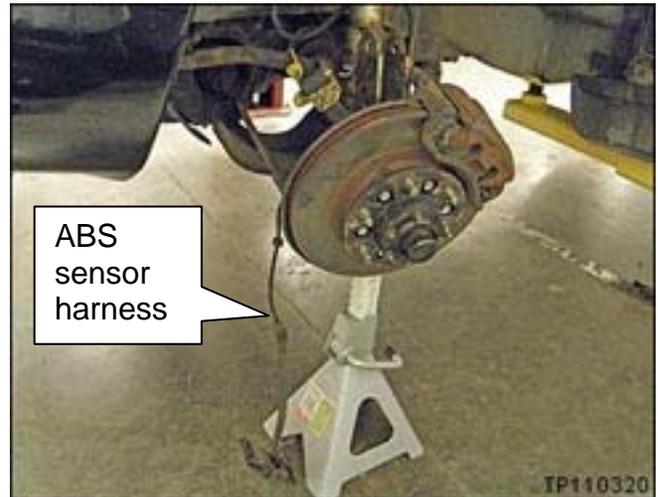
Figure SR6

8. Let the ABS sensor harness hang out of the way as shown.

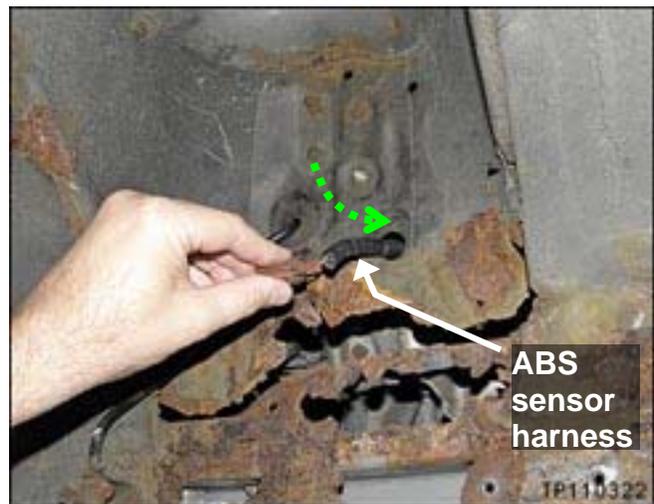
Figure RB1

1. Inspect the ABS sensor harness for damage. If damaged, repair as necessary.
2. Push the ABS harness and connector through the panel.
 - The harness/connector will now be out of the working area.

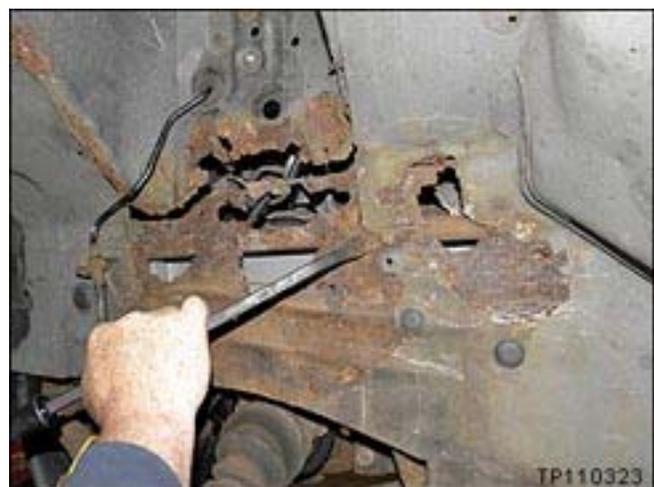
Figure RB2

3. Use a scraper bar to scrape off loose flaking rust and corrosion.

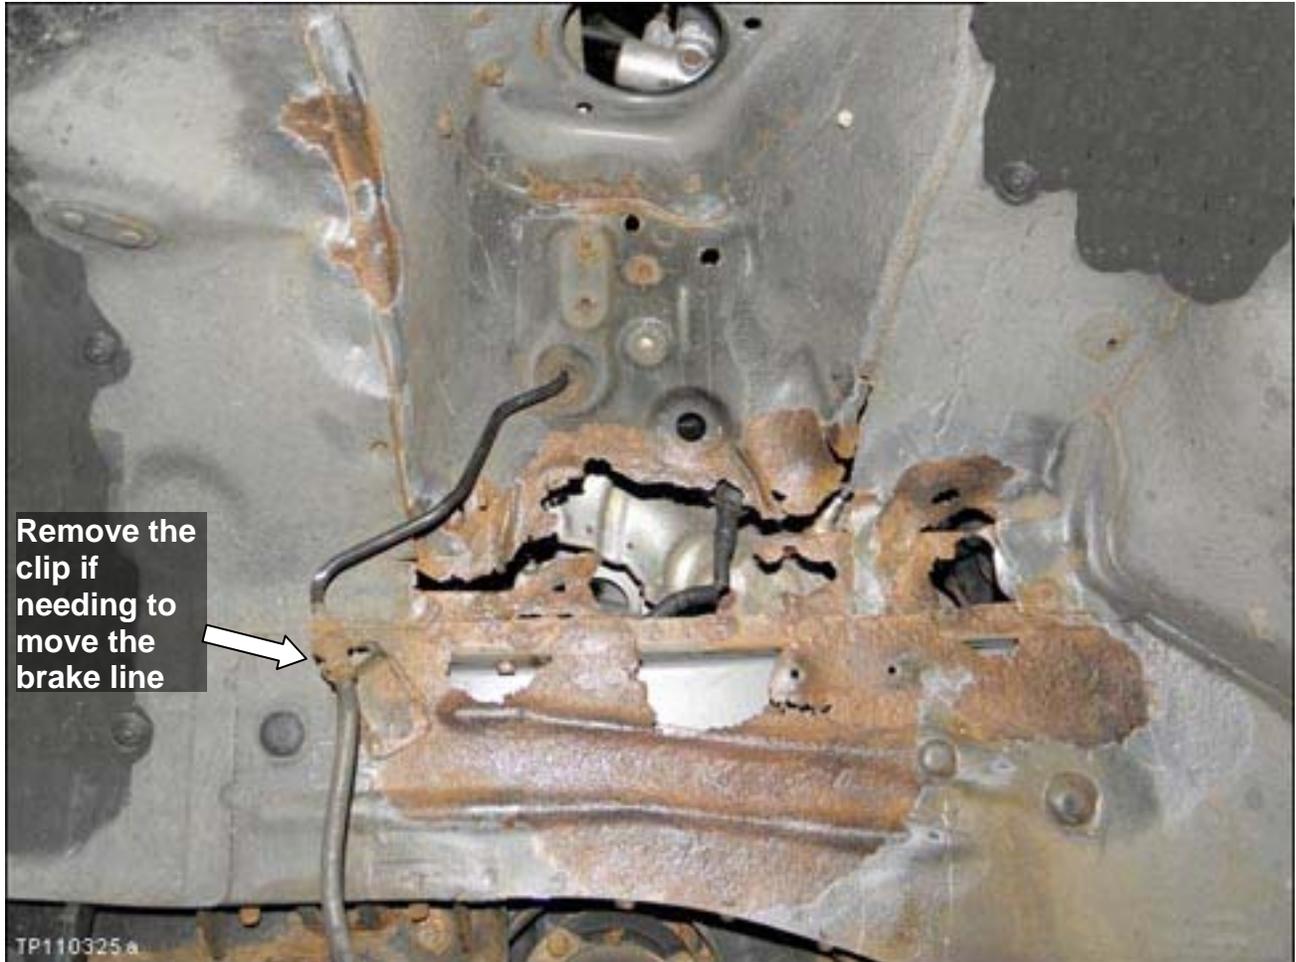
Figure RB3

4. Clean all the loose rust from the strut housing and wheel house areas (see Figure RB3).

NOTE: If the brake line is in the way of an area that needs cleaning, move it out of the way by first removing the clip from the mount.

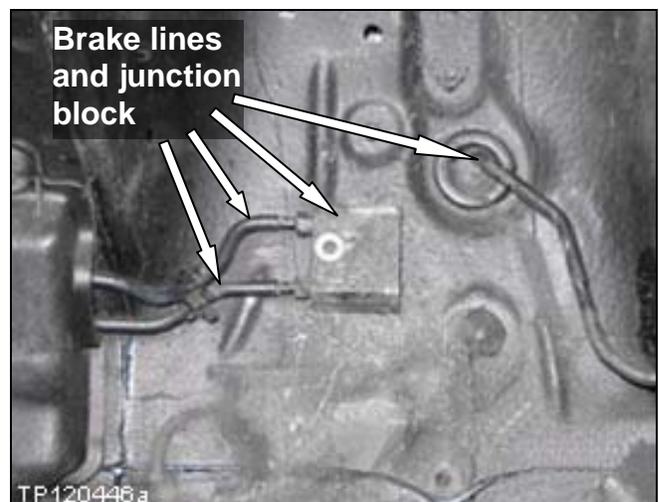
Figure RB4

4a. Passenger side: work around the 2 brake lines and junction block best as possible (see Figure RB4).

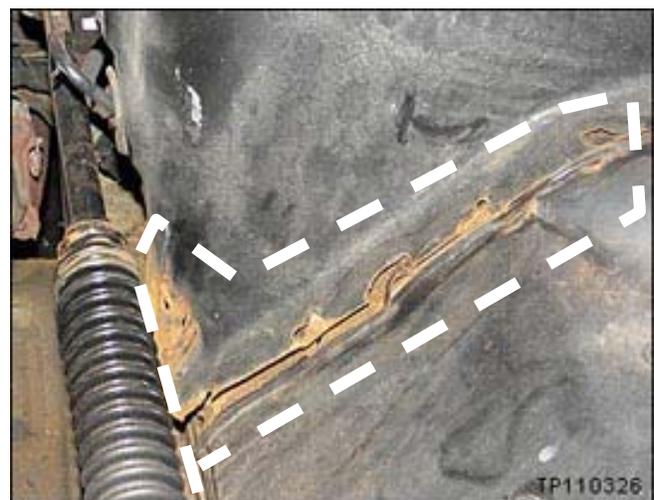
Figure RB6

Use a wire brush to clean any loose rust, paint, or other debris from the area shown with dashed line.

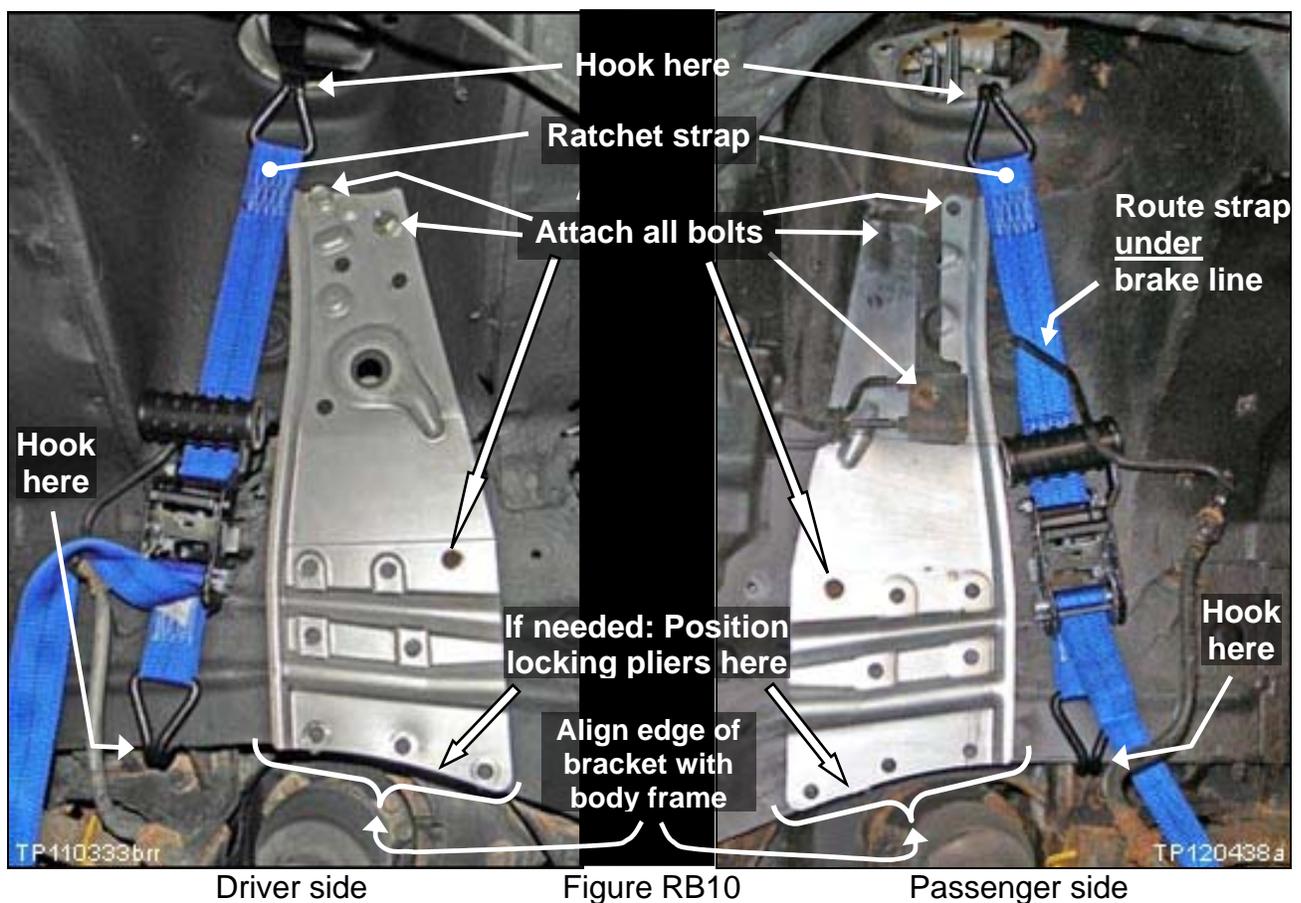
- a. Attach the ratchet strap as shown in Figure RB10.
- b. Use the ratchet strap to pull the strut housing panel down until the existing threaded hole(s) is aligned with the matching hole in the repair bracket (see Figure RB10).

- At this time, a pair of locking pliers or equivalent tool may be used to further support the repair bracket (see Figure RB10).
- Bolts need to be tight enough to hold the bracket in place while center punching and drilling holes in the next step.

NOTE: Photos for installation of the repair bracket show the ratchet strap being used. In most cases, the strut housing panel will not be separated and the ratchet strap will not be needed.

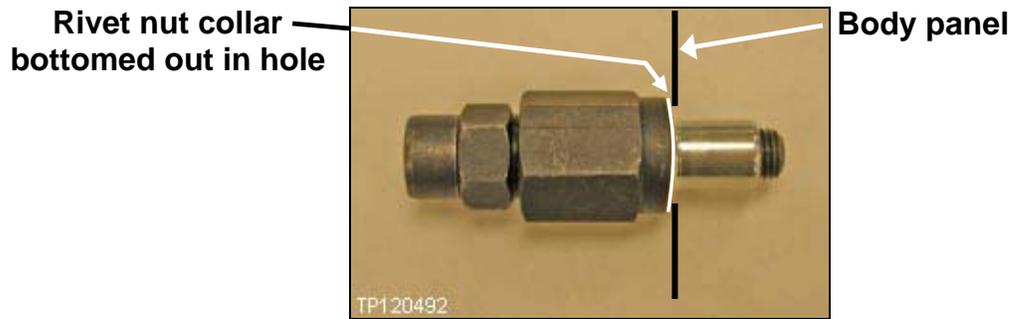
Figure RB17

4. Insert the rivet nut into the 13.1 mm (33/64 in) hole until it bottoms out on its collar.

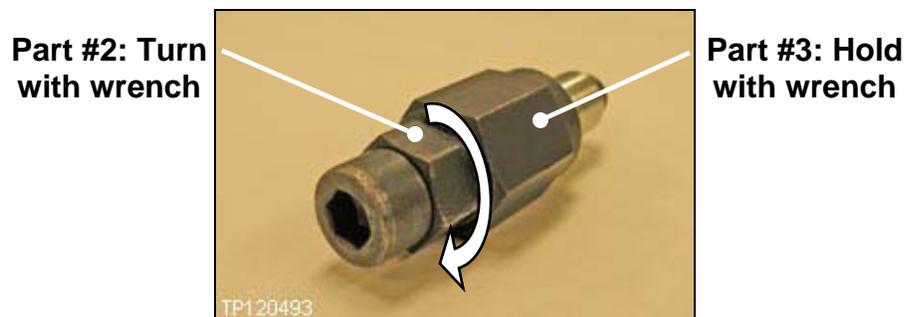
Figure RB18

5. Install the rivet by performing the following:
 - a. Hold the rivet nut and tool against the body panel with moderate pressure.
 - b. Hold stationary part #3 while turning part #2 clockwise.
 - c. Turn part #2 approximately 2 turns or until turning resistance increases.
 - At this point, the rivet nut is installed.

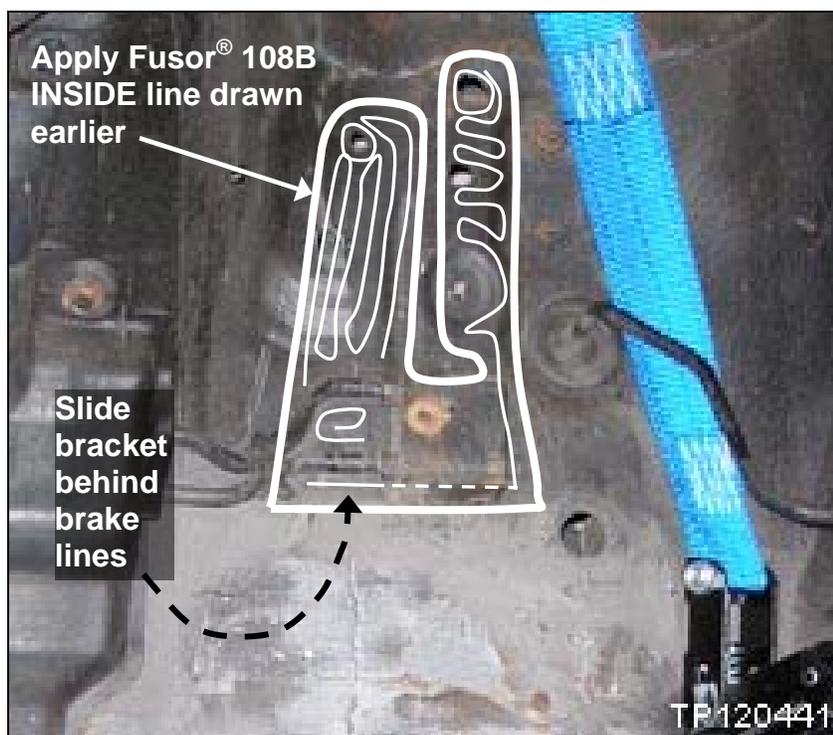
RB24 – Passenger side

27. Passenger side: Liberally apply Fusor® 108B on the strut housing area within the white line drawn earlier (see page 24, step 20, and Figure RB24 below).

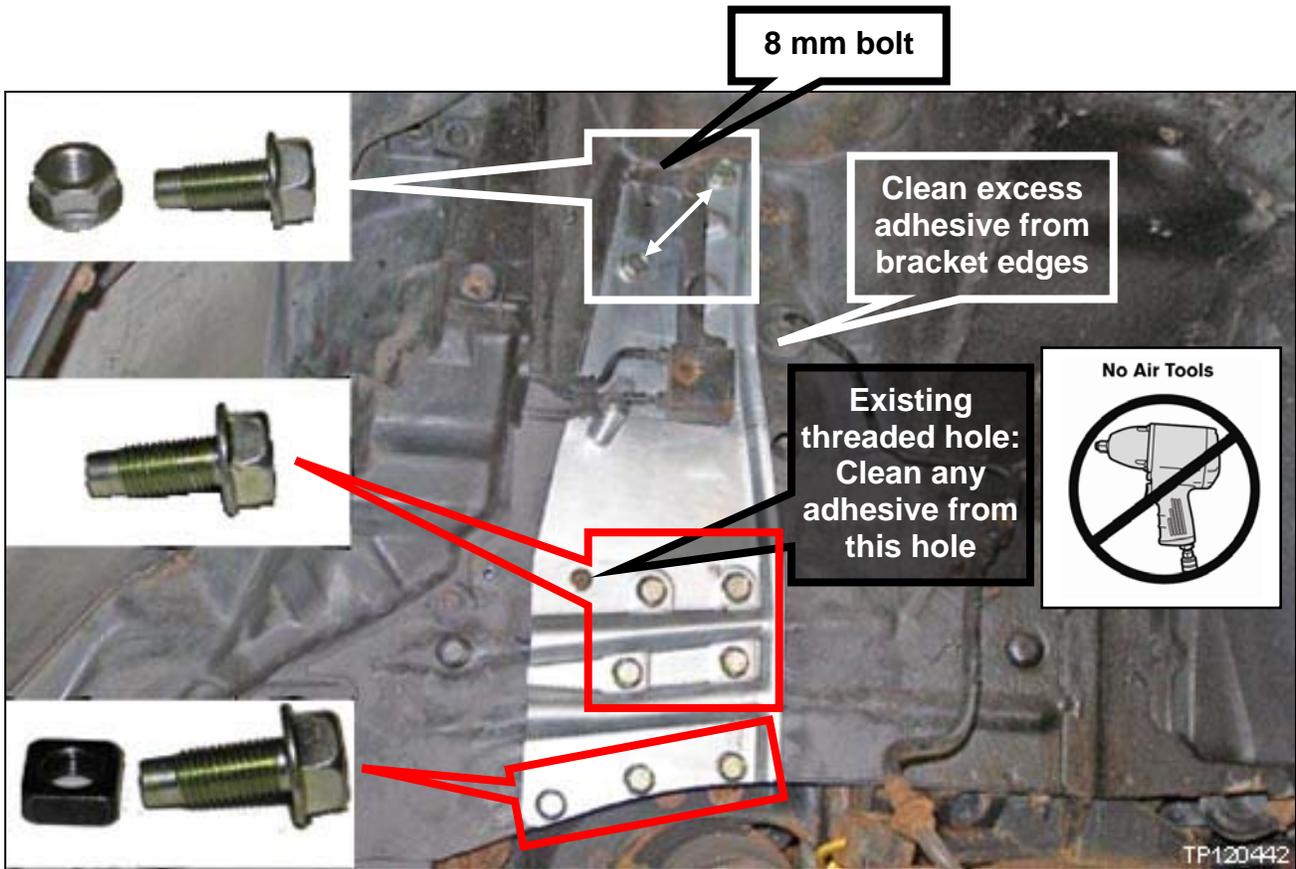
Figure RB26 – Passenger side

- Driver side: make sure the ABS harness is pulled through its hole in the repair bracket.
- Use the correct nuts (see Figure RB25, or RB26 on next page, as it applies).
- **Do not use air tools to tighten the bolts.**
- Torque all new bolts/nuts to 50 N•m (5.1 kg-m, **37 ft-lb**).
- Secure all existing bolts.

- These bolts are required and must accept the torque value of 50 N•m (5.1 kg-m, 37 ft-lb).
- If these bolts will not accept the specified torque value, the vehicle is not repairable:
 - a. Retain the vehicle at the dealer.
 - b. Supply the customer with a rental car.
 - c. Fax a completed Non-Repairable Report to Morley (see page 53).

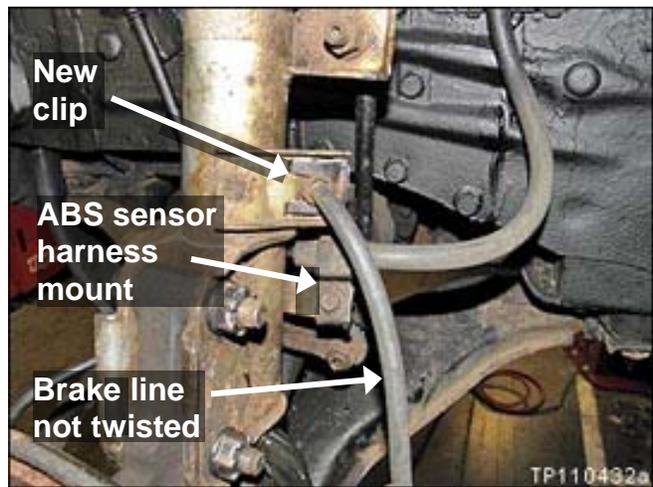
Figure RB37

- Use a new clip for the brake line mount (P/N 46206 – 2J00A).
- Confirm the ABS sensor harness is mounted correctly as shown in Figure RB37.
- Make sure the brake line is not twisted.

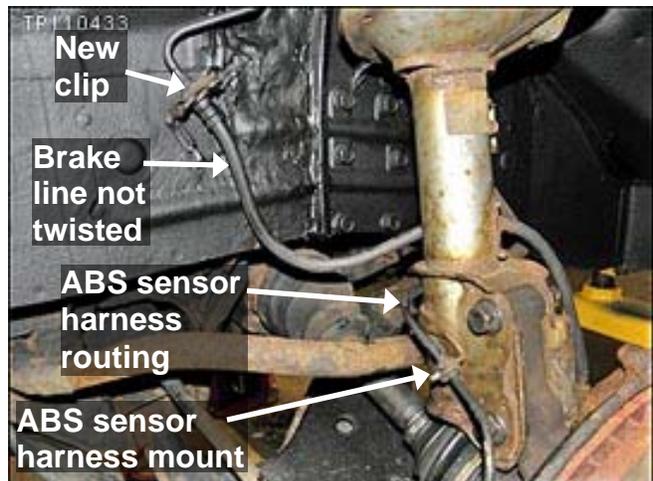
Figure RB38

- Use a new clip for the brake line mount (P/N 46206 – 2J00A).
- Make sure the brake line is not twisted.
- Confirm the ABS sensor harness is routed correctly behind the strut.
- Make sure the ABS sensor harness is mounted correctly as shown in Figure RB38.

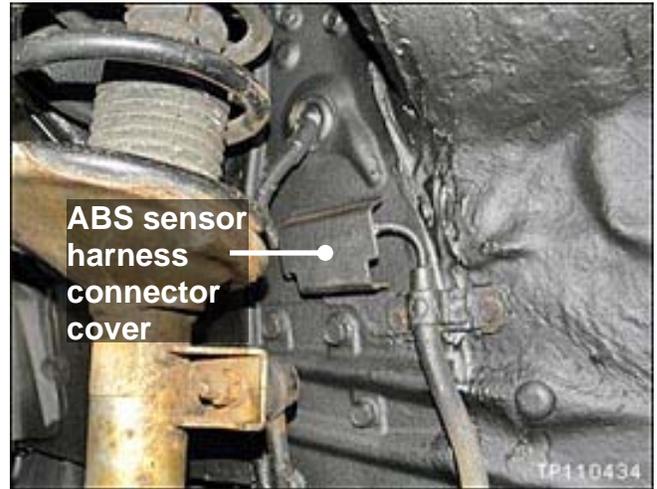
Figure RB39

- Make sure the ABS sensor harness connector cover is installed as shown.
 - If the cover is missing, install a new one.
 - Coat the cover with 3M Rubberized Undercoating (P/N 051135 – 08883); don't get any undercoat on the strut rod.

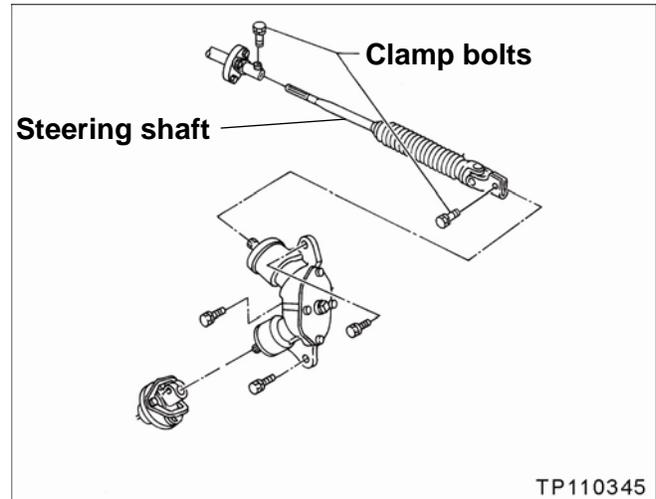
Figure SS1

2. Remove the clamp bolts at each end of the steering column upper joint (steering shaft).

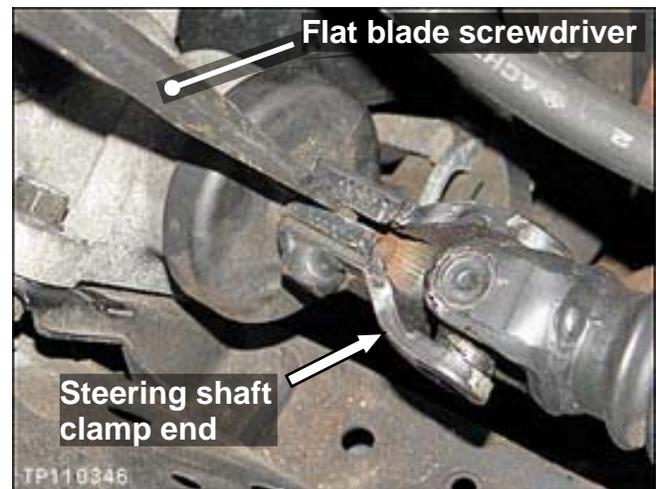
Figure SS2

3. Use a flat blade driver or other suitable tool to loosen both clamp ends of the steering shaft.

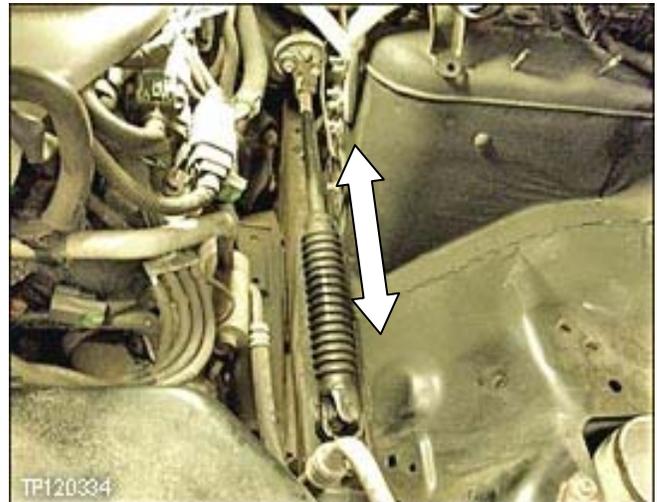
Figure SS3

4. Loosen the clamp ends enough so the steering shaft is loose at both ends.
 - Steering shaft will move back and forth a small amount.

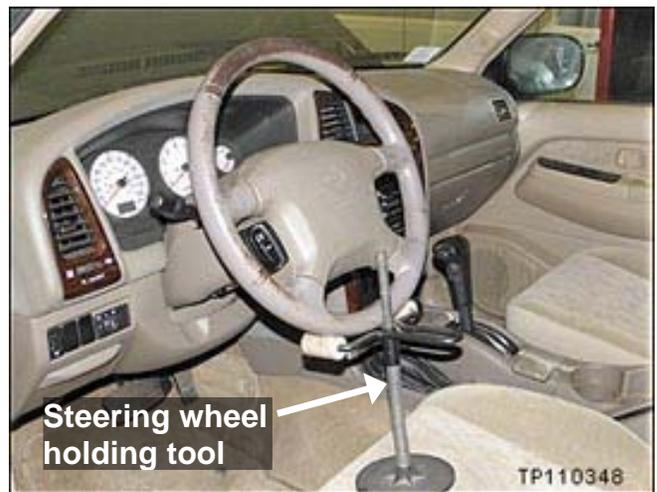
Figure SS4

5. Set the steering wheel in the straight ahead position.
6. Position a steering wheel holding tool as shown.
 - This will keep the steering wheel stationary while replacing the steering shaft.

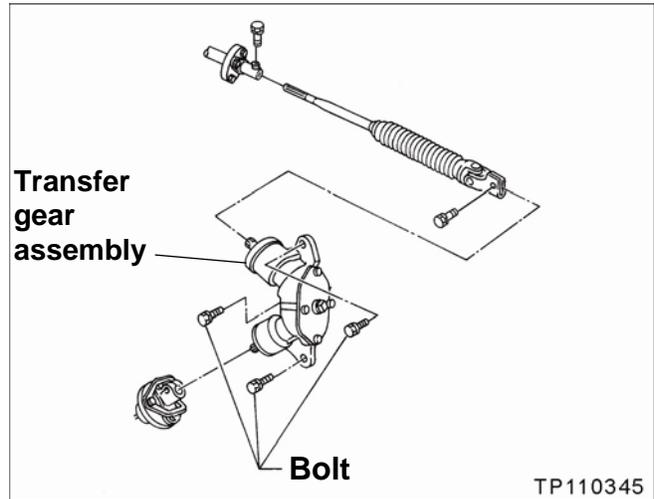
Figure SS6

7. Remove the 3 transfer gear assembly mounting bolts.

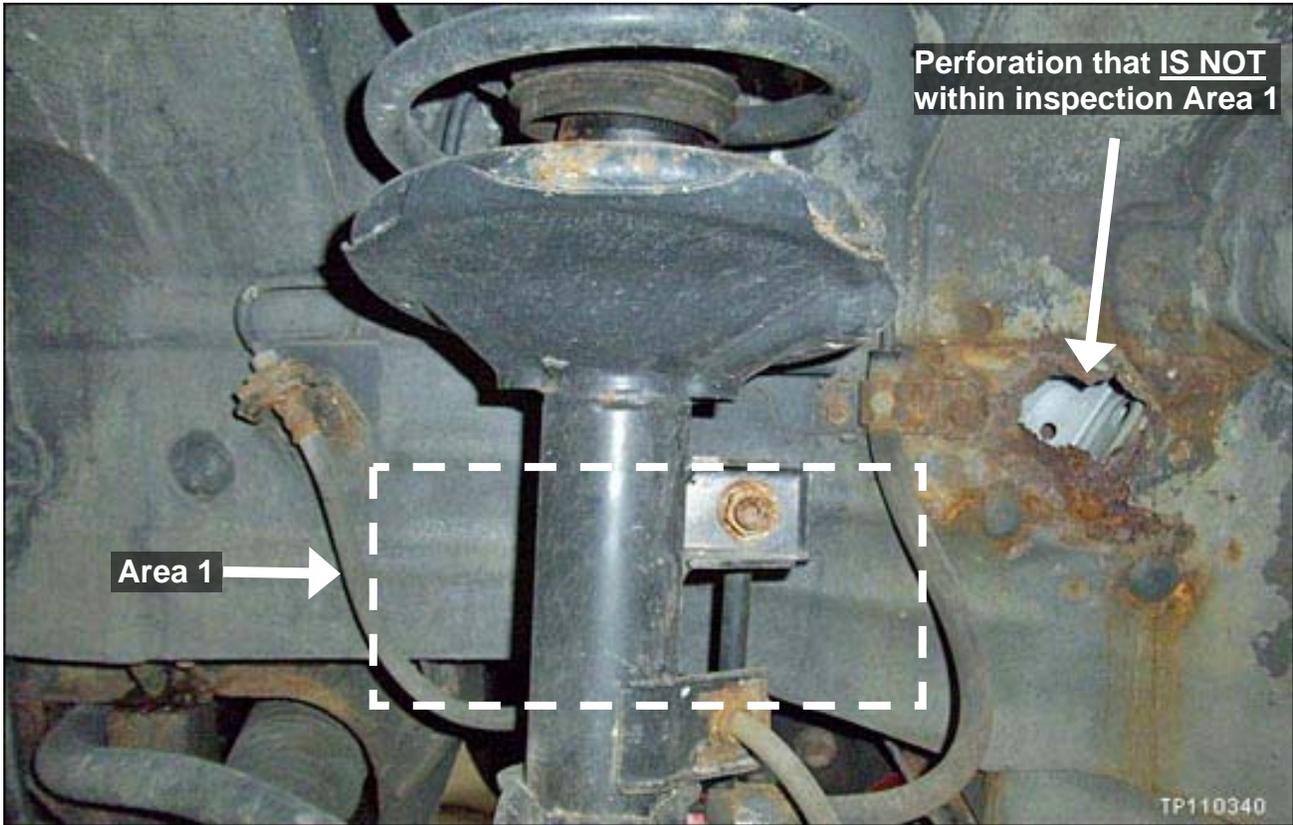
Examples (Additional Photos) of Area 1 Perforation Inspection

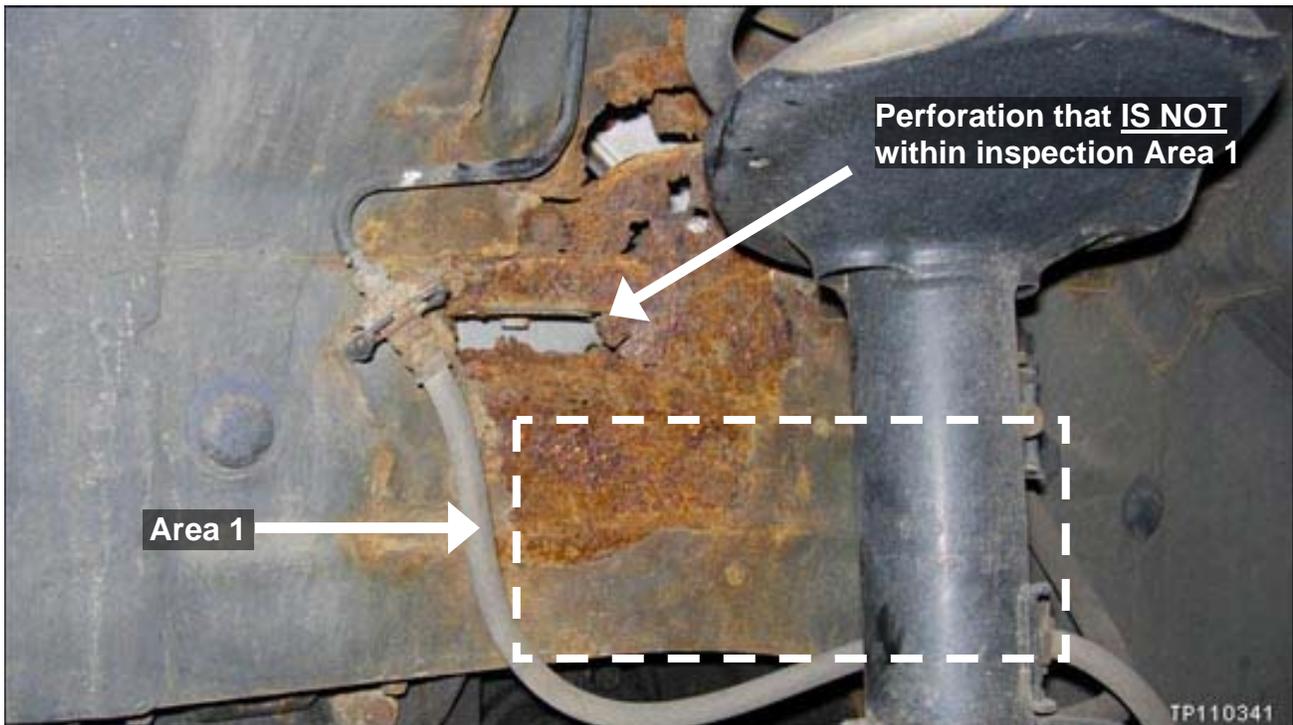
Example (Additional Photo) of Area 1 Perforation Inspection

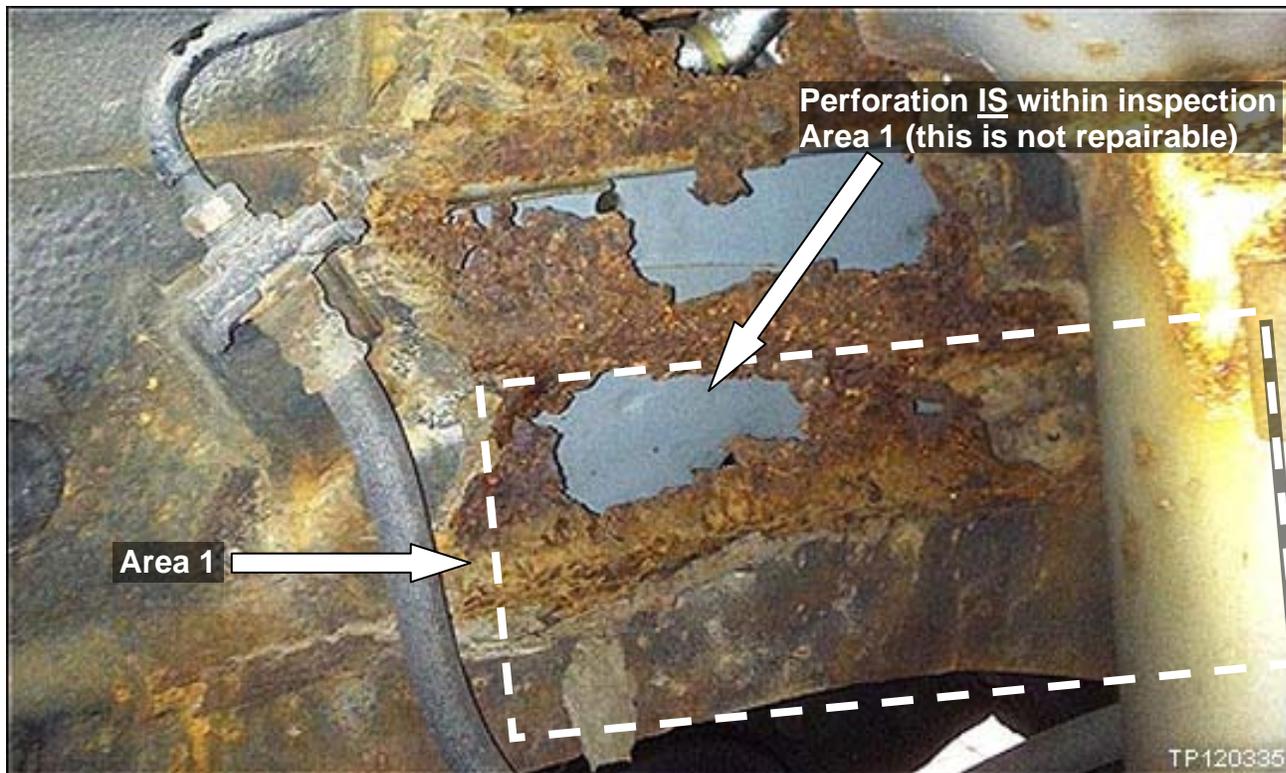
Example (Additional Photo) of Area 1 Perforation Inspection

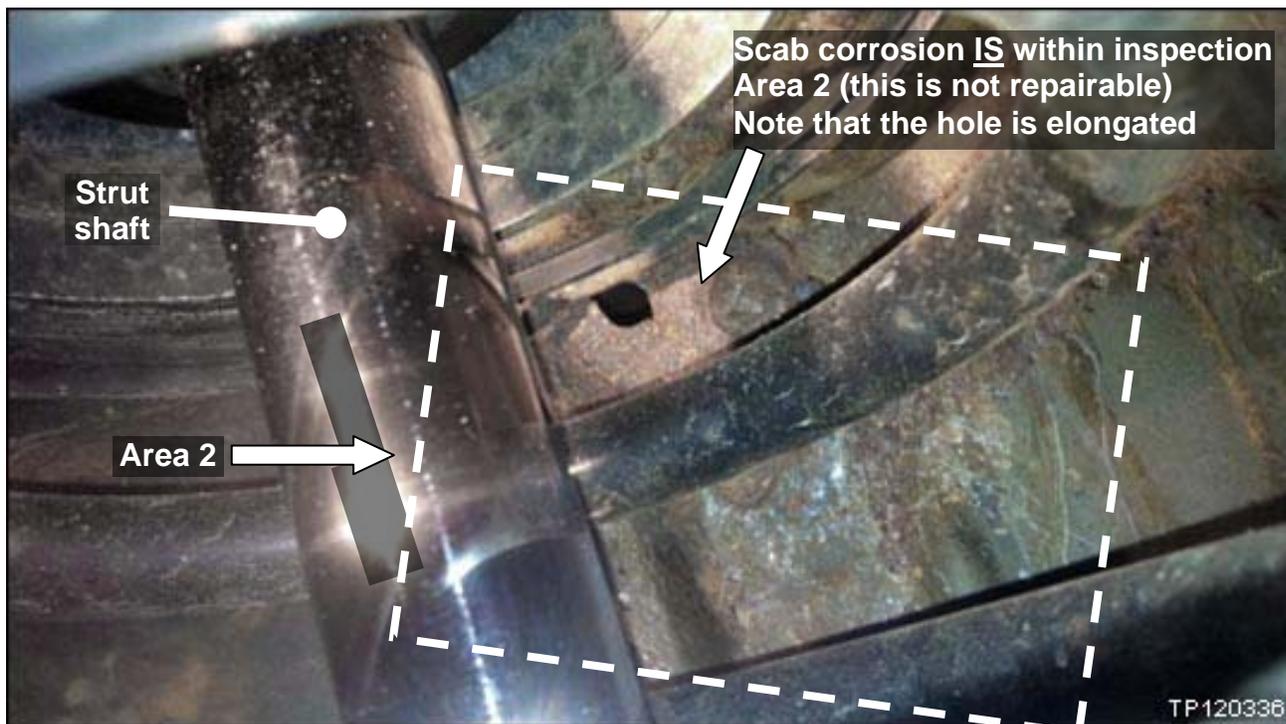
Example (Additional Photo) of Area 2 Scab Corrosion Inspection
