Technical Service Bulletin

GROUP CAMPAIGN	NUMBER 12-01-019
DATE JULY 2012	MODEL(S) SONATA (YF) SONATA (YF-HEV)

SUBJECT SONATA YF AND YF-HEV CURTAIN AIRBAG (CAB) REPLACEMENT (CAMPAIGN 106)

Description: This bulletin describes the procedure to replace the Curtain Airbag (CAB) on Sonata YF and YF-HEV vehicles.

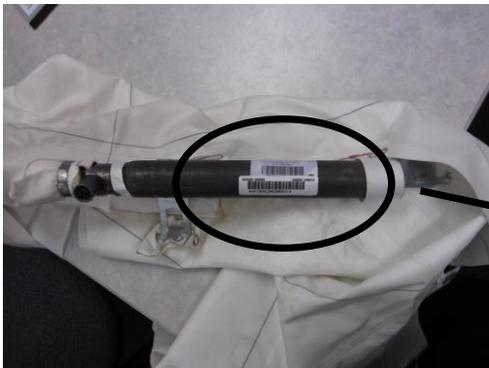
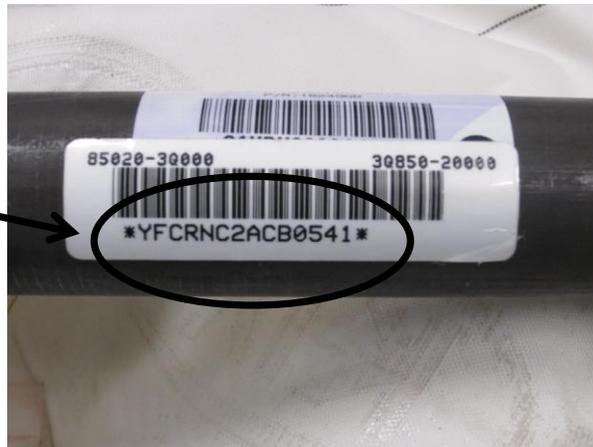
The serial number is a 14 digit number. Please clearly write down all the numbers.

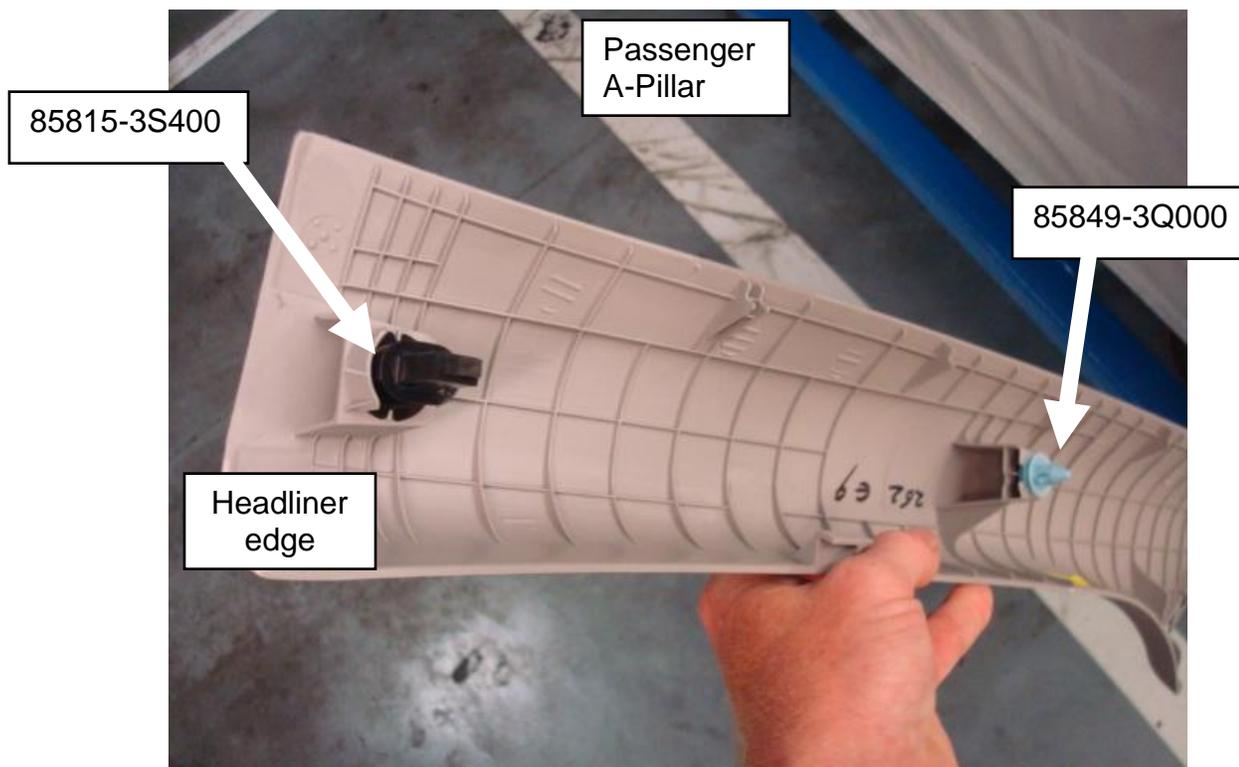
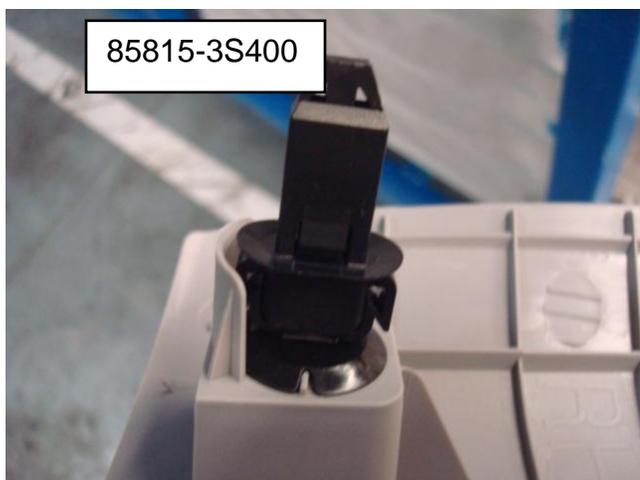
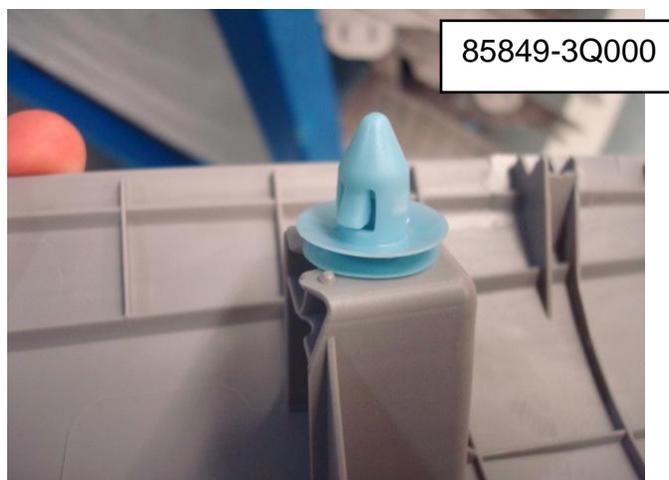
IMPORTANT: All repairs regardless of Passenger, Driver or both sides, ***must*** include two (2) each of 85815-3S400 (CLIP-TRIM MTG) and 85849-3Q000 (CLIP-TRIM MTG) to replace the clips on the LH and Passenger A-pillar trim. (See clip locations and images below.)

The tether clips **MUST** be replaced prior to installing the A-pillar trim pieces.

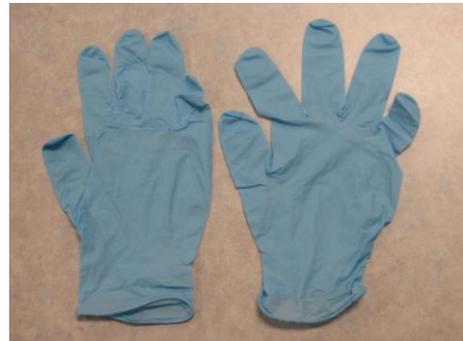
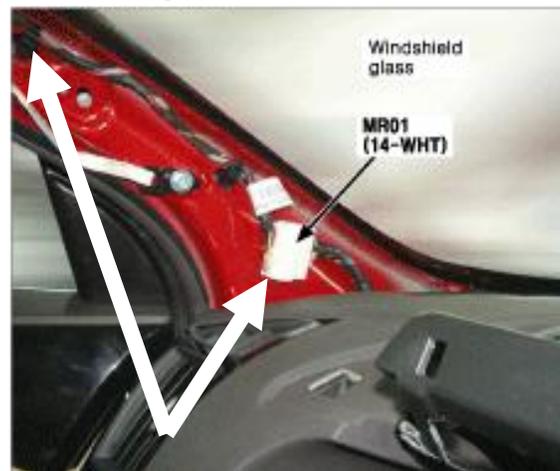
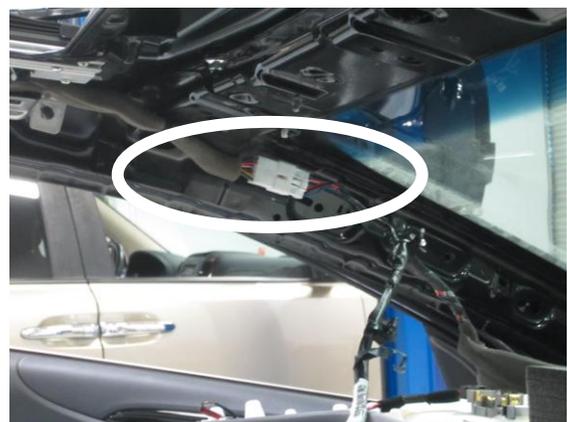
2. Carefully remove the body-side weatherstripping and A, B, and C-pillar trim panels following procedures detailed in the 2012-2013 Sonata Service Manual (Body Group(BD) section)

Disconnect connector MR01 at the Driver A-pillar and then remove the Roof Harness clips from the A-pillar.

Disconnect the connector on Driver A-pillar head liner.

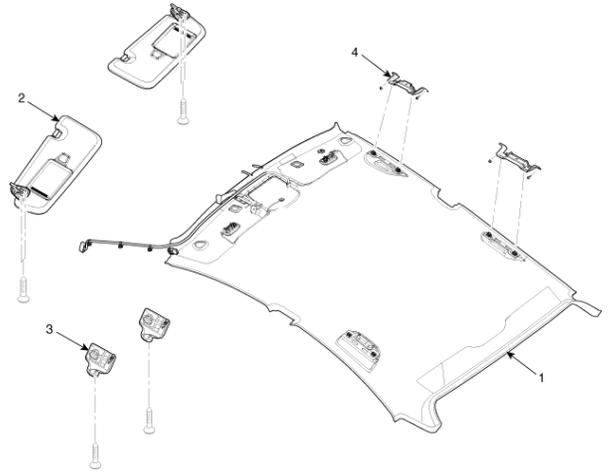
3. Follow the removal procedures detailed in the 2012 – 2013 Sonata Service Shop Manual (Body Group(BD) section) to remove the interior roof items.

- a. Driver and Passenger Sunvisors and retainers.
- b. Overhead Console and Room Lamp.
- c. Driver and Passenger front and rear Assist Handles, and Headliner Clips.
- d. Blue Link Mirror Connector.

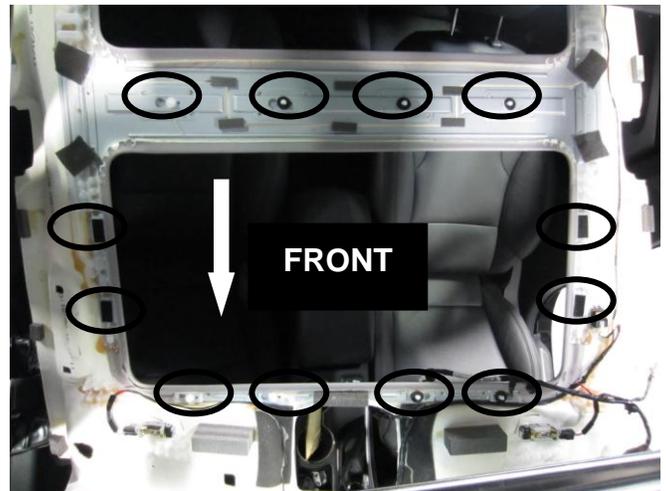
If vehicle is equipped with Sunroof or Panoramic Sunroof - use caution when removing the headliner clips around the sunroof opening to prevent damage to the headliner. Wear clean gloves to prevent contamination to the headliner.

For the vehicle equipped with sunroof - Note the mounting clips location along with the velcro.

In the picture to the right, the front of the vehicle is on the bottom.

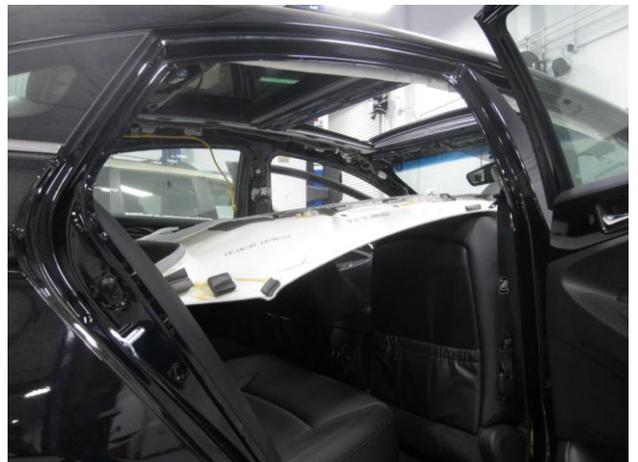
4. Place a protective cover over the dash to avoid permanent markings/scuffings on the dash panel from the corner of the headliner edges.

Remove both the driver and passenger headrest and then lower the headliner.

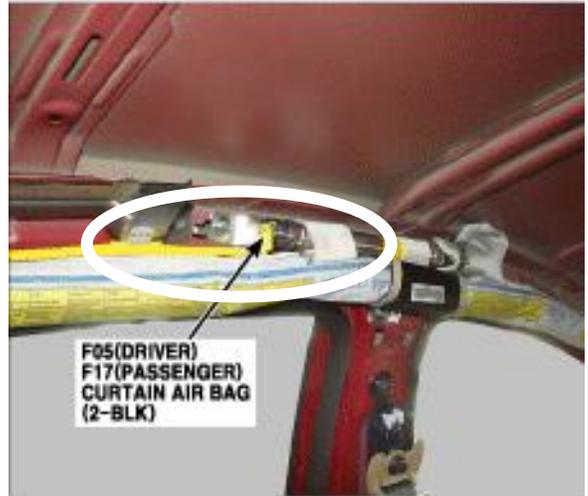
5. Record the Serial Number to the tracking sheet on page 3 of this TSB.
6. Carefully disconnect the Floor Harness connection to CAB inflator canister.
 - For Driver CAB, connector F05
 - For Passenger CAB, connector F17

Ensure the locking tab is released prior to separating the connector. Do not pull on the wires to disconnect the harness from CAB.

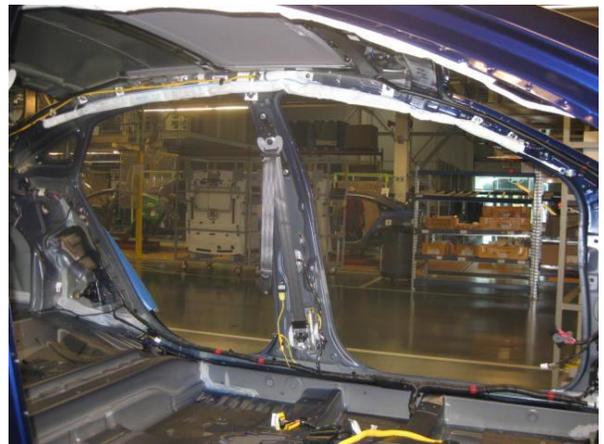
7. Remove all mounting bolts and nuts from the CAB assembly and remove the CAB from the vehicle.

Use caution when removing the CAB from the vehicle to prevent damage to the vehicle.

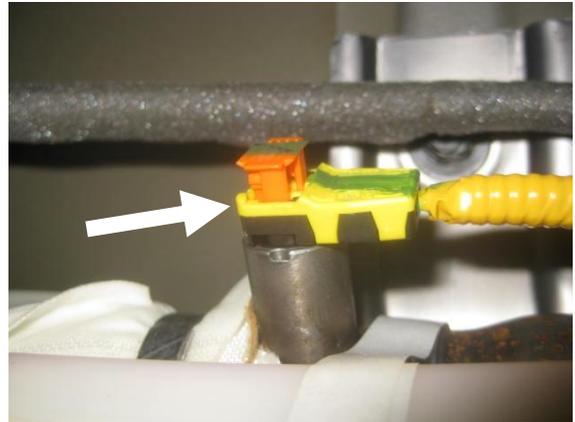
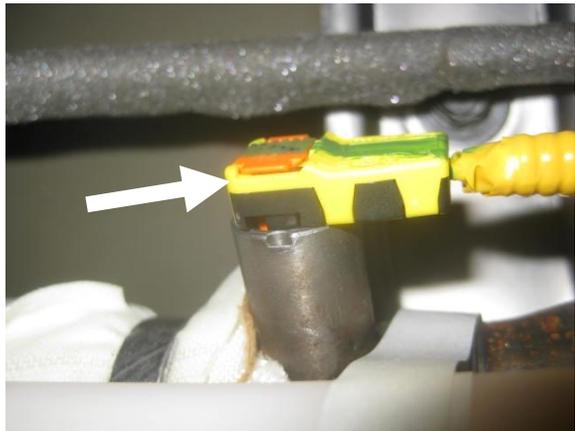
HANDLE WITH CAUTION!
Never twist the curtain airbag module during installation. If the curtain airbag module is twisted, it may not operate as designed.
