TMS-NTC-13202  
August 16, 2013

Re: Toyota Safety Recall 13V-133 Dealer Notification - Remedy

Subject: Safety Recall (D0F) – **Remedy Available**  
2003-2004 Model Year Corolla, Corolla Matrix, and Tundra Vehicles  
2002-Early 2004 Model Year Sequoia Vehicles  
Front Passenger Airbag Inflator Module

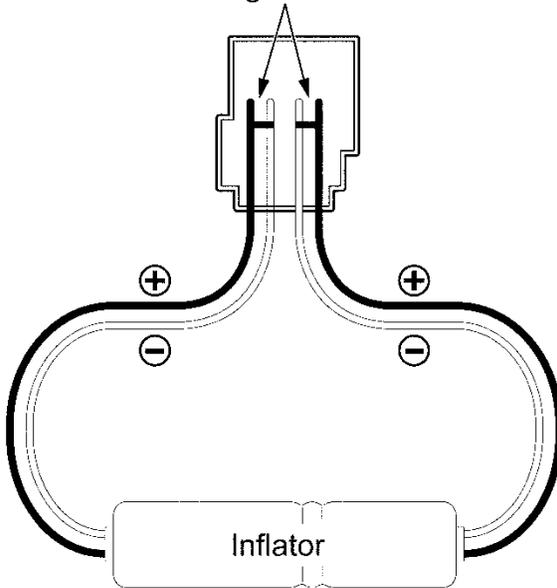
Short circuiting on both sides.

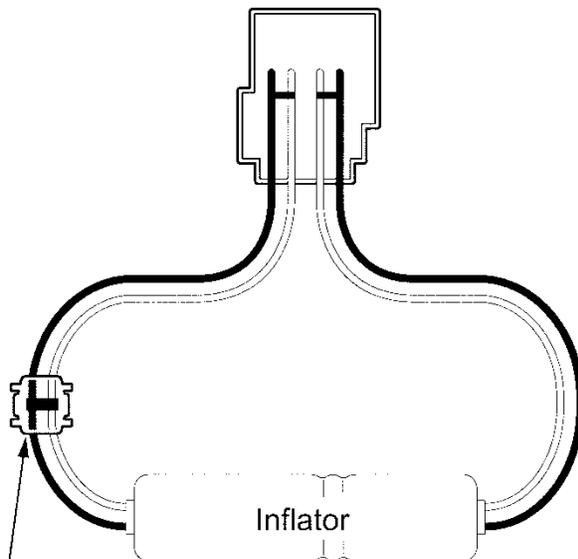
(2)

Create new short circuit using electro tap.

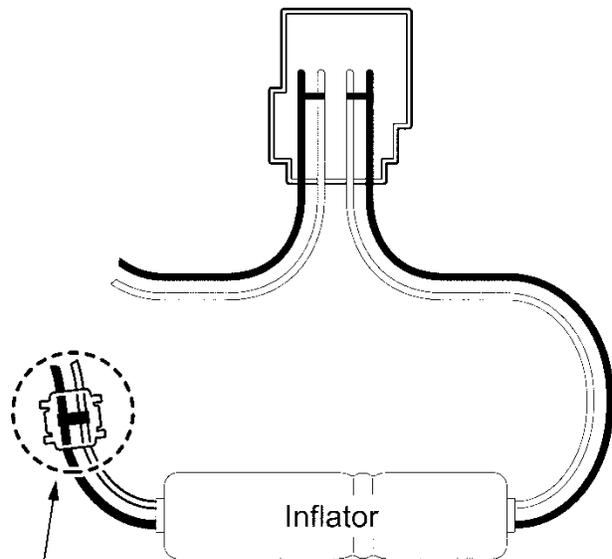
(3)

Short circuiting is maintained even after cutting harness.

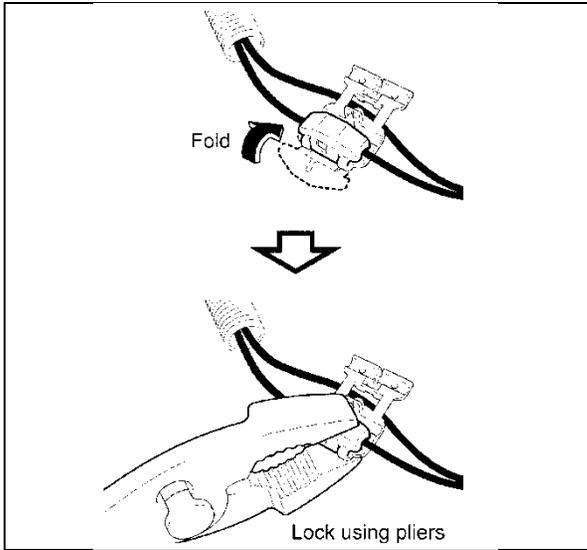
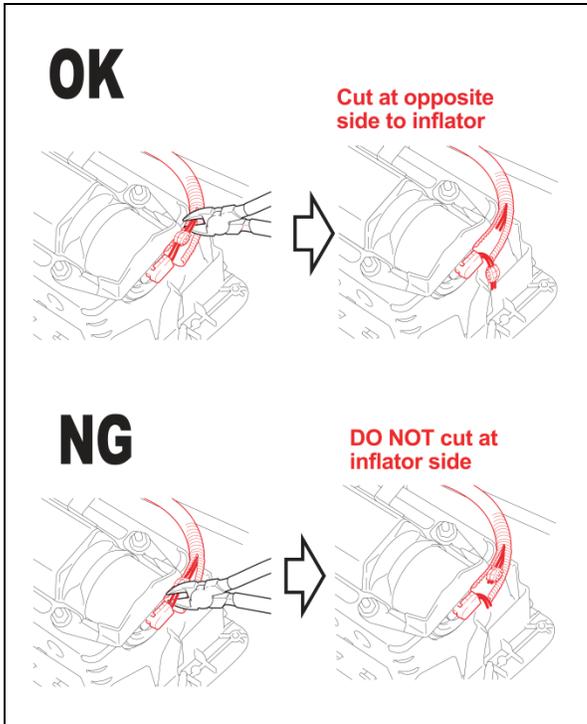
- Cut off the tab of the electro tap shown in the illustration.  
**NOTE: The electro tap is included in the inflator parts kit.**

This tab **MUST** be removed to ensure a good short.

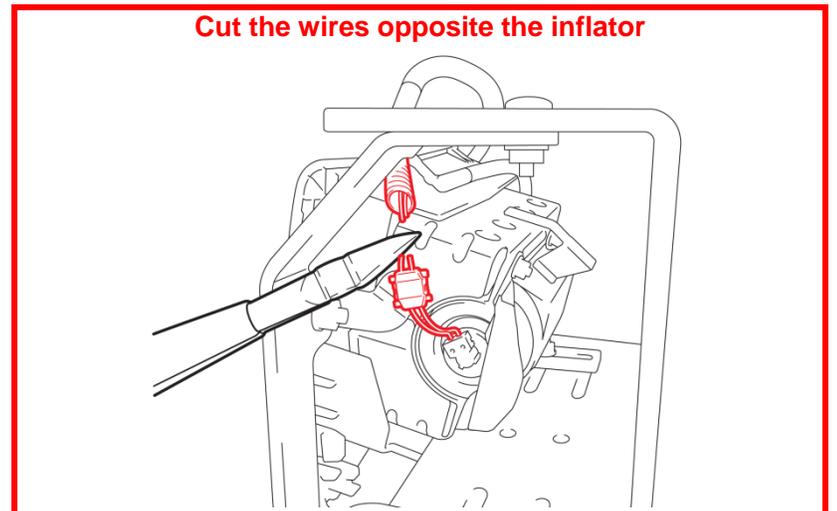
- a) Cut the 2 wires at the side of the electro tap that is farthest away from the inflator.

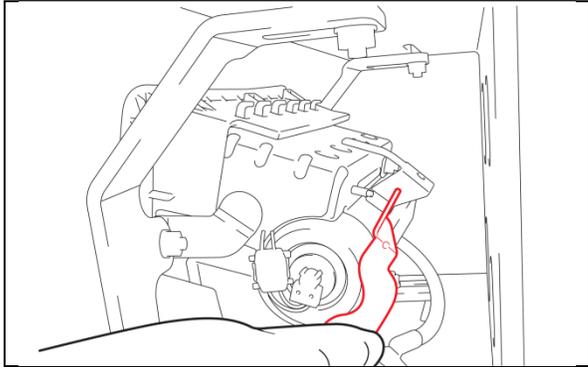
- **DO NOT** use power tools.
- The bracket support bars may need to be repositioned to remove the nuts through the access holes.

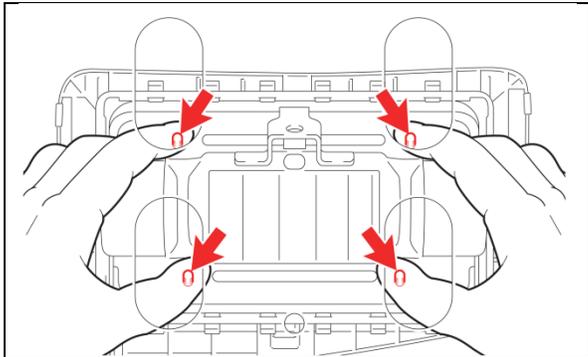
b) Remove the stopper plates.

c) Discard the 4 nuts and 2 stopper plates as they are not to be reused.

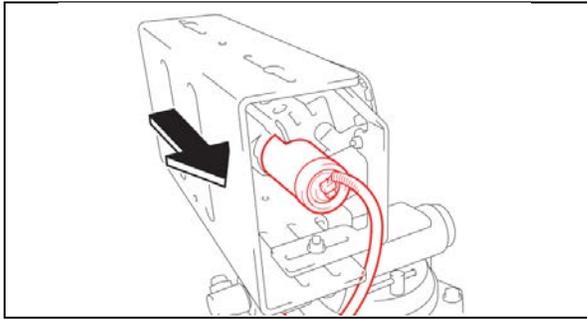
a) Gently push in the 4 studs to loosen the inflator for removal.

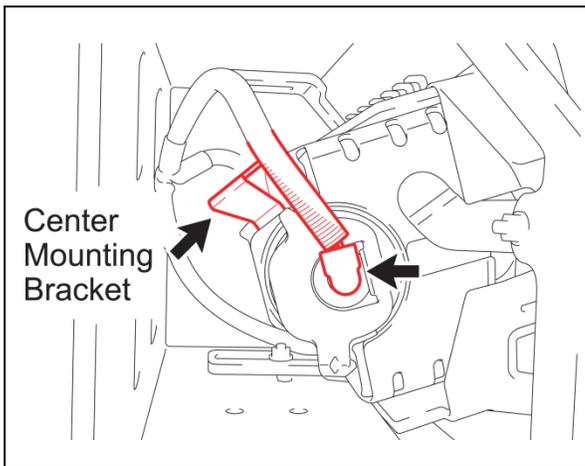
- There will be some resistance when tightening the nuts because they are self-locking, confirm the nuts are tightened correctly.
- DO NOT** use a power tool, T-handle, or ratchet when tightening the nuts to avoid overtightening.

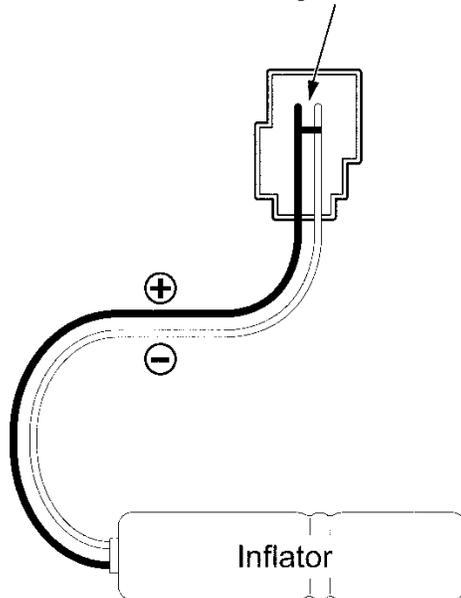
(1)  
Short circuiting on both sides.

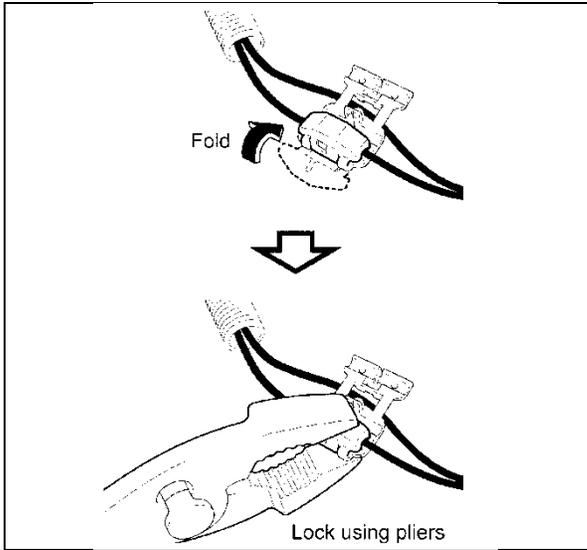
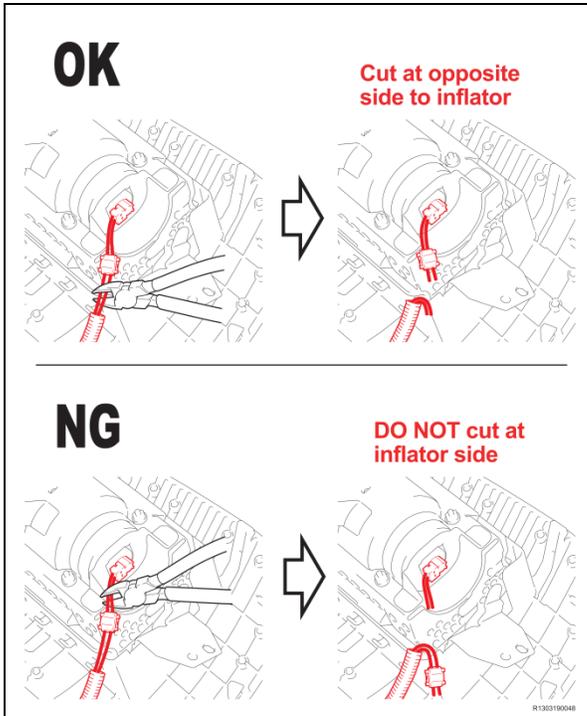
- b) Cut off the tab of the electro tap shown in the illustration.

This tab **MUST** be removed to ensure a good short.

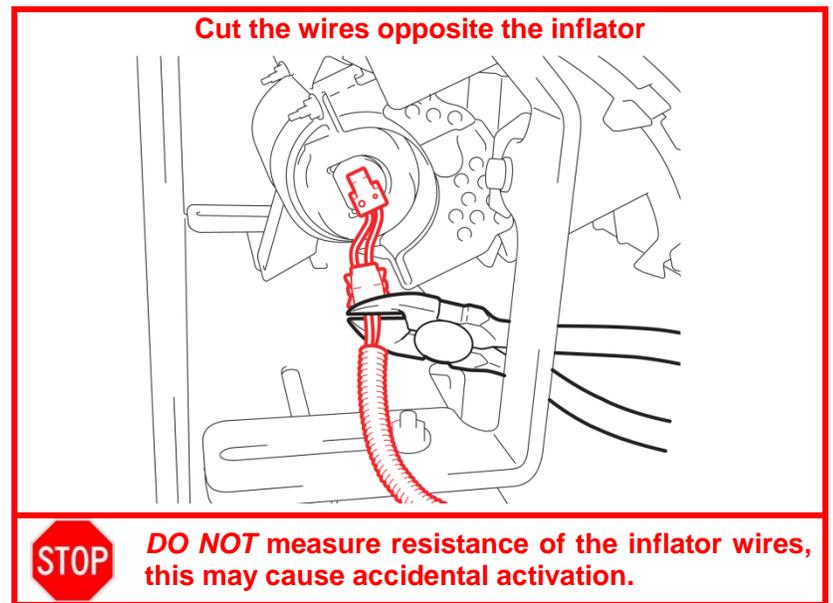
a) Cut the 2 wires at the side of the electro tap that is farthest away from the inflator.

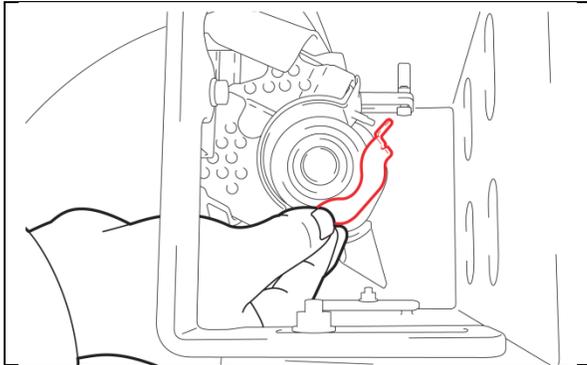
- **DO NOT** use power tools.
- The bracket support bars may need to be repositioned to remove the nuts through the access holes.

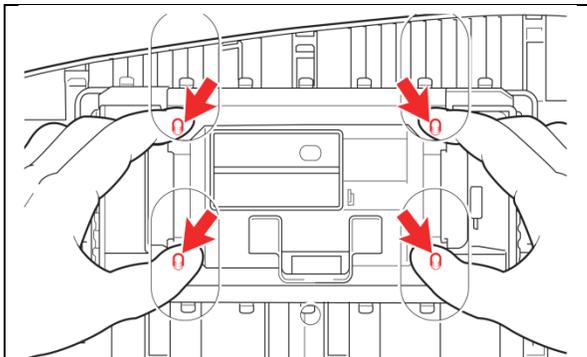
b) Remove the stopper plate.

c) Discard the 4 nuts and stopper plate as they are not to be reused.

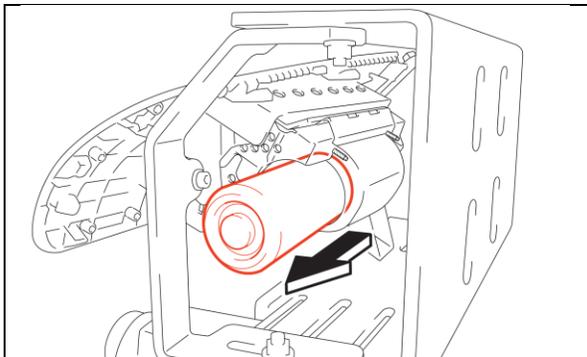
a) Gently push in the 4 studs to loosen the inflator for removal.

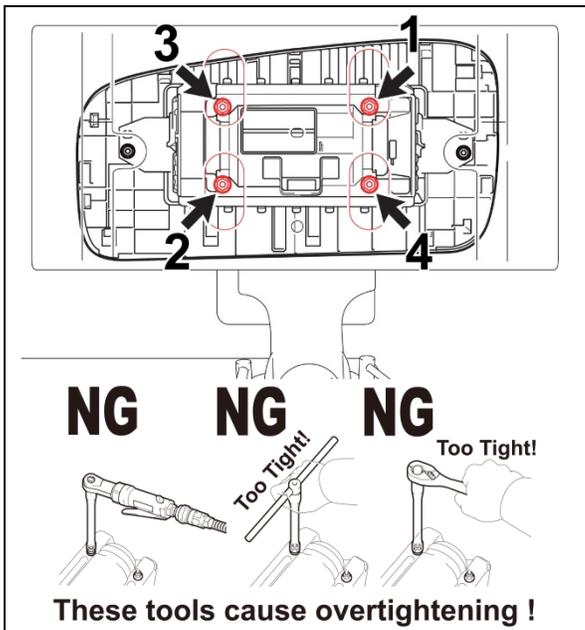
- a) Place the **NEW** stopper plate on the airbag assembly.
- b) Install **NEW** stopper plate nuts by hand. They will be torqued on a later step.
- c) Install the **NEW** nuts on the airbag assembly bracket by hand. They will be torqued on a later step.
