## Micro Brake Switch

**2007-2014 VN, VAH, VHD, VT**

### **RVXX1303, Micro Brake Switch**

#### **(August 2013)**

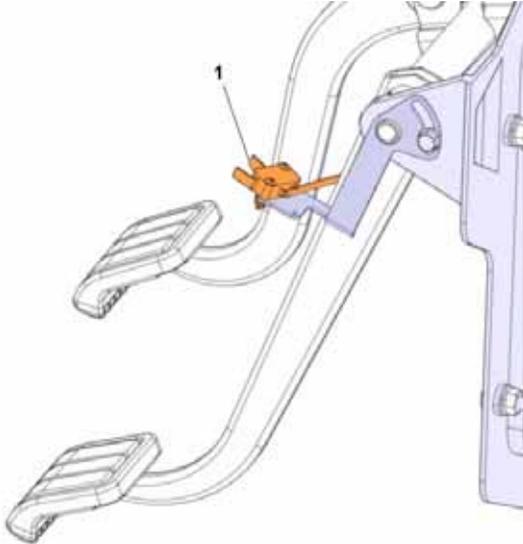
3. Install the micro switch onto the bracket and secure (1) (Part numbers 82274560, 25154798, 25106704 and 25160047). Torque the fasteners to 3 +/- 0.3 Nm (26 +/- 3 in-lb).  
NOTE: Install the switch onto the hole group located closest to the driver's seat.

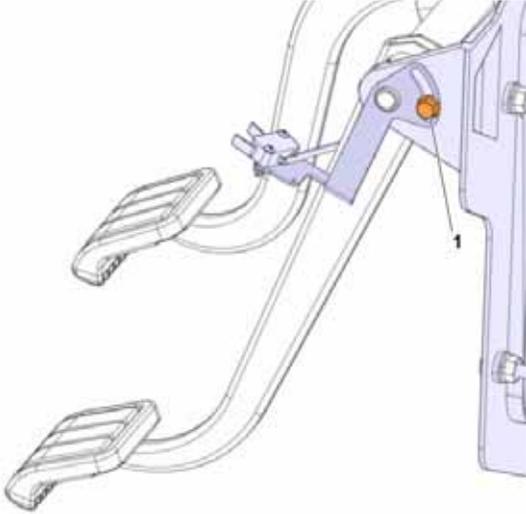
4. Locate the harness for the micro switch. Loosen the harness attached to the micro switch. Remove the jumper from between the harness and the micro switch.  
NOTE: Discard the removed jumper.
5. Reconnect the harness and the micro switch.

6. Loosen the brake micro switch adjustment screw.

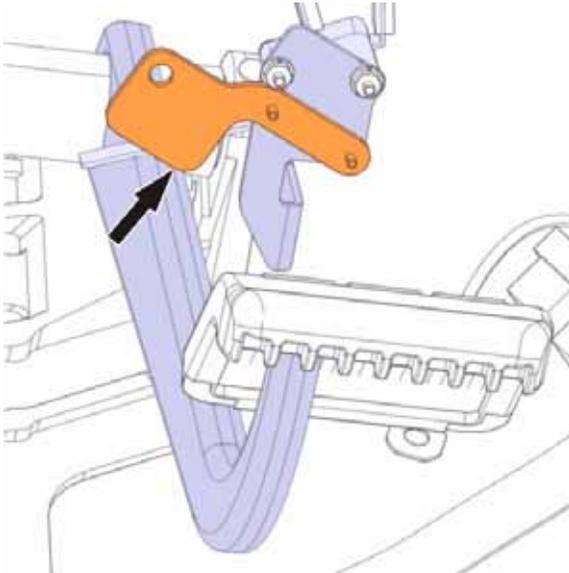
7. Install the Switch Adjustment Tool (part number 88800461) into the lower hole group on the brake switch bracket, as shown. If necessary, rotate the micro switch bracket assembly up/down until the tool touches the brake pedal arm.

NOTE: Ensure that the brake pedal is set at the recommended vehicle brake pressure.
