Re: **Extang Corporation's 573.6(c) Defect Information Report**

Brand Name: Extang **Model Name:** *Encore* **Model No.:** None

IMPORTANT SAFETY RECALL STOP SALE NOTICE

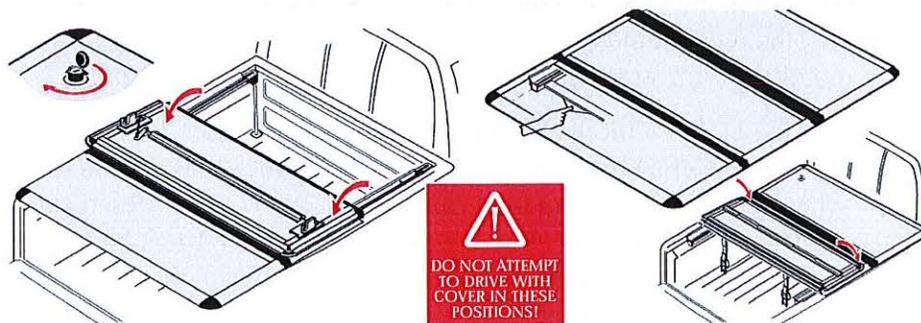
Figure 1 – *Encore* Tonneau Installation Sheet Excerpt

Extang's *Encore* tonneau cover is a hard panel, tri-fold pick-up truck bed cover that has been in production since September 2011 and sold in the U.S. as an aftermarket accessory for pick-up trucks. The rear latch secures the cover at the tailgate and the front latch and lock secures the front panel at the cab. The front and rear-most cab panels can be unlatched and opened, allowing access to the front or back area of the truck bed as noted in *Figure 1*, below.

Both panels must be closed and secured during vehicle operation. The *Encore* is the only tonneau cover manufactured by Extang with a front cab panel that can be unlatched and opened.

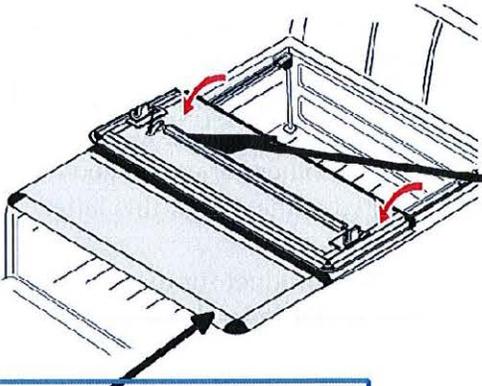
How to Identify an Encore Tonneau Cover

The diagram shows a perspective view of the Encore Tonneau Cover installed on a truck bed. Red arrows point to the front panel and the rear panel. A black arrow points from the front panel to a callout box containing a part number label. Another black arrow points from the rear panel to a callout box containing a shipping box marking label.

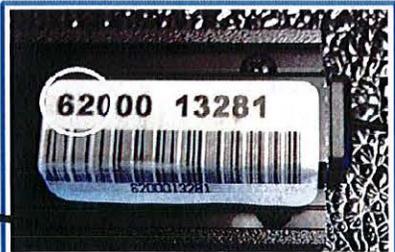
This part number label will appear on the inside of the front panel. The *Encore* tonneau covers all start with "62xxx" in the part number sequence.

This label will appear at the right rear of the *Encore* tonneau cover.

Shipping box markings for the *Encore* tonneau cover (includes part number "62xxx").
