HYUNDAI

Technical Service Bulletin

14-01-001

SUBJECT: FRONT LOWER ARM CORROSION TREATMENT (RECALL 115)

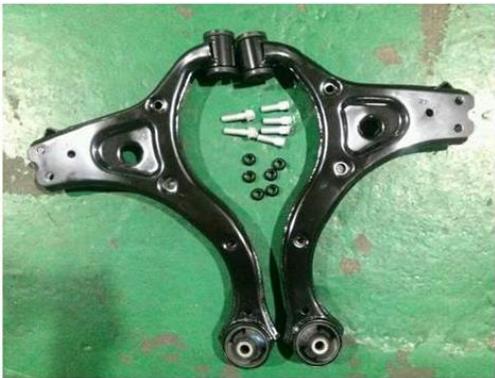
54500-4D102QQH	Front Lower Arm Kit (Left and right lower arms, hardware, and bushings)

54500-18GAP	Front Lower Arm Thickness Gauge

The Thickness Gauge shown below will be sent to dealers separately from the Front Lower Arm Kit. Additional gauges can be ordered through the PDC using the listed part number.

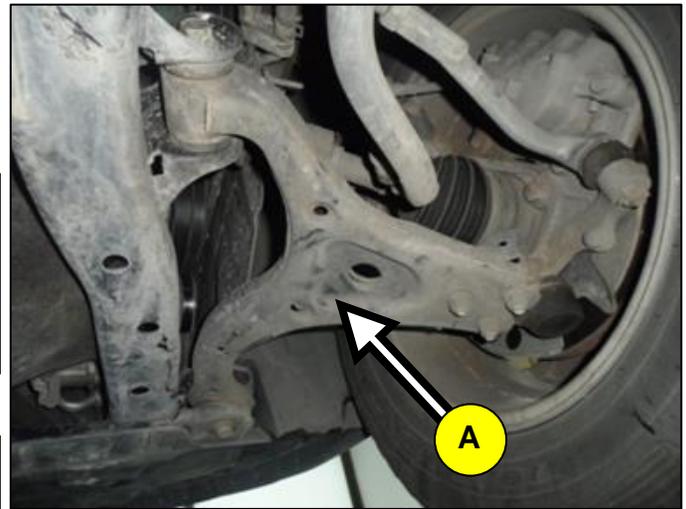
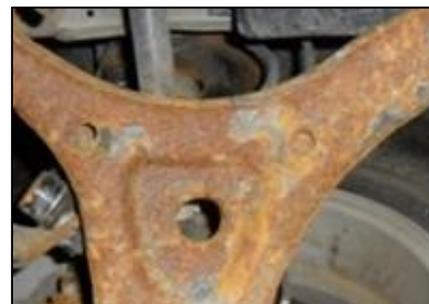
1. Lift the vehicle on a hoist, check if there are any holes due to corrosion on both front lower arms (A).

Example of corrosion

If any holes due to corrosion are found on either front lower arm, skip the rest of the inspection procedure and proceed to 'FRONT LOWER ARM REPLACEMENT' on page 8.

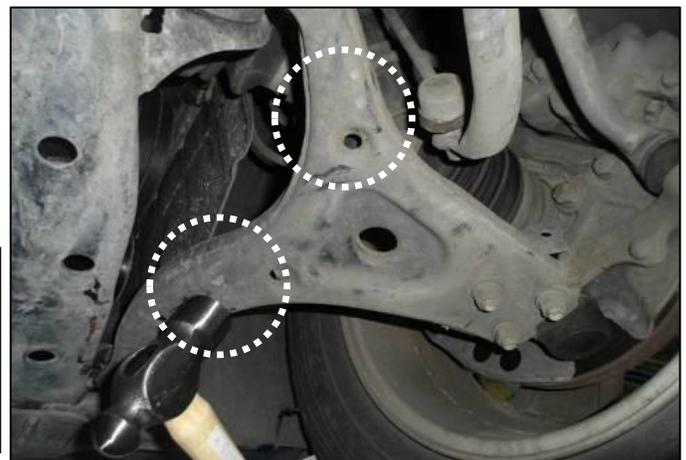
2. Using a 16 oz. hammer, lightly tap the circled areas shown on the photo to the right to remove loose debris to expose the arm.

Inspect the arm for any corrosion damage.

If any of the circled areas on either arm show signs of corrosion damage, skip the rest of the inspection procedure and proceed to 'FRONT LOWER ARM REPLACEMENT' on page 8.

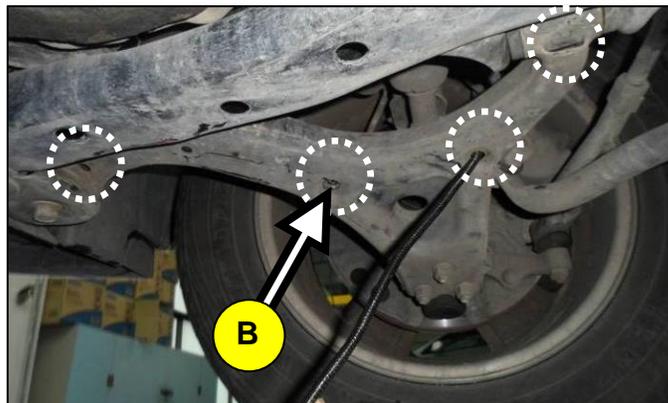
3. Insert the magnetic stick into the circled holes (B) of the lower arm to remove interior debris.

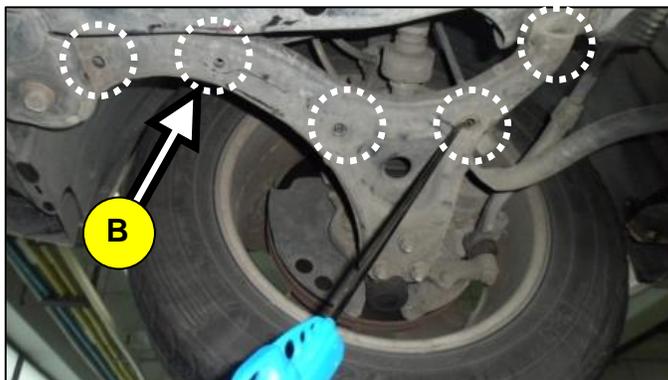
4. Remove the remaining debris in the lower arm by inserting an air gun into the circled holes (B) of the lower arm. Blow the air in multiple directions to remove as much debris as possible.

Repeat this step two to three times to remove the remaining debris from inside the lower arm.

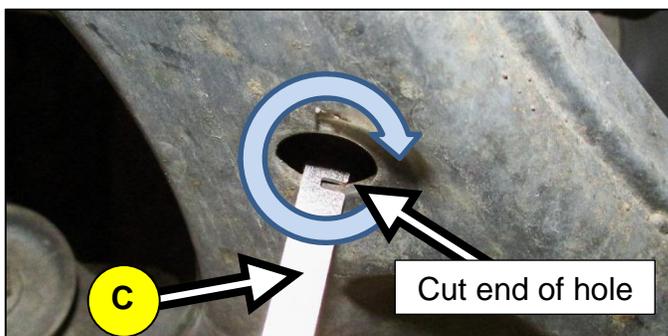
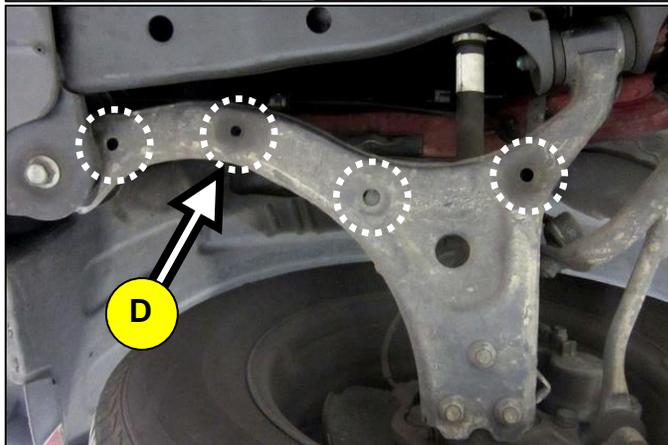
5. Use the lower arm thickness gauge (C), to measure the thickness around each of the cut ends of the four circled holes (D) of lower arm. Repeat this step on the other front lower arm.

If the gauge can be inserted over any of the cut ends of the holes of either arm, replace **both** front lower arms following the 'FRONT LOWER ARM REPLACEMENT' procedure on page 8.

If the gauge cannot be inserted over any of the cut ends of the holes on either arm, perform the 'FRONT LOWER ARM WAX / UNDERCOATING APPLICATION' procedure on page 11.

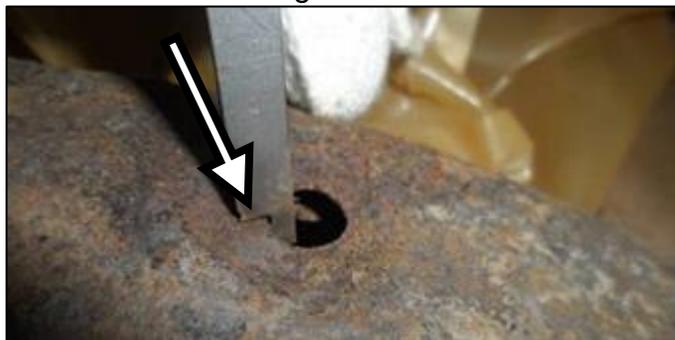
Gauge inserted

LOWER ARM **NO GOOD**

Proceed to the 'FRONT LOWER ARM REPLACEMENT' on page 8.

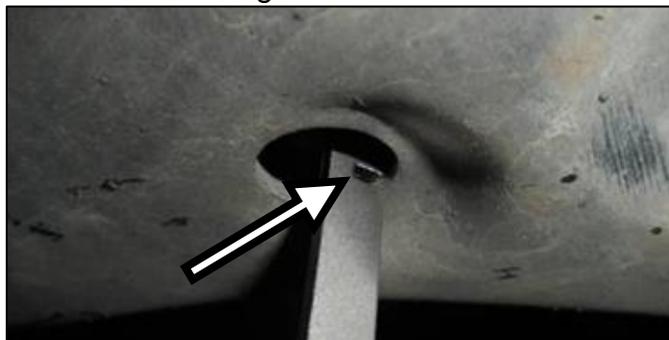
Gauge NOT inserted

LOWER ARM **GOOD**

Proceed to the 'FRONT LOWER ARM WAX / UNDERCOATING APPLICATION' procedure on page 11.

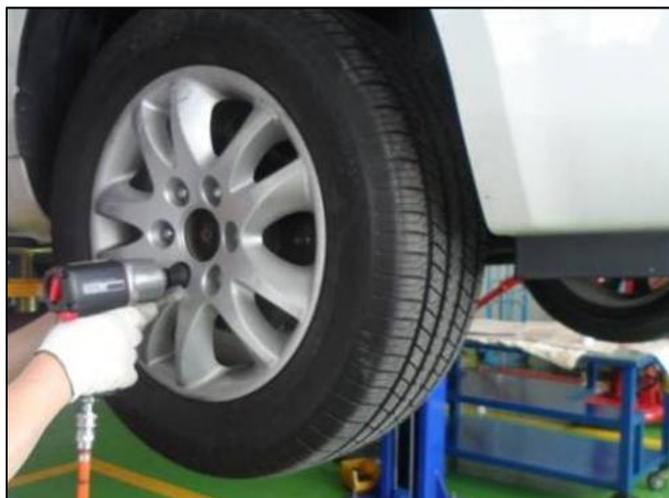
2. Remove the three ball joint nuts, studs, and bolt (A) and separate the ball joint from the lower arm. Discard the nuts, studs, and bolt. During reinstallation use the hardware supplied in the kit.

Ball Joint Nut Tightening Torque:

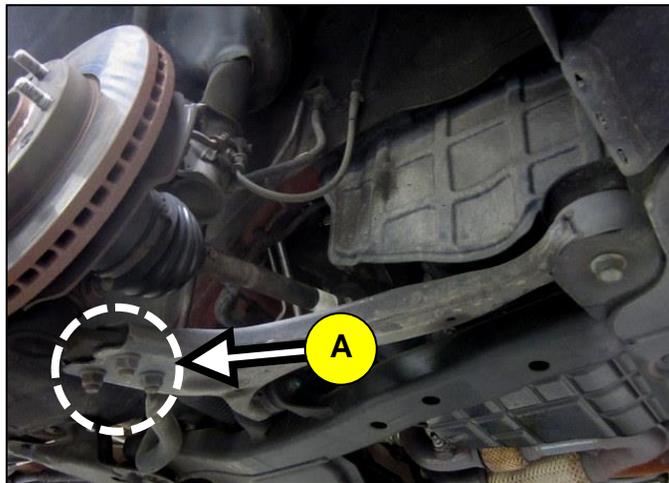
72.3 ~ 86.8 lb-ft (98.1 ~ 117.7 Nm, 10.0 ~ 12 kgf.m)

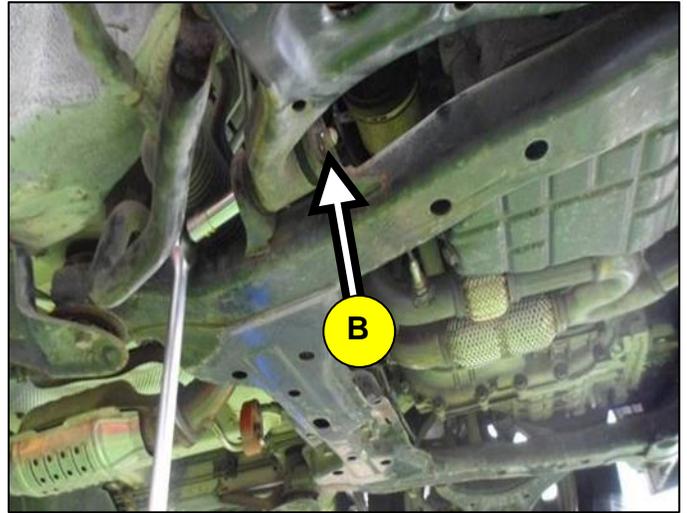
3. Remove the lower arm rear nut and bolt (B).

Tightening Torque:

115.7 ~ 130.2 lb-ft (156.9 ~ 176.5 N.m, 16.0 ~ 18.0 kgf.m)

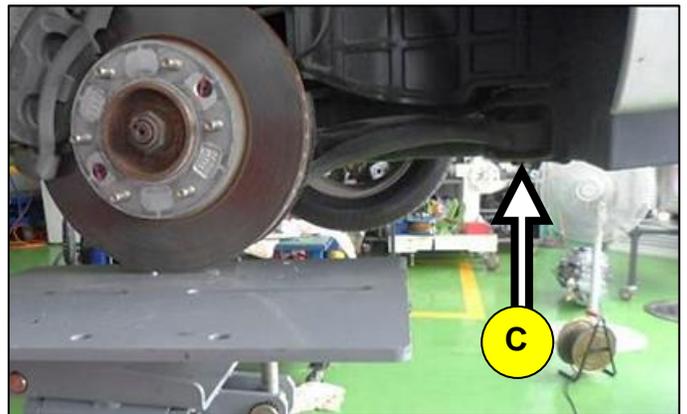
4. Remove the lower arm front nut and bolt (C).

Bolt Tightening Torque:

115.7 ~ 130.2 lb-ft (156.9 ~ 176.5 N.m, 16.0 ~ 18.0 kgf.m)

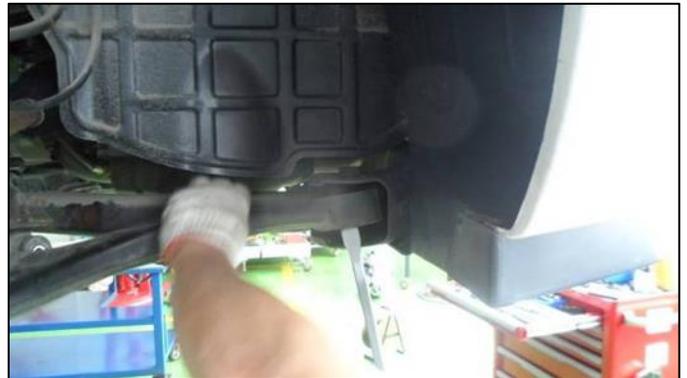
5. Remove the lower arm. It may require the use of a pry-bar.

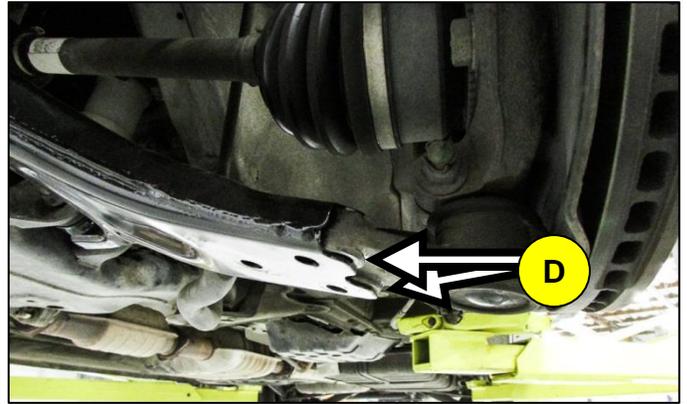
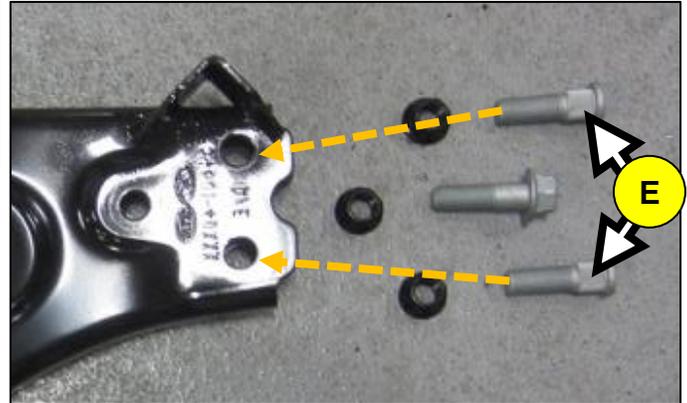
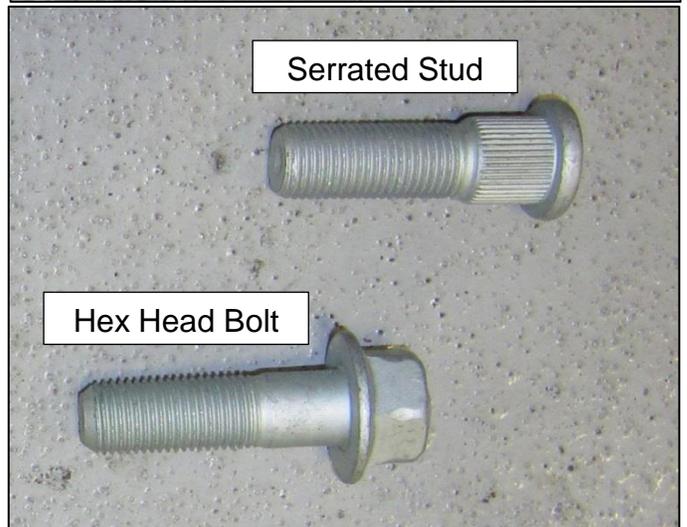
6. Installation of the new lower arm is reverse of removal.

Tap the areas shown by the arrows (D) to help insert the lower ball joint into the lower arm.

After the lower ball joint is inserted to the lower arm, ensure that the two serrated studs (E) are installed in the locations shown in the photo to the right.

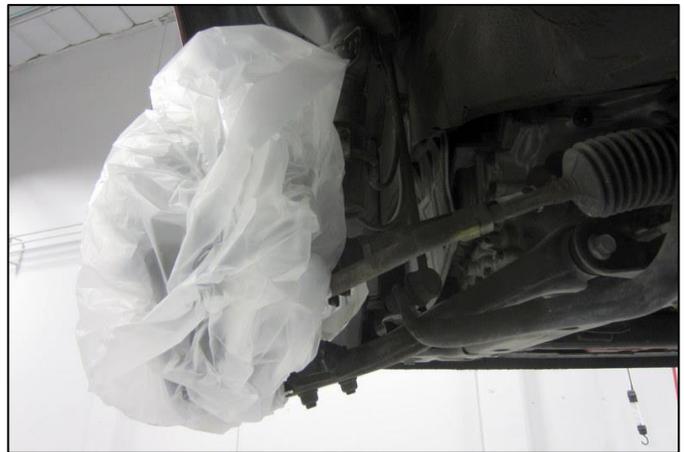
3. Wrap plastic bags around both front brake assemblies to protect it from overspray.

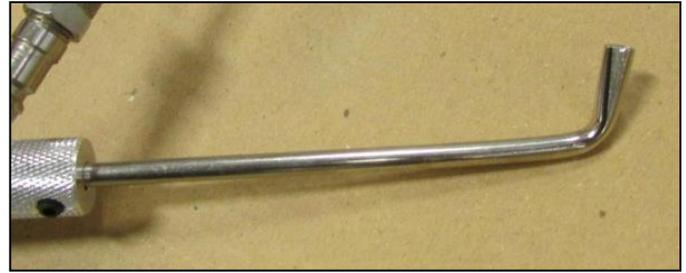
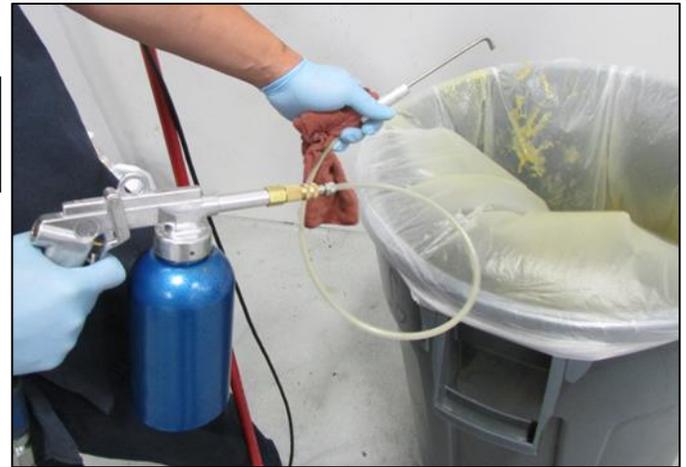
4. Select the nozzle shown to the right to spray the interior of the lower arm.

When spraying the wax, a light mist should be visible. If no mist is seen, point the nozzle in a safe direction, and press the gun's trigger until a mist is visible.

Supply air pressure must be set to 70 PSI.

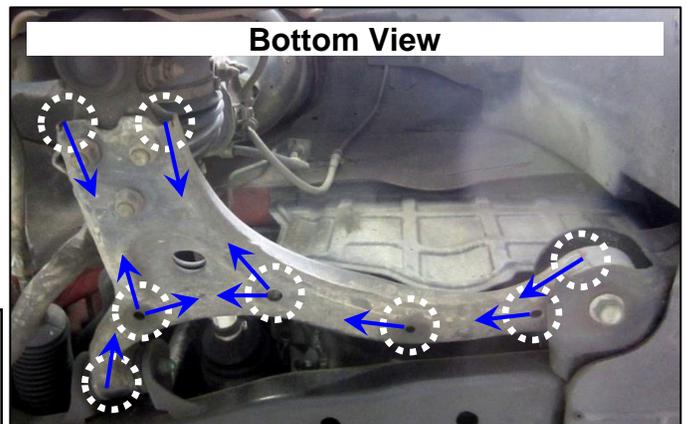
Bottom View

5. Spray cavity wax in the interior of the front lower arms through the top and bottom holes.

Locations (circled) and wax spraying directions (arrows) are shown in the photos to the right.

Spray the wax in each location for 15 seconds. A light mist of wax should be visible indicating good wax flow.

Some locations show multiple directions. For these locations, rotate the nozzle while spraying to ensure good coverage.

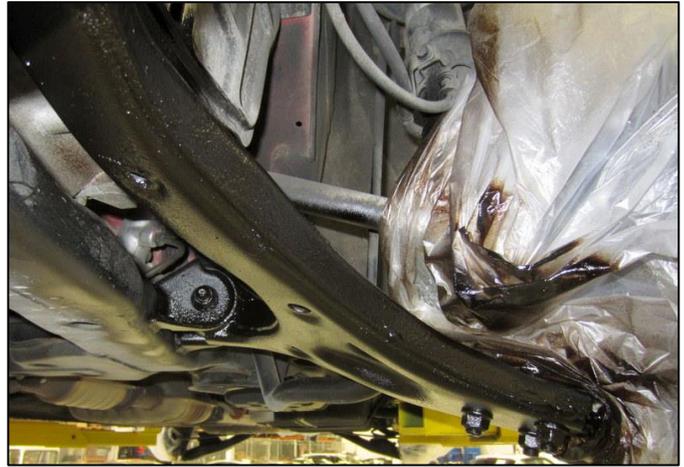
6. Spray the black undercoating on all exterior surfaces of the lower arms.
