Bulletin No.: 15406A
Date: November 2015

Recall Bulletin

SUBJECT: **Front Passenger Air Bag Inflator Module**

MODELS: **2004-2007 Pontiac Vibe**
Currently Registered or Previously Registered in Alabama, Florida, Georgia, Hawaii, Louisiana, Mississippi, South Carolina, Texas, Guam, Puerto Rico, Saipan, U.S. Samoa or U.S. Virgin Islands

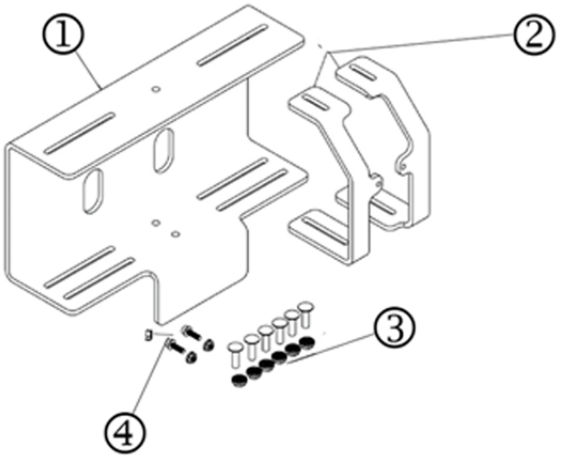
4006668

(1) Mounting Bracket (2) Support Bars (3) Support Bar Hardware (4) Air bag Mounting Hardware.

Note: Dealers are required to use the air bag mounting bracket, shown below, to perform the front passenger air bag inflator module replacement procedure. These brackets were previously provided to all registered Pontiac Service Stations and all Chevrolet dealers for product safety recalls 13112 and 14491. A list of the dealers that were shipped this special tool is available in the GM GlobalConnect Library. Check this list to identify a dealer in your area that has the tool and request to borrow the air bag mounting bracket. You're GM District Manager – Aftersales

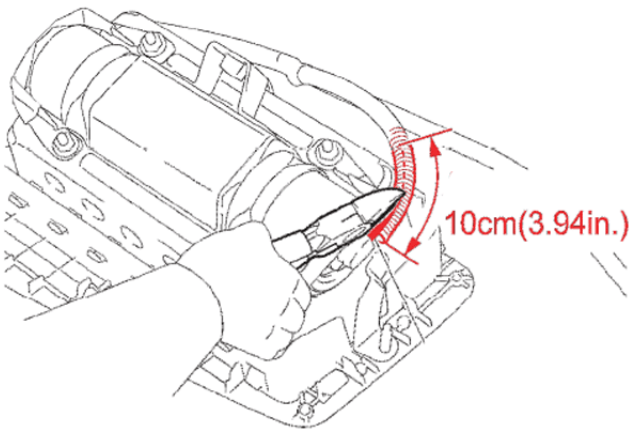
3470432

Note: The connector of an air bag inflator has a short-circuiting mechanism that eliminates voltage difference when disconnected (1). To allow for the replacement of the inflator module, a new short circuit using and electro tap (2) MUST be created BEFORE cutting the wires (3) and removing the inflator.

7. Create a short circuit before disconnecting the inflator wire harness.

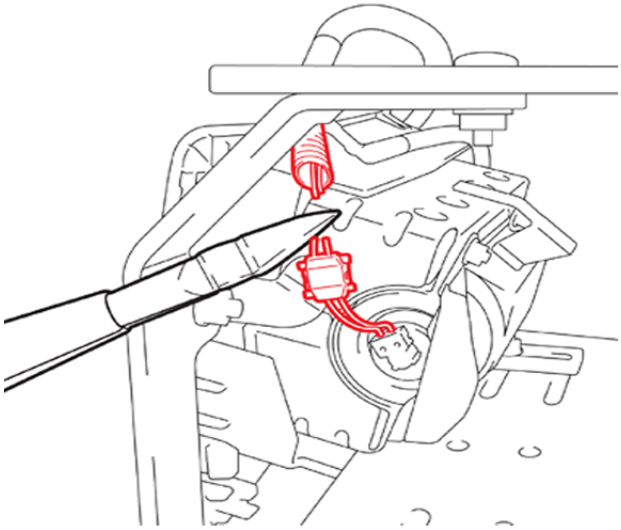
3607837

OK: Cut wires at opposite side to inflator. NG: Do NOT cut at inflator side.

Caution: Ensure to cut the two wires at the correct location. Refer to the illustration.

8. Cut the two wires at the side of the electro tap opposite to the inflator (the side of the electro tap that is farthest away from the inflator).

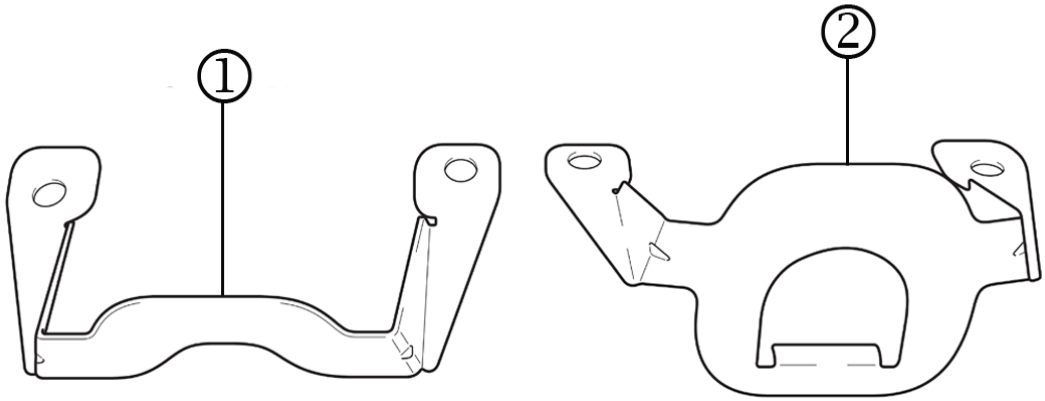
3607880

14. Confirm the identification of the stopper and the position determining plate. ***THEY ARE DIFFERENT.*** Refer to the illustration: (1) Stopper Plate (2) Position Determining Plate.
