Center for Auto Safety White Paper on Concerns With Chrysler Recall of the Jeep Grand Cherokee and Liberty Presented to NHTSA July 1, 2013

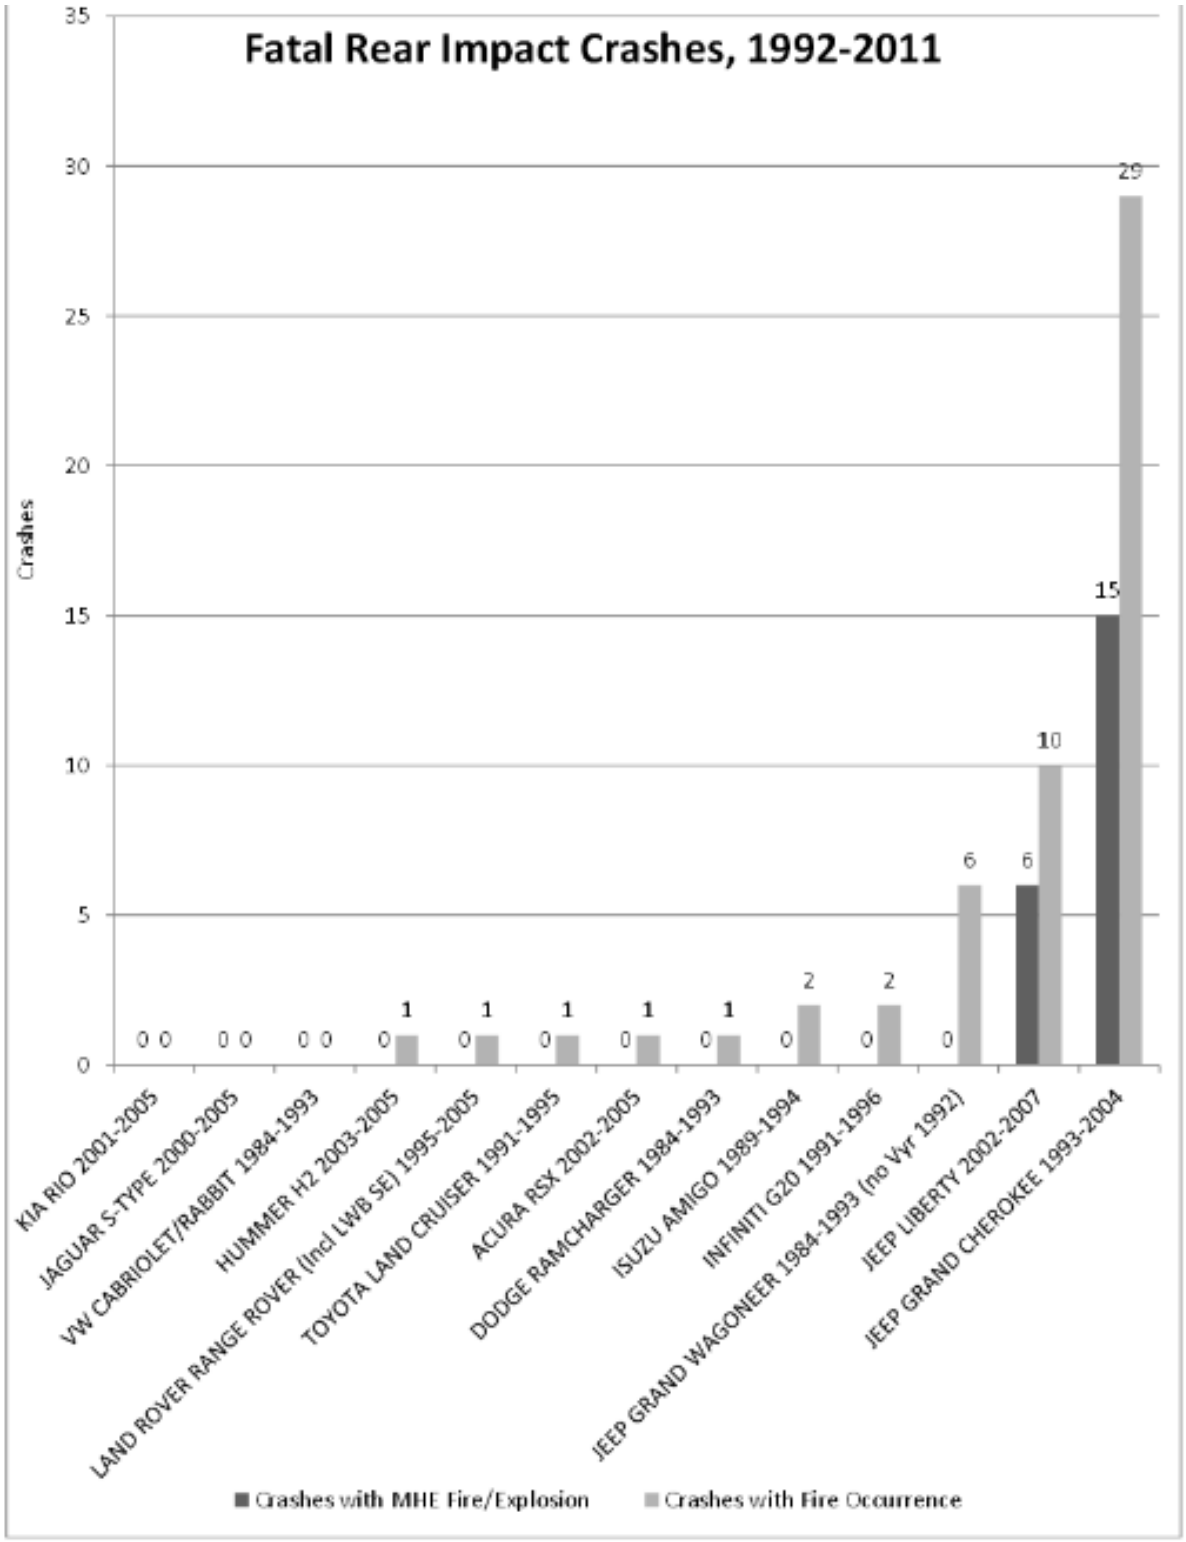
Chrysler has produced various tables that claim to show that Jeep Grand Cherokee and Liberty models have crash fire rates that are no worse than most other vehicles. We looked at the FARS files from 1992-2011 for the 31 vehicles where some or all of the vehicles were made in 1993 or later and found quite a different picture. Figure 1 shows that the Grand Cherokee and Liberty had 21 crashes (15 for the former and 6 for the latter) where fire was listed as the most harmful even and 39 crashes where there was fire (29 and 10, respectively). By comparison, eleven of the Chrysler so-called comparable vehicles did not have any crashes where fire was the most harmful event. Thirteen more vehicles had only one or two rear impact fire crashes. Only the 1994-2004 Ford Mustang has a comparable Fire-MHE fire rate. [5] <u>What Chrysler was doing was counting trauma deaths along with fire deaths knowing that compact vehicles like the 2300# Toyota MR2 would always have a higher fatality rate due to trauma versus fire compared to the 4100# Grand Cherokee</u>.

Figure 1. A comparison with the subject Jeeps and other vehicles that Chrysler had purported to show had worse rear impact fire performance but which had no deaths due to fire in FARS in rear impacts where there was a fire in the listed vehicle.

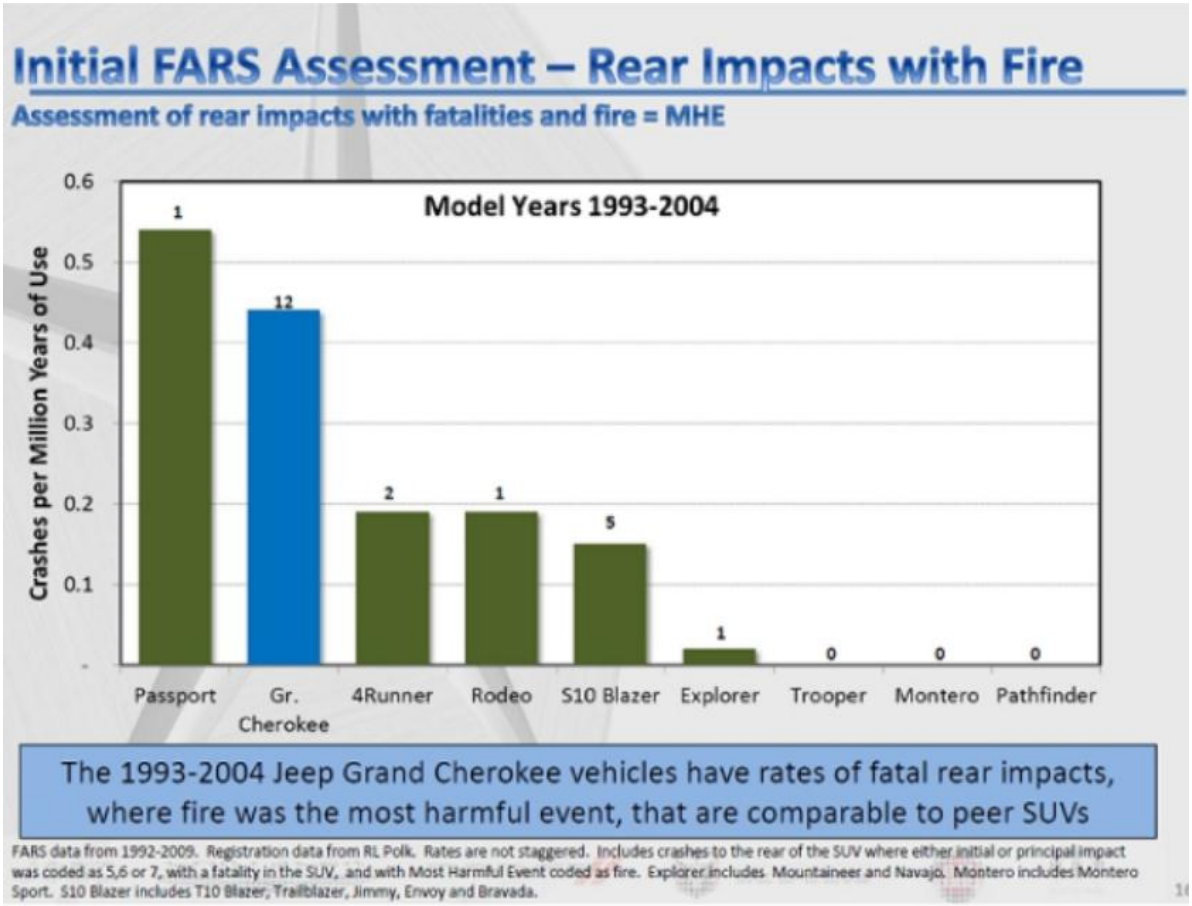
Looking at Chrysler's own chart which normalized these results (Figure 2) for the Grand Cherokee – with 12 cases where fire was the most harmful fatal event – had 4.4 per hundred thousand vehicle-years of use. The Honda Passport, which is a sister of the Isuzu Rodeo and should have been included with them, had only one crash on this chart, but when we looked at this case it was not even a rear impact but rather a frontal with a Chevrolet Tahoe.[6] (Also, because of the small population of these vehicles, there were a

Figure 2. A chart submitted by Chrysler as part of their early response to NHTSA's investigation. Note that while Chrysler combined sisters and clones in most cases, it did not combine the very small volume Honda Passport with its sister Isuzu Rodeo.
