Subject: Safety Recall BLG (Interim B2G) - Remedy Available
Certain 2004 and 2005 Model Year ES 330 and RX 330 and Certain 2006 Model Year RX 400h Vehicles
1MZ-FE/3MZ-FE V6 Engine Crankshaft Pulley

CRANKSHAFT PULLEY REPLACEMENT

**CERTAIN 2004 – 2005 MODEL YEAR ES330 & RX330
CERTAIN 2006 MODEL YEAR RX400h**

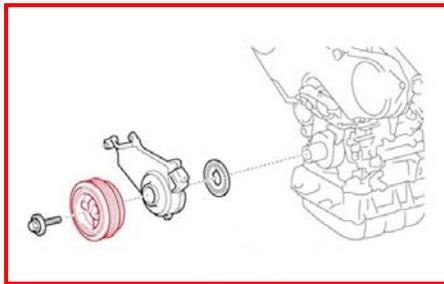
In certain 2004 and 2005 model year ES 330 and RX 330 and certain 2006 model year RX 400h vehicles equipped with a 1MZ-FE or 3MZ-FE V6 engine, the amount of adhesive agent applied between the outer ring and the torsional rubber damper (inner ring) in the crankshaft pulley may be inadequate. If the adhesive is insufficient, there is a possibility that the outer ring may become misaligned and it may not properly rotate with the inner ring, causing noise and/or illumination of the discharge warning light. In some cases, the belt for the power steering pump may become detached from the pulley. The driver may notice a sudden increase in steering effort. A sudden increase in steering effort could increase the risk of a crash.

Lexus dealers will inspect the engine crankshaft pulley and, if necessary, replace it at **NO CHARGE** to the vehicle owner. For additional information on inspection and repair procedures, please refer to TIS.

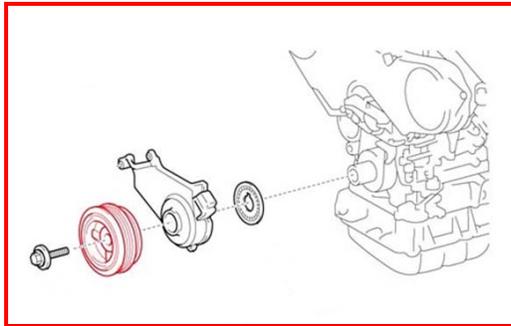
In certain 2004 and 2005 MY Camry, Camry Solara, Highlander, Sienna, certain 2004 MY Avalon, and certain 2006 MY Highlander HV vehicles equipped with a 1MZ-FE or 3MZ-FE V6 engine, the amount of adhesive agent applied between the outer ring and the torsional rubber damper (inner ring) in the crankshaft pulley may be inadequate. If the adhesive is insufficient, there is a possibility that the outer ring may become misaligned and it may not properly rotate with the inner ring, causing noise and/or illumination of the discharge warning light. In some cases, the belt for the power steering pump may become detached from the pulley. The driver may notice a sudden increase in steering effort. A sudden increase in steering effort could increase the risk of a crash.
