**RE: Defect Information Report – Supplemental Report No. 4
11V-514, FL-614, Rack and Pinion Steering Pinion Bearings
Dealer Notice**

Subject: Rack and Pinion Steering Pinion Bearings

Models Affected: Specific Freightliner Cascadia, Century Class S/T, Classic XL, Columbia, and Coronado vehicles manufactured November 1, 2004, through June 15, 2010, with a ThyssenKrupp rack and pinion steering system.

June 2012
FL614AB
NHTSA #11V-514
Transport Canada #11-367

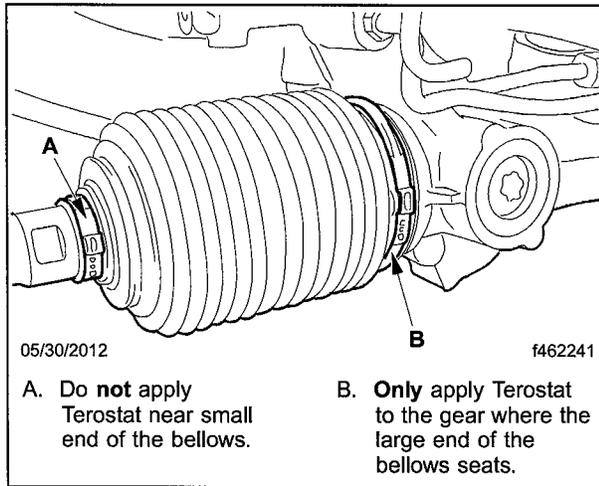
Fig. 9, Apply Terostat To Large End of Bellows

Do not allow Terostat MS 939 sealant to come into contact with the inner tie rods. Mistakenly applying sealant to the inner tie rods may cause damage to the bellows and the gear. See Fig. 9.

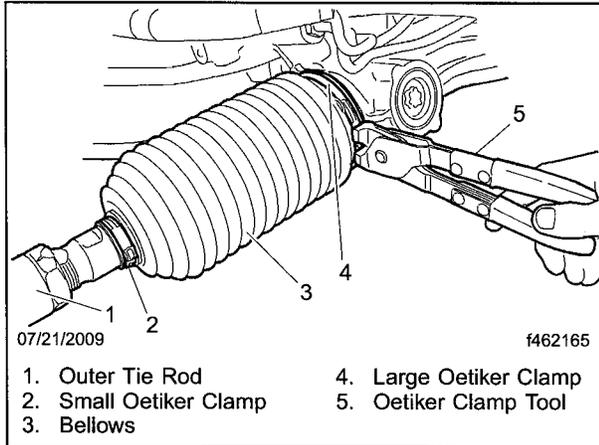
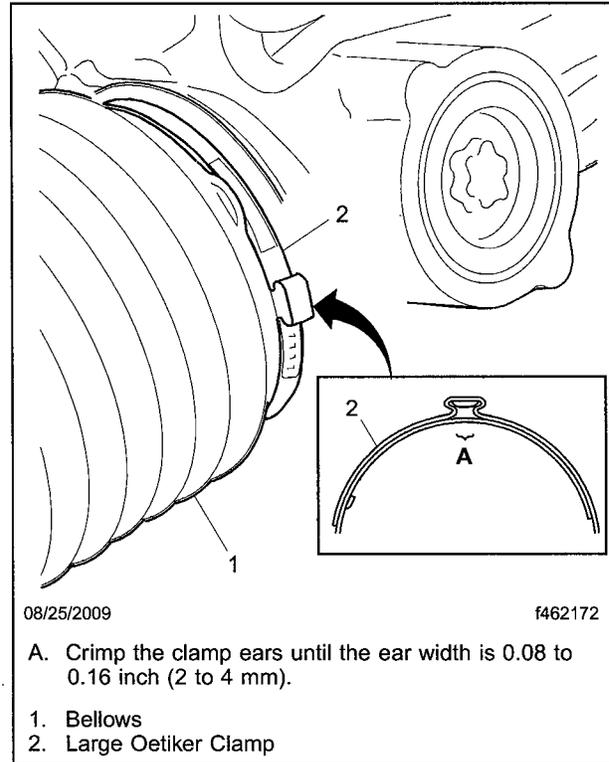
All three barbs on the clamp must be engaged: If all three barbs are not engaged after crimping, remove and discard the clamp and install a new clamp. Oetiker clamps must be adequately crimped and the bellows must be tightly secured to the gear housing to prevent moisture intrusion and corrosion.

Do not over-tighten the Oetiker clamps. Over-tightening may lead to stretching of the clamp, which could allow moisture intrusion and corrosion. If an Oetiker clamp stretches, remove and discard the clamp and install a new clamp.

- 12.2 Using an Oetiker clamp tool (Fig. 12), crimp the small and large Oetiker bellows clamp ears until the ear width is 0.08 to 0.16 in (2 to 4 mm). See Fig. 13 and Fig. 14.
