**NABI Optima: Steering Column Shaft Pinch Bolt**

**SAFETY RECALL #20122**

**Property name and top bus number:** Optima buses manufactured by NABI (NABI Safety Recall #20122; NHTSA #12V-189)

**Issue:** Steering column shaft pinch bolt(s) may be loose or missing

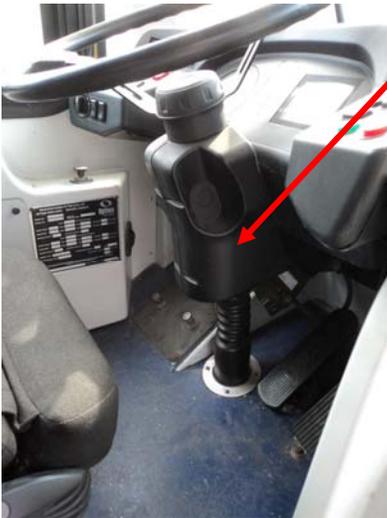
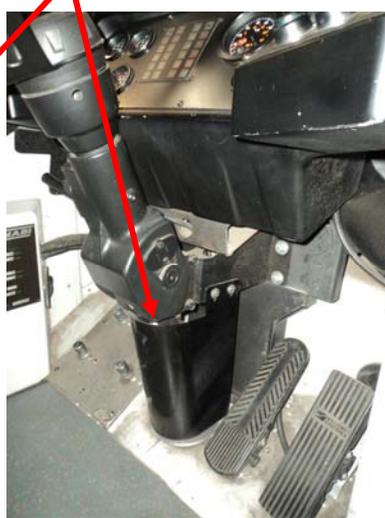
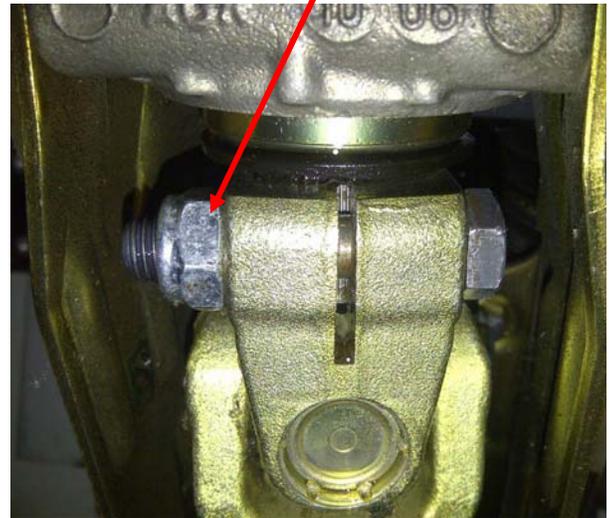
1. Park the bus on a flat surface.
2. Apply the parking brake.
3. Remove closeout panels right below the steering column to access the top pinch bolt. There are two different closeout panels as pictures show below.

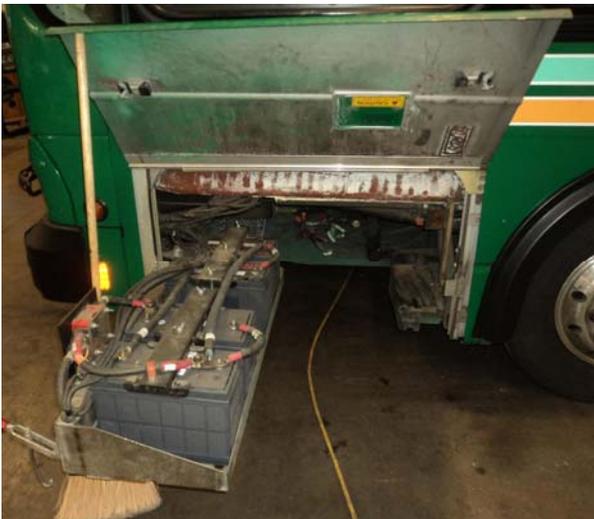
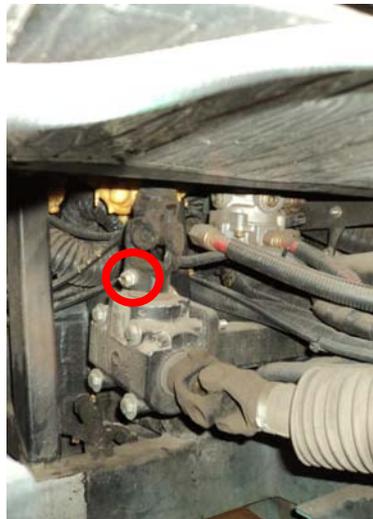
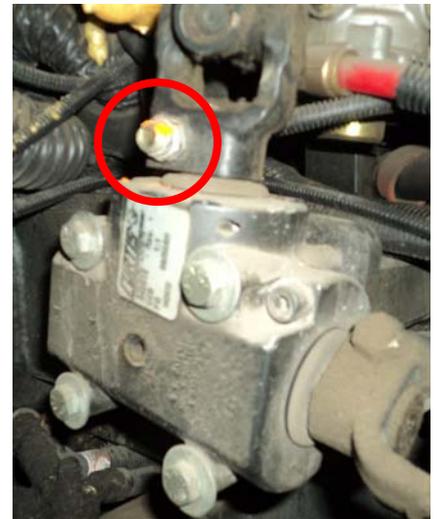
4. Open the battery access door and pull/turn the batteries out from the compartment to access the bottom pinch bolt (see below).
