Safety Defect and Noncompliance Report Guide for Equipment  
**PART 573 Defect and Noncompliance Report**<sup>1</sup>

**Part Number:** HUB-3208 **Size:** 2" Drop 8" between Hole Centers. 2" sq. Solid Shank 1 x 3" Flange

### Chronological Summary of Defect in HUB-3208

Report of Hitch Testing  
Performed on a **Ball Mount Design**  
in Accordance with SAE J684  
Exceeds Class 4 – 16,000 lbs. Wt. Carrying  
Model/Part Nos.: **HUB-3208**

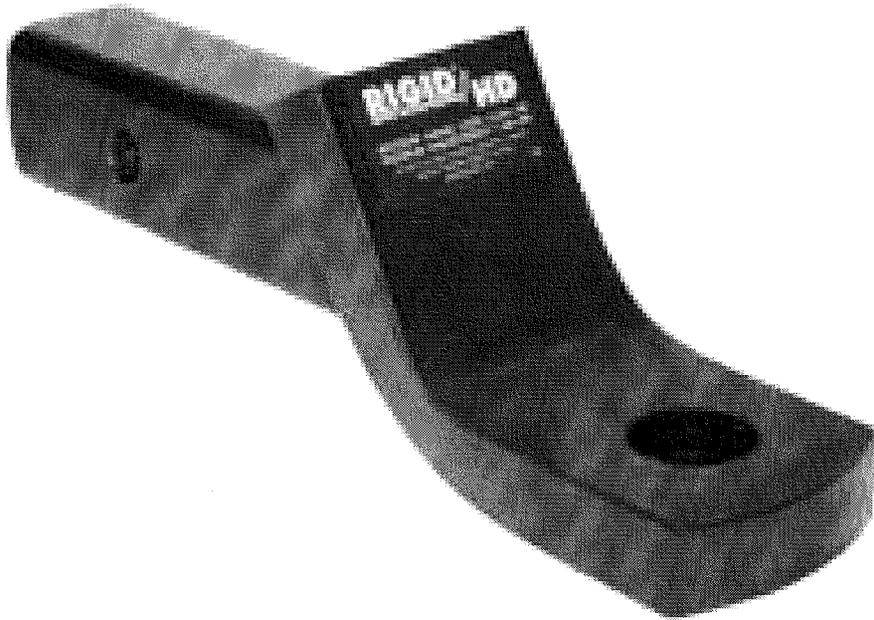
Pin Marking of Julian Date Code 33411-04812 located on the long side of the shank approximately 1-1/2" above the weld line

Torch angle and position of the weld on the toe were incorrect.

The reduced penetration of weld into the shank at the toe could cause the weld to fail.

Cracking in the welds.

The process that created the condition for the defect was to simply butt the shank up to the flange and weld the two pieces together. New processes have been put in place. A bevel will be ground on the shank creating better penetration into the shank through the use of a fillet weld. The torch angle will be flattened out driving the root of the weld deeper into the seam. All returned product to be destroyed.
