RECALL CAMPAIGN BULLETIN

NTB13-035b

VOLUNTARY SAFETY RECALL CAMPAIGN 2013 PATHFINDER OCS SENSORS

CAMPAIGN ID #: PC216
NHTSA #: 13V-069
APPLIED VEHICLES: 2013 Pathfinder (R52)

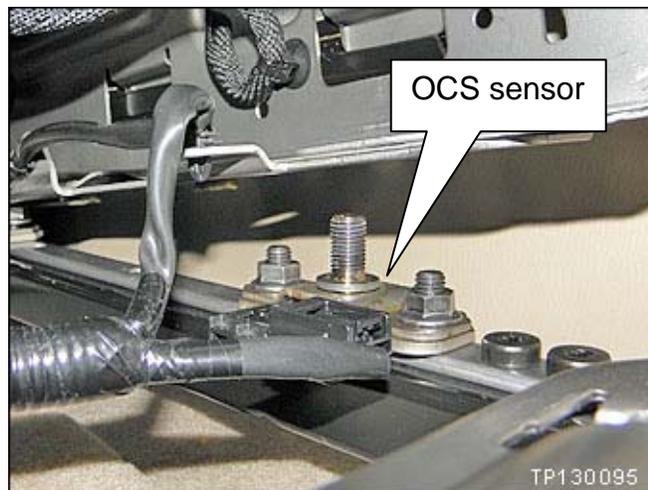
Figure 15

NG: Lot code is in this range - 2472 to 3102; replace the sensor

- If the first four digits of the lot code are 2472 to 3102, replace the sensor.

11. Install the front OCS sensor (new or original).

a. **Use new 12 mm nuts.**

- Torque nuts to:
22 N•m (3.04 kg-m, **16 ft-lb**)
