TO: All Mazda Dealership General Managers, Service Managers, and Parts Managers
DATE: April 2014
SUBJECT: 2010-2012 Mazda6 2.5L Engine Fuel Tank Safety and Emission Recall 7214C

ATTACHMENT I - DEALER INFORMATION
Safety & Emission Recall 7214C

2010-2012 MAZDA6 2.5L ENGINE FUEL TANK SAFETY AND EMISSION RECALL 7214C

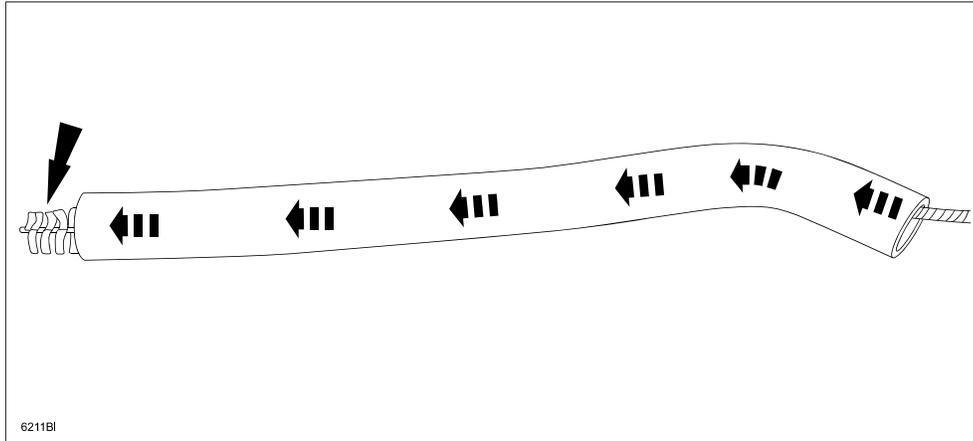
- a. Run the brush through the short ventilation hose, then check the tip of the bush to see if spider webs are present or not.

- b. Pull the brush out of the hose.
- c. Clean the brush of spider webs as necessary.

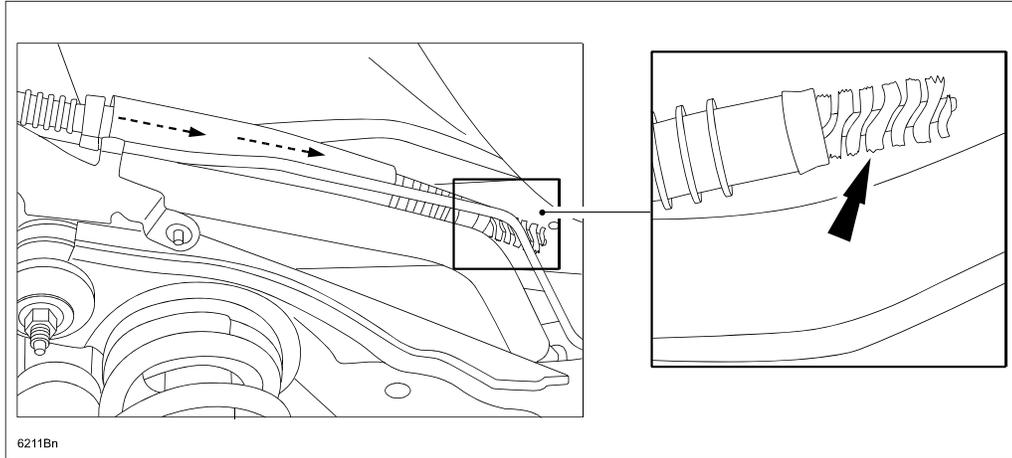
b. Check the tip of the brush to see if spider webs are present or not.

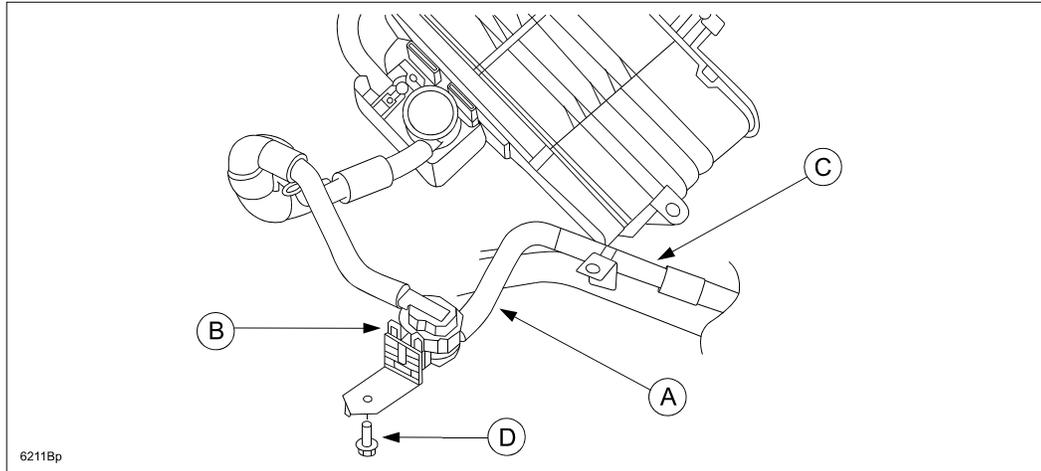
- For vehicles where spider webs WERE NOT FOUND during inspection, reinstall the original evaporative chamber onto the body.
- For vehicles where spider webs WERE FOUND during inspection, install a new evaporative chamber onto the body according to "E. FUEL TANK AND EVAPORATIVE CHAMBER REPLACEMENT".

5. Reinstall evaporative chamber bolt (D).

Tightening Torque: 71-97 in. lbf., 8-11 N-m, 82-112 kgf-cm

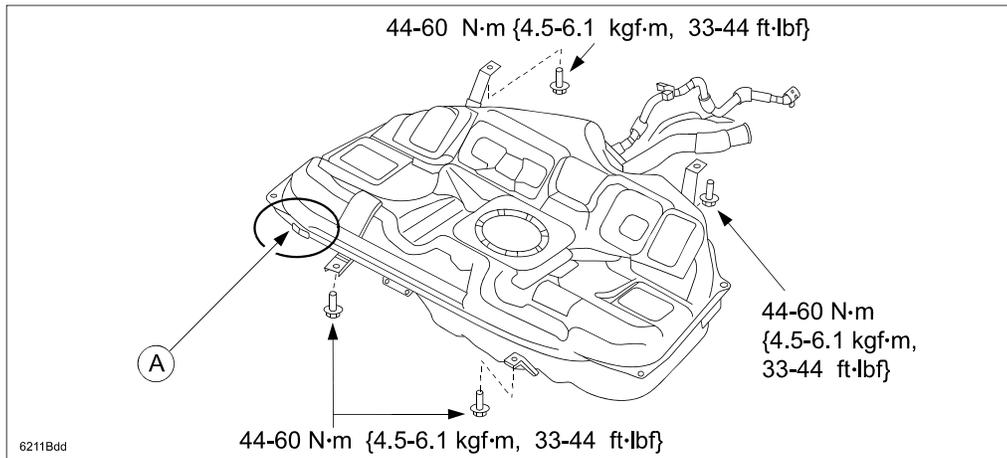
NOTE: Two small rubber clips (A) may exist on the flange of the original tank. These rubber clips have been deleted, so there is no need to transfer them to the new tank.

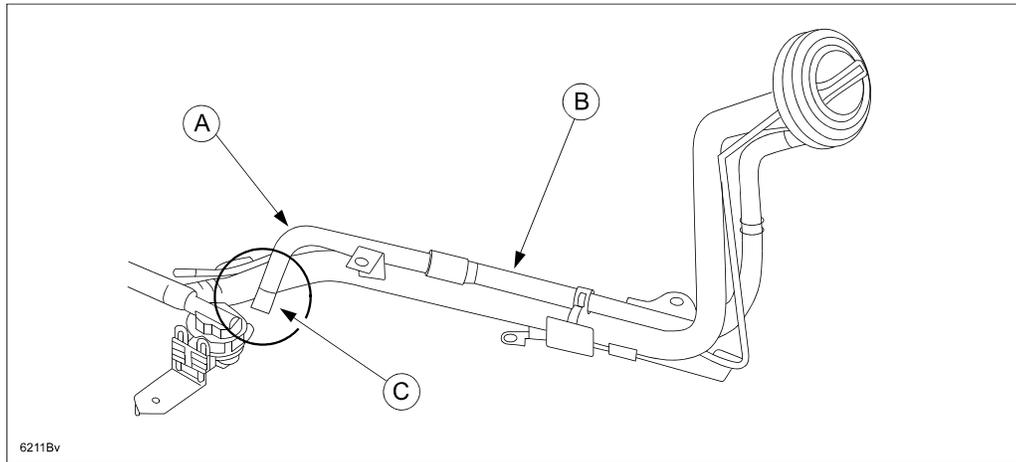
CAUTION: If the new evaporative chamber is not immediately available, make sure to put the parts back as follows to prevent re-entry of spiders into the hose.

- Connect the short ventilation hose (A) to the long ventilation hose (B).
- Plug the other end of short ventilation hose (C) with a rag or tape. DO NOT connect it back to the original evaporative chamber as there may still be spiders inside.
