PRODUCT SAFETY RECALL

SUBJECT: Front Passenger Air Bag Inflator Module

MODELS: 2003-2005 Pontiac Vibe
Currently Registered or Previously Registered in Alabama, Florida, Georgia, Hawaii, Louisiana, Mississippi, Texas, Guam, Puerto Rico, Saipan, U.S. Samoa or U.S. Virgin Islands

GM Recall Number: 14735

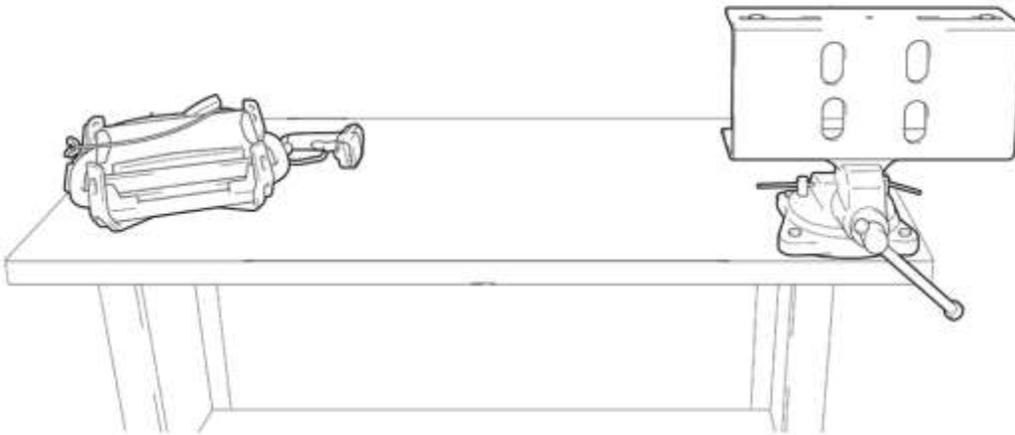
3607819

Danger: To avoid personal injury or death, it is critical to use an air bag module bracket when replacing an inflator module. Carefully read and follow the instructions below:

- Confirm the bracket assembly is installed securely in the vice.
- Confirm there are no loose objects or people exposed to the back side of the bracket for safety in the unlikely event of air bag deployment due to improper work procedures. The air bag is NOT being replaced due to an inadvertent deployment concern.
- Confirm that no objects, tools or people are within 3 feet (1 meter) of the back side of the bracket.
- Confirm that no objects, tools or people are within 2 feet (0.6 meters) of the sides of the bracket.
- BEFORE starting work and periodically while working on the air bag module, touch a metallic part of the work bench to discharge static electricity in the body.

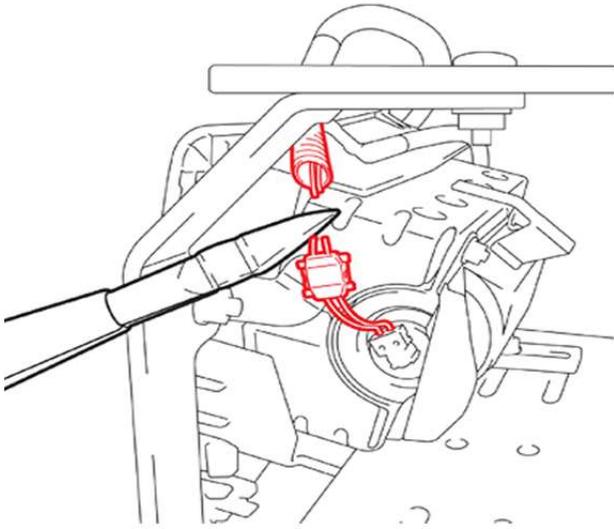
3607837

OK: Cut wires at opposite side to inflator. NG: Do NOT cut at inflator side.

8. Cut the two wires at the side of the electro tap opposite to the inflator (the side of the electro tap that is farthest away from the inflator).
