Re: Engineering Analysis (EA02-018)

**Engineering Analysis – EA02-018  
Eaton Corporation – Information for Section 1**

**Engineering Analysis – EA02-018**  
**Eaton Corporation – Information for Section 2**

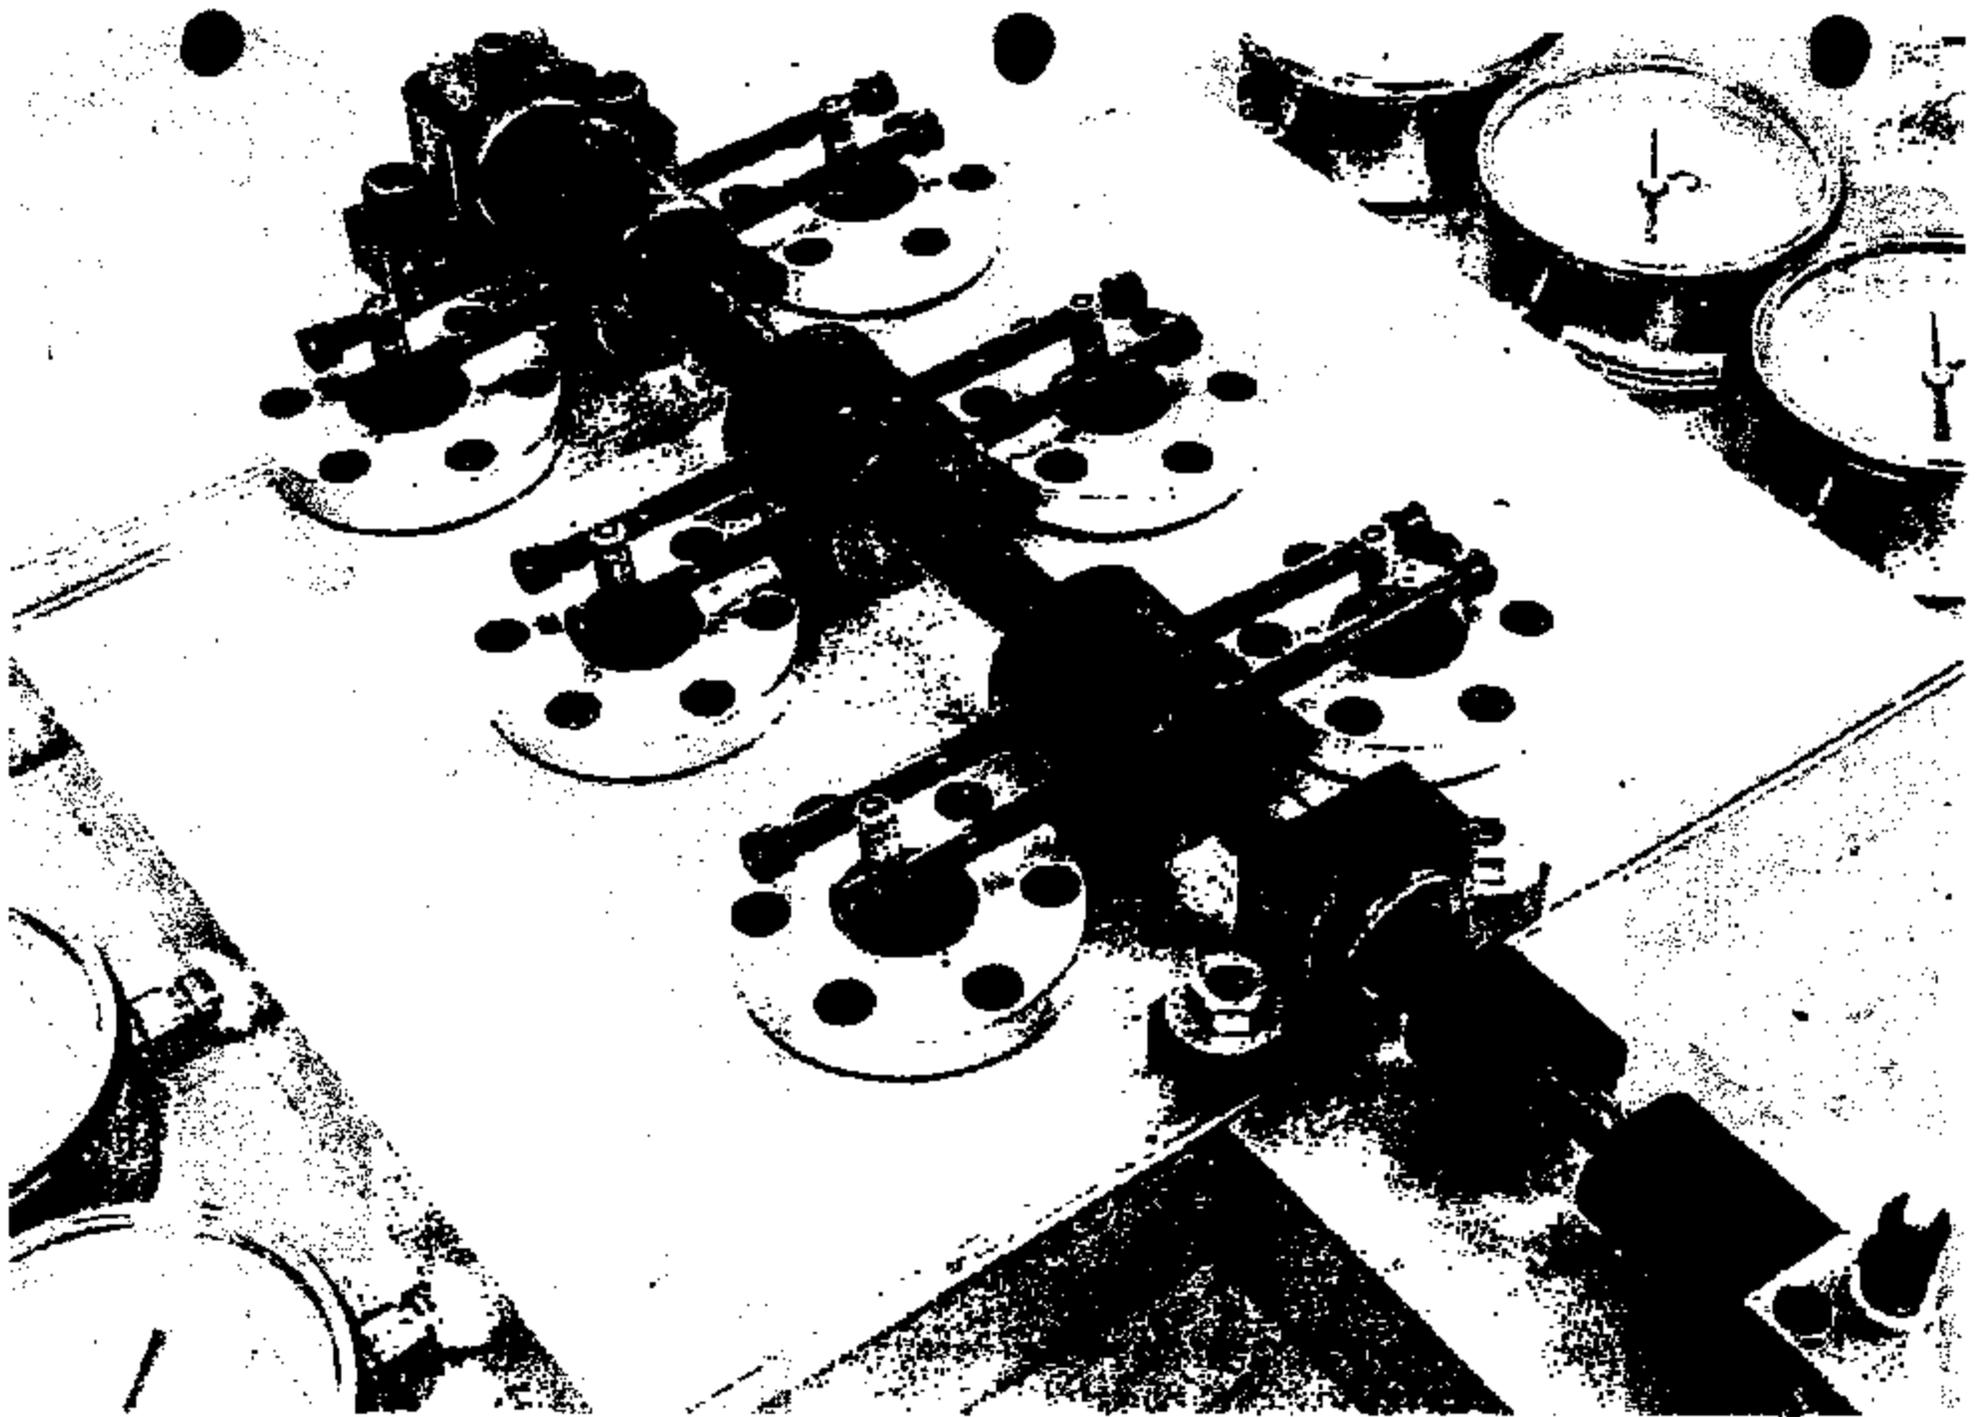
<b>E-600 Flex Test</b>				
<b>Production E-600 vs Redesigned E-600</b>				
Valves in slots 1 & 2 are production E-600				
Valve in slots 4 & 5 are Redesigned E-600				
Date	Time	No. Cycles	Slot No.	Gauge Reading (PSI)
11/29/00	8:30 AM	56685	1	X
Started @ 8:30 AM			2	X
			4	67
			5	X
11/29/00	10:30 AM	61815	1	X
			2	X
			4	67
			5	X
11/29/00	1:30 PM	64155	1	X
			2	X
			4	67
			5	X
11/29/00	3:30 PM	66715	1	X
Stopped @ 3:30 PM			2	X
			4	67
			5	X
11/30/00	6:30 AM	65715	1	X
Started @ 6:30 AM			2	X
			4	65
			5	X
11/30/00	12:30 PM	70395	1	X
			2	X
			4	65
			5	X
11/30/00	3:00 PM	72345	1	X
Stopped @ 3:00 PM			2	X
			4	65
			5	X
12/1/00	6:30 AM	72345	1	X
Started @ 6:30 AM			2	X
			4	65
			5	X
12/1/00	11:00 AM	75835	1	X
			2	X
			4	0 Valve Broke
			6	X

**Flex test set-up: Valves being flexed 30°  
in both directions.**

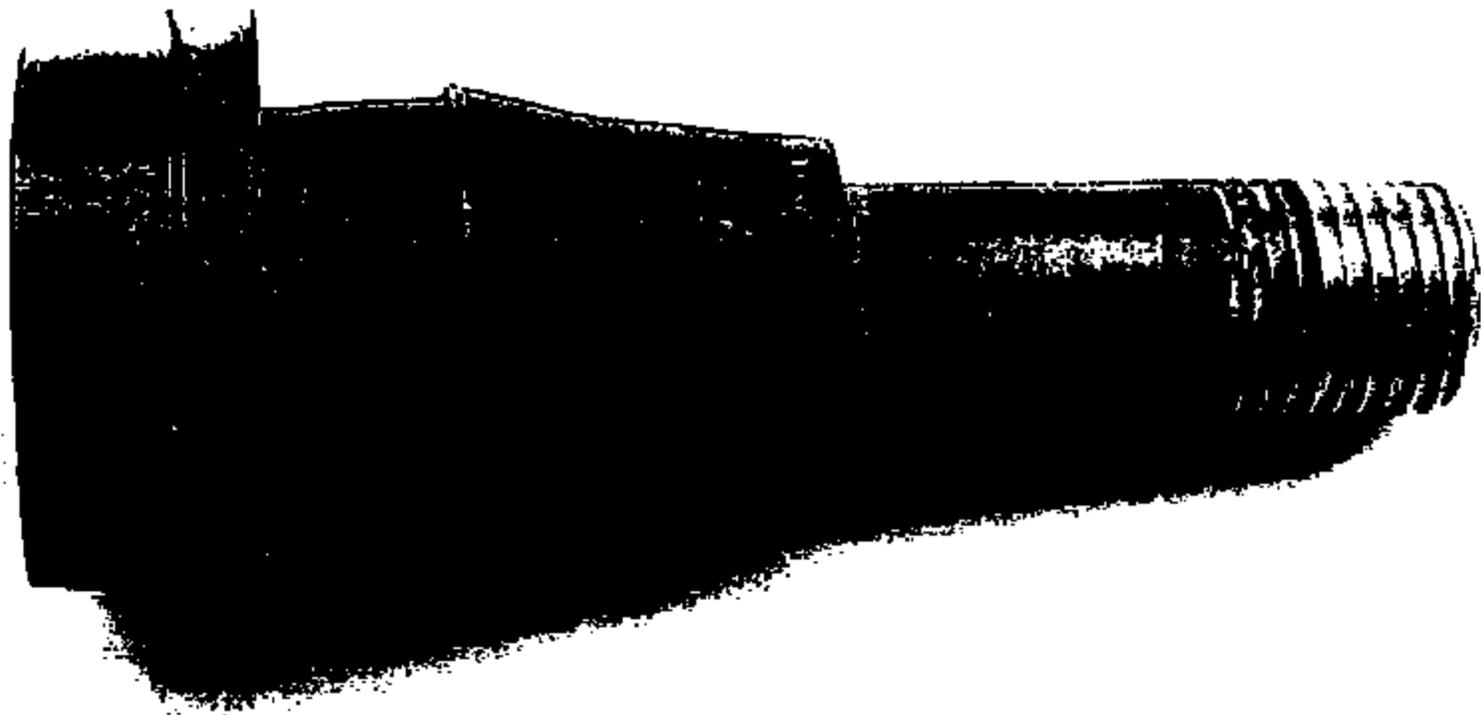
Daw Tire Repair Return

4. Dimensional analyses indicated that the base of the valve, which remains inside the rim and tire cavity, incurred compression set of approximately 6%, which reduced length G, Figure #1. The averages of other dimensional changes are noted in Table #2.

5. Cut section analyses of the bases of the valves indicated similar tearing for the control test valves pulled externally from the wheel aperture after mounting (#33, #95 and #160) and the valve removed from service (#89). The tearing in valve #89 had progressed to a greater depth, and this tearing is thought to be the cause of loss of serviceability. The appearances of these cross sections may be found in photomicrographs #1 - #4.
