Subject: 08091 - Product Safety Recall
Windshield Wipers May Become Inoperative
Under Heavy Snow and Ice Loads

Models: 2008 Buick Enclave
2007-2008 GMC Acadia
2007-2008 Saturn Outlook

SUBJECT: Windshield Wipers May Become Inoperative Under Heavy Snow and Ice Loads

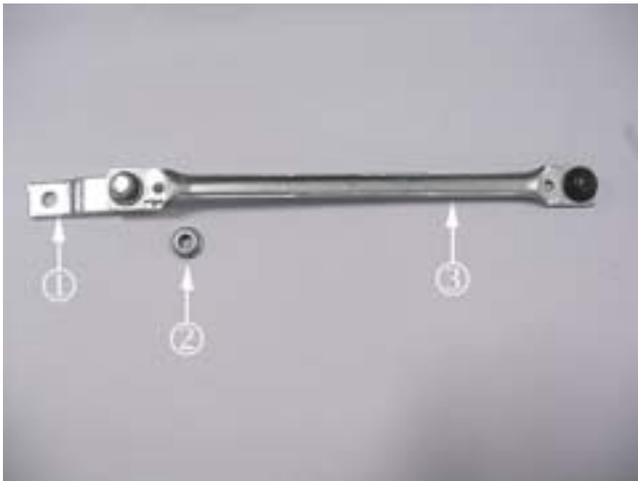
2180785

Replacement Kit P/N 20785184: Link is assembled with the motor crank arm.

- 1) Motor Crank Arm
- 2) Nut
- 3) Link
