SERVICE PROCEDURE

G-07501-R2
AUGUST 2007

**SUBJECT: SAFETY RECALL (U.S., EXPORT)
BATTERY CABLES on certain 9000 Models built
4/1/2002 thru 12/25/2006 with Caterpillar® Engines**

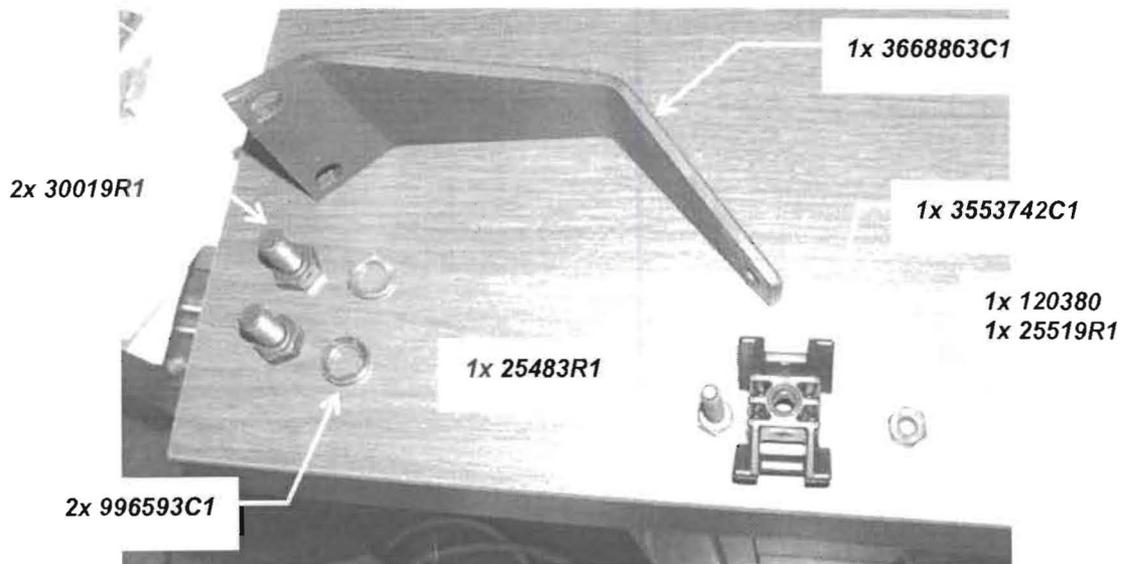
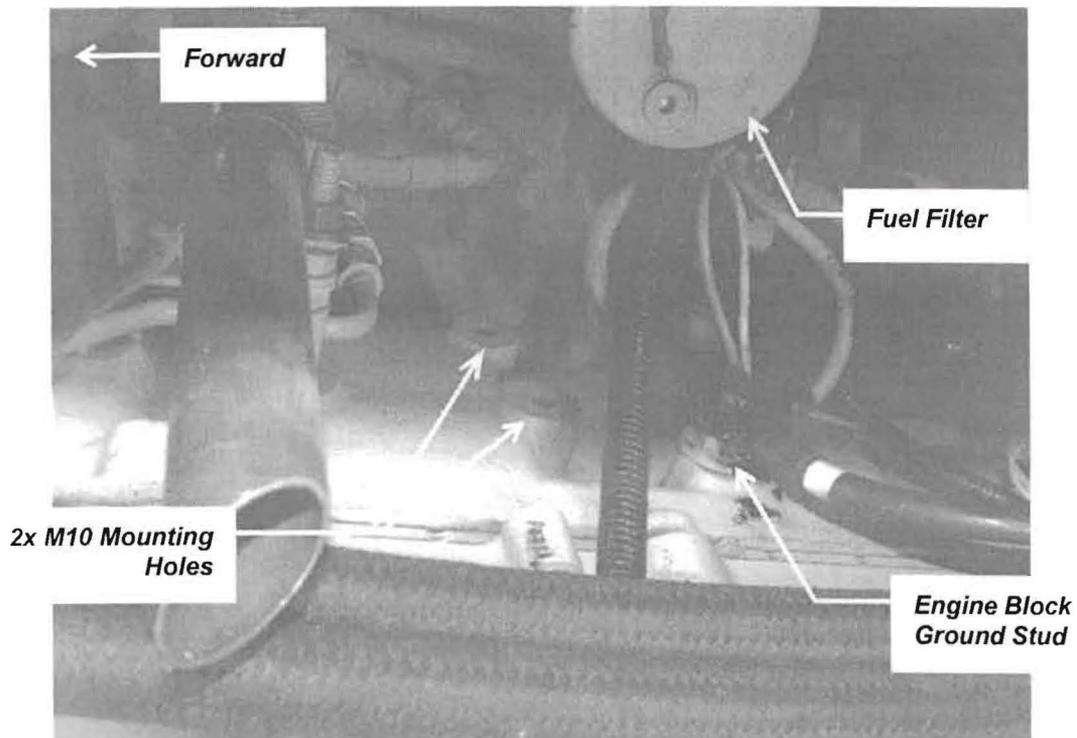
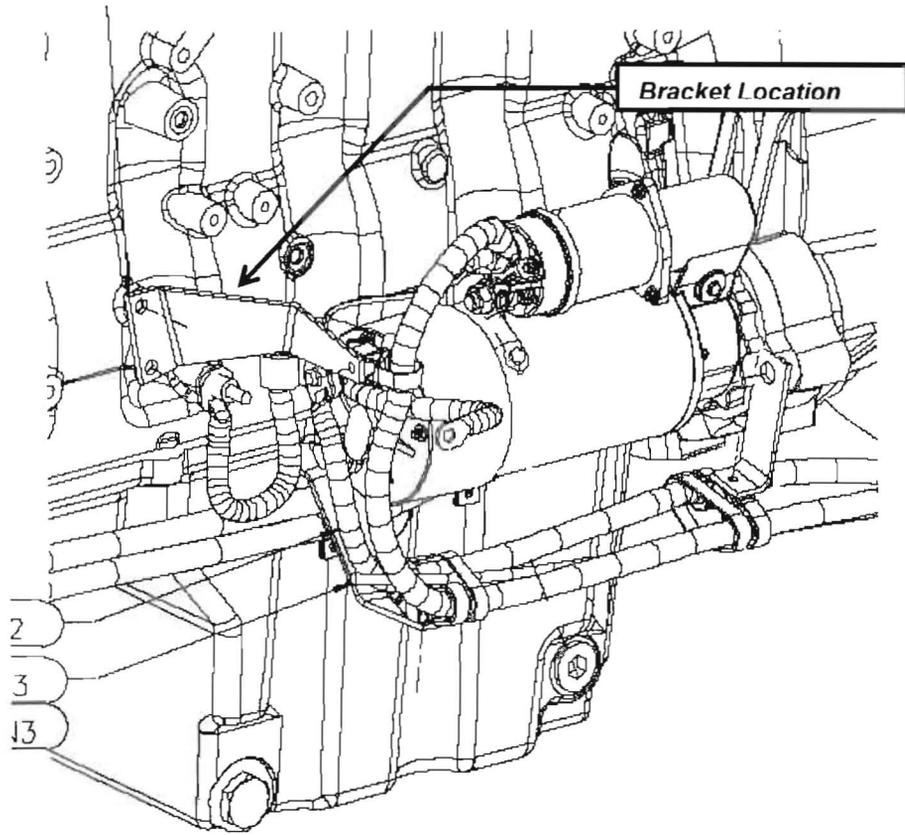
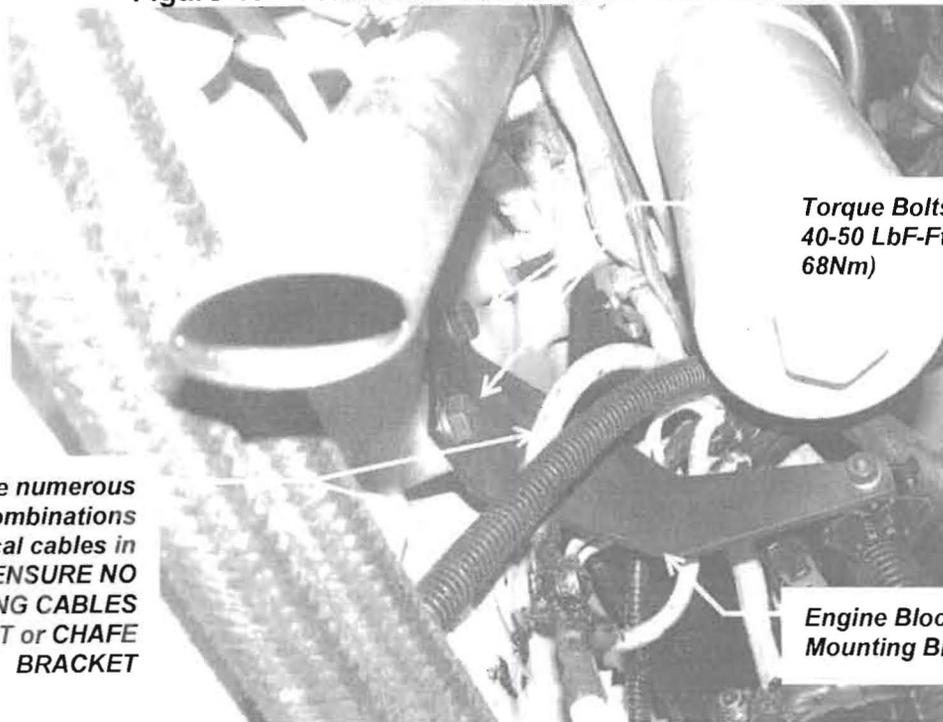
Figure 4a – Forward Engine Block Mounting Bracket Parts.

Figure 4b – Mounting Holes in Engine Block -- View from Below

Figure 4c – Frame Rail Removed for Clarification

Figure 4d – In Vehicle

7. Install the forward engine block mounting bracket.

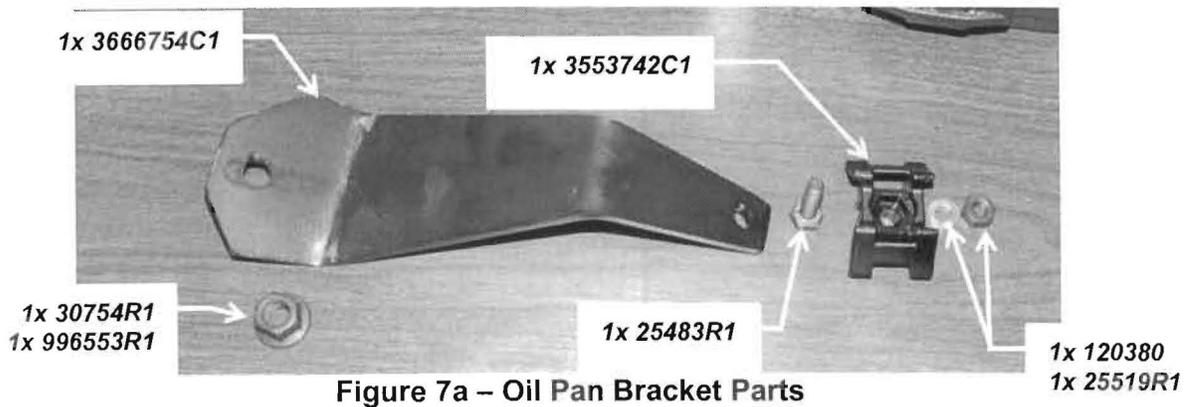
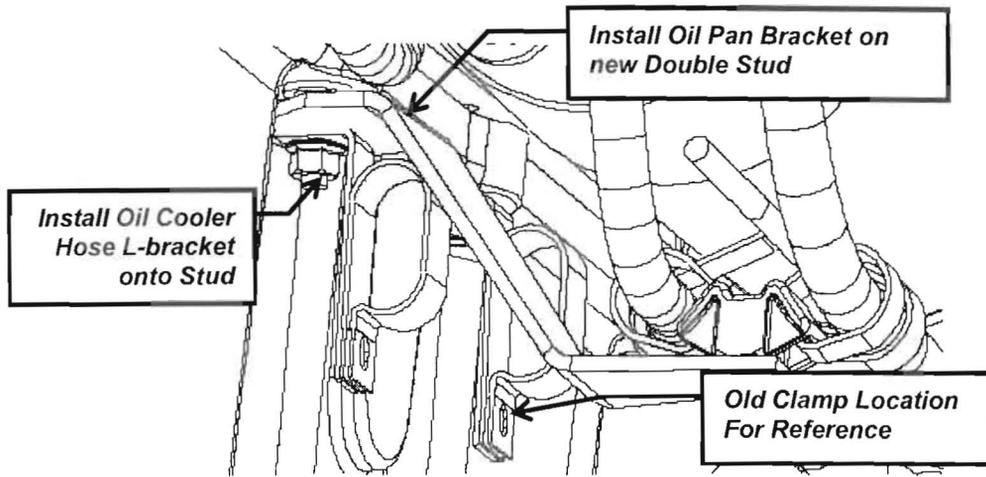
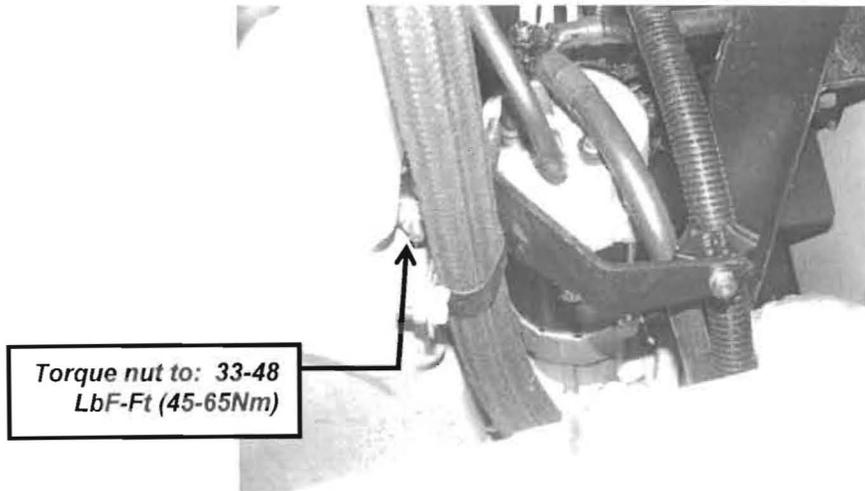
Figure 7a – Oil Pan Bracket Parts

Figure 7b – Frame Rail Removed for Clarification

Figure 7c – In Vehicle

12. Install oil pan rail mounting bracket.

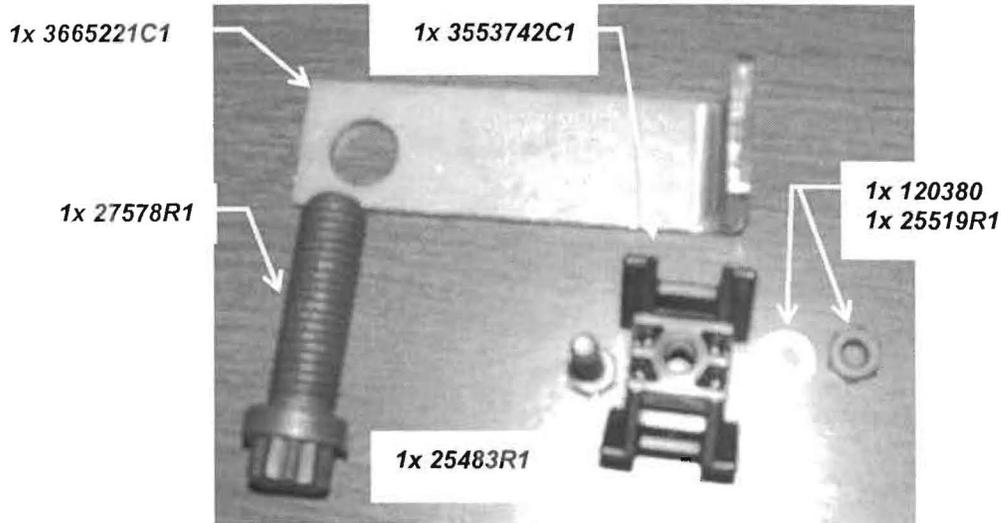
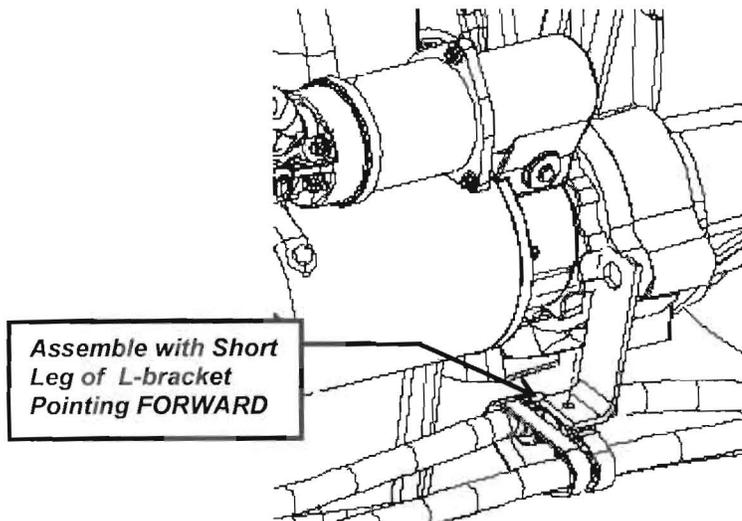
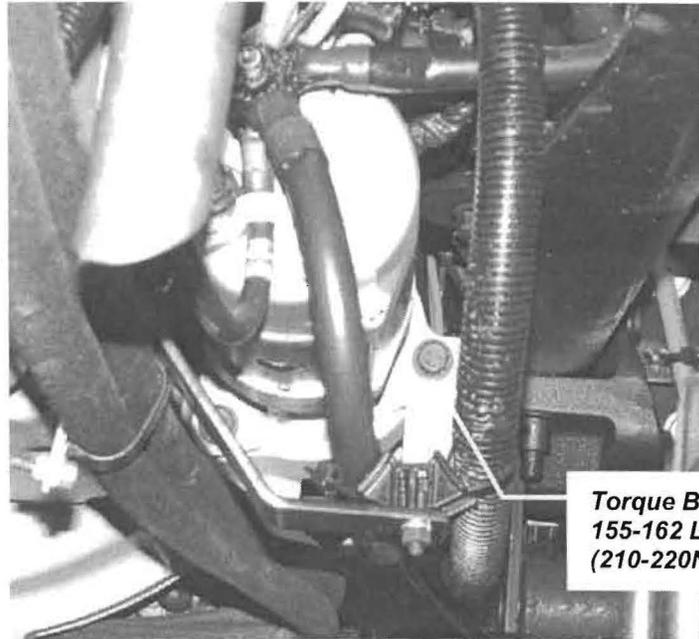
Figure 11a – Starter Mounting L-bracket Parts

Figure 11b – Frame Rail Removed for Clarification

Figure 11c – In Vehicle

19. Install the starter mounting L-bracket.

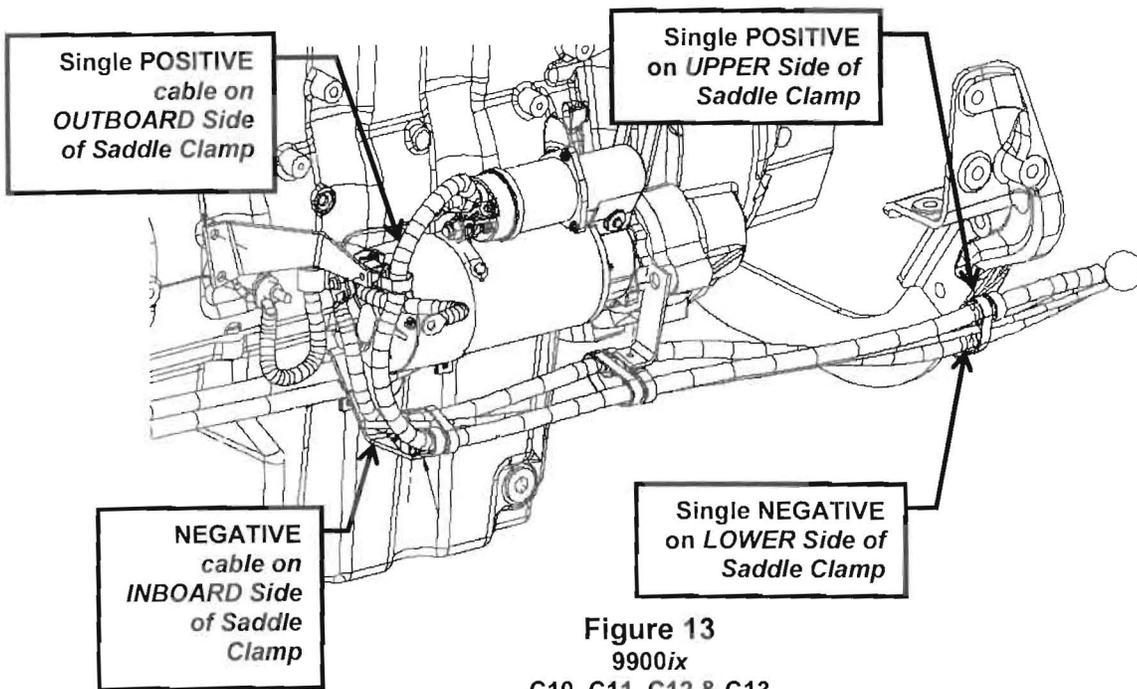
Figure 13
 9900ix
 C10, C11, C12 & C13
 Under CAB Battery Box and Belly Band

21. Based on the vehicle configurations listed below in Table 1, refer to the following figures for the proper routing of the forward section of battery cables.

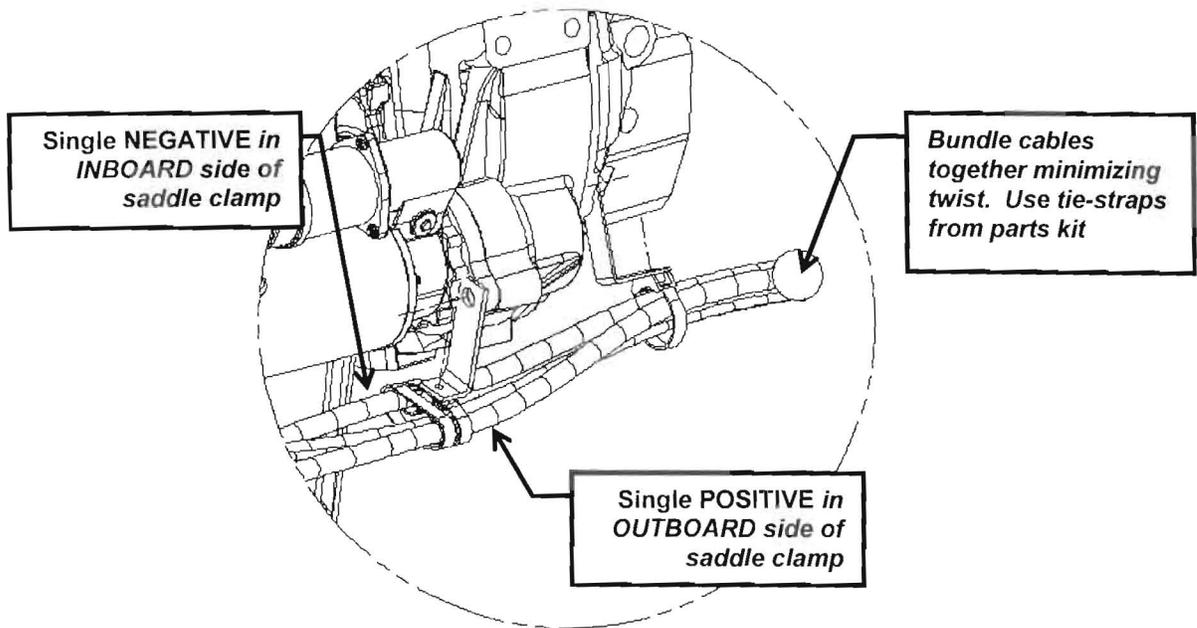
Figure 14
 9900ix
 C10, C11, C12 & C13
 Under CAB Battery Box, NO Belly Band
 Forward Portion of Routing Same as Figure 13

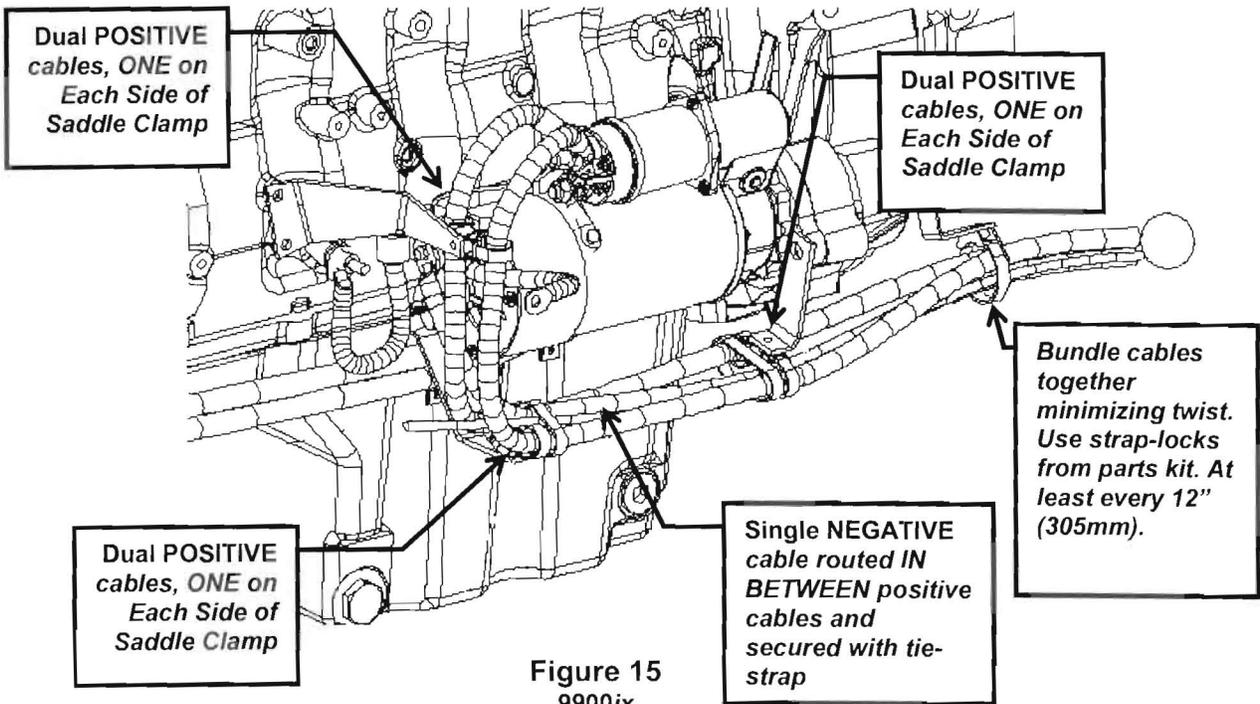
Figure 15
 9900ix
 C10, C11, C12 & C13
 Back of Cab Battery Box NO Belly Band

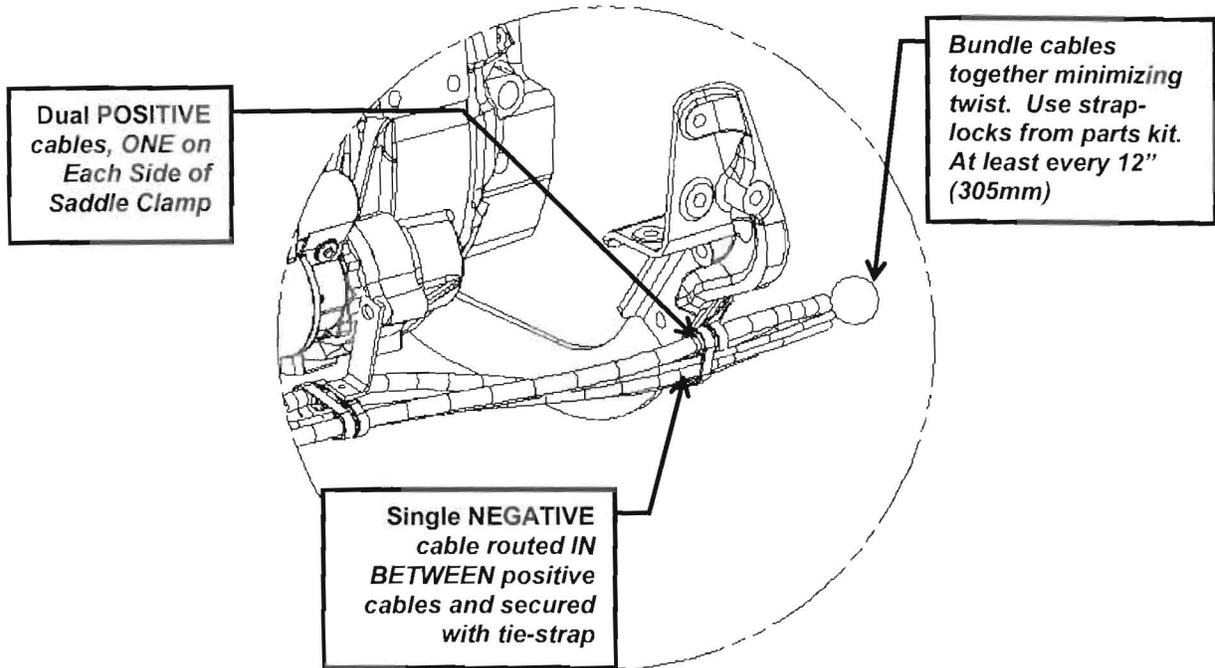
Figure 16
 9900ix
 C10, C11, C12 & C13
 Back of Cab Battery Box, with Belly Band
 Forward Portion of Routing Same as Figure 15

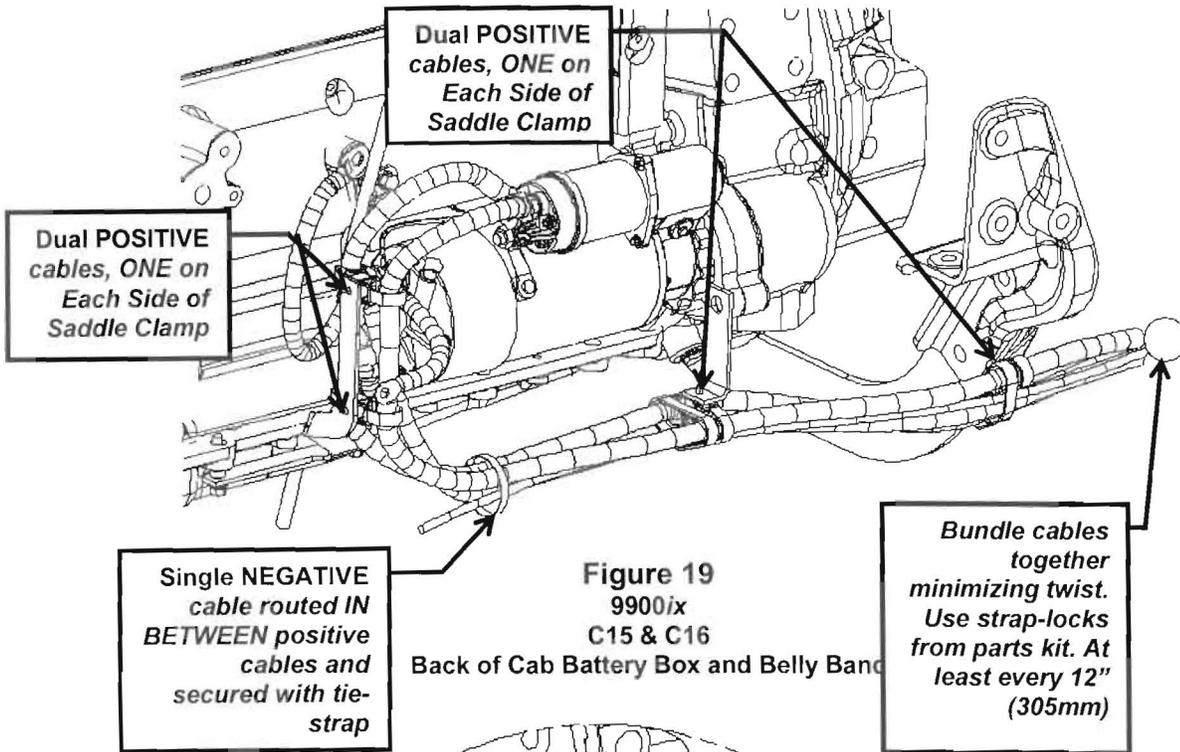
Figure 19
 9900ix
 C15 & C16
 Back of Cab Battery Box and Belly Band

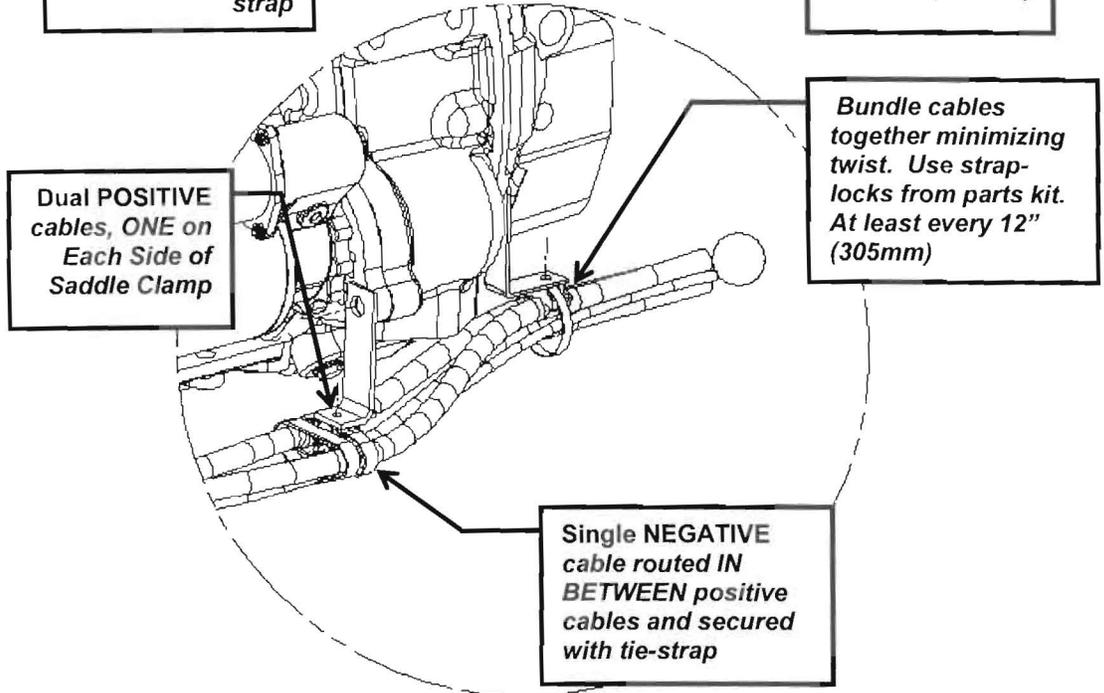
Figure 20
 9900ix
 C15 & C16
 Back of Cab Battery Box NO Belly Band
 Forward Portion of Routing Same as Figure 19

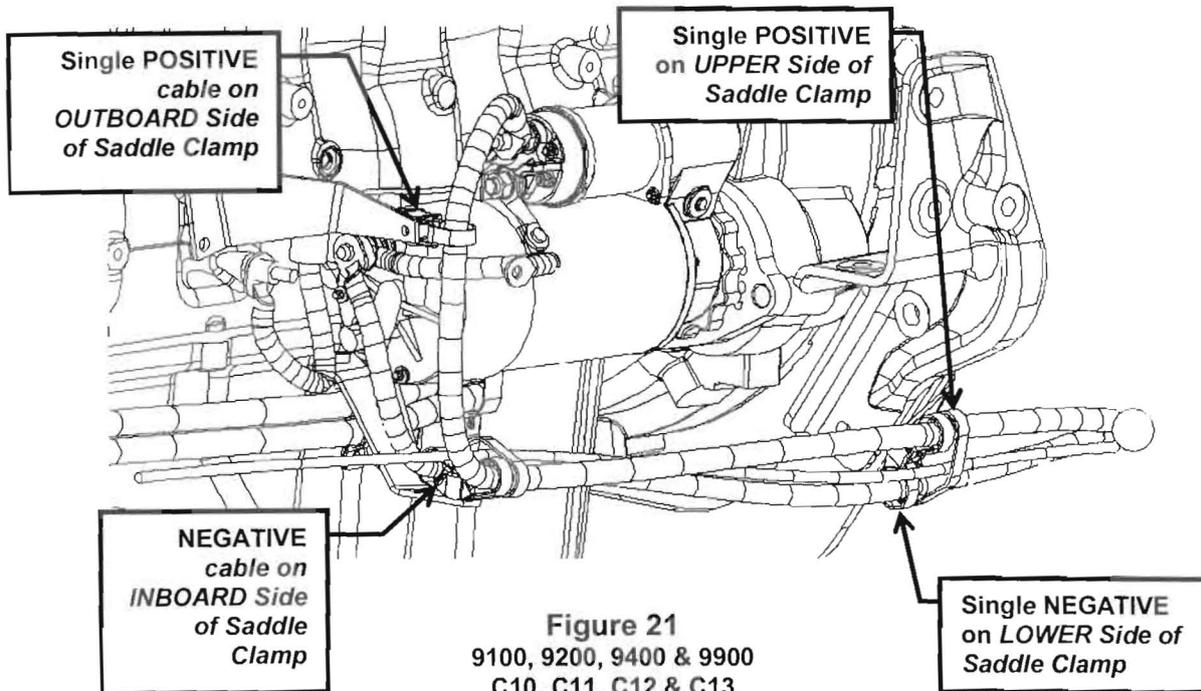
Figure 21
 9100, 9200, 9400 & 9900
 C10, C11, C12 & C13
 Under CAB Battery Box and Belly Band

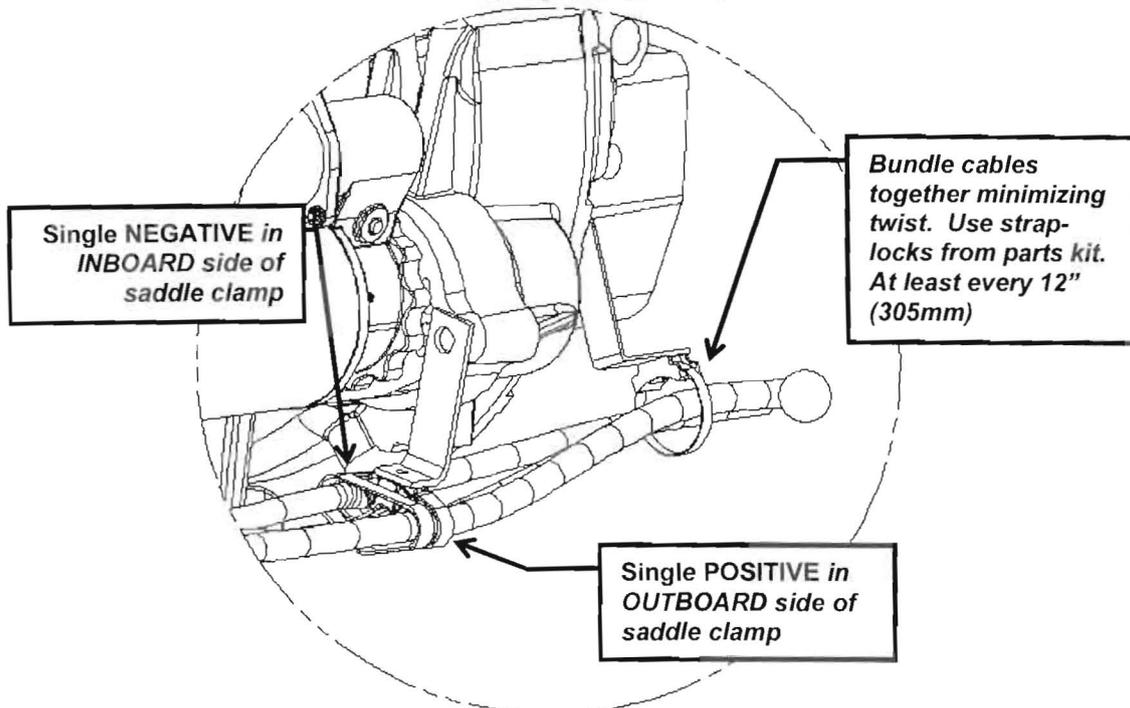
Figure 22
 9100, 9200, 9400 & 9900
 C10, C11, C12 & C13
 Under CAB Battery Box NO Belly Band
 Forward Portion of Routing Same as Figure 21

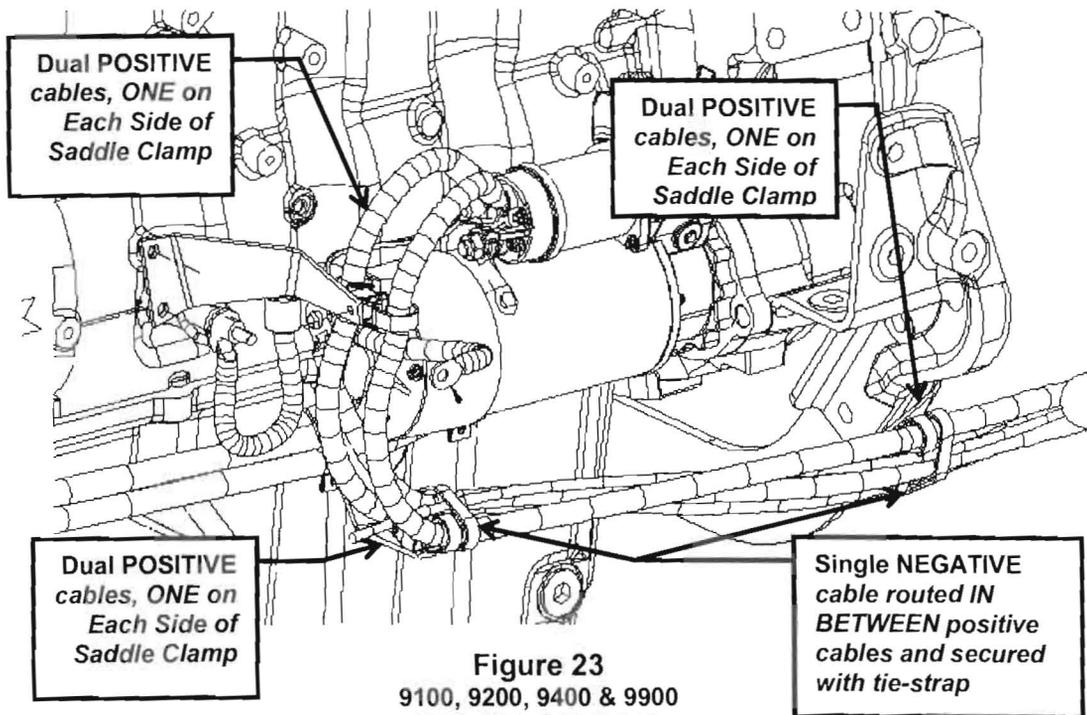
Figure 23
 9100, 9200, 9400 & 9900
 C10, C11, C12 & C13
 With Back of Cab Battery Box and Belly Band

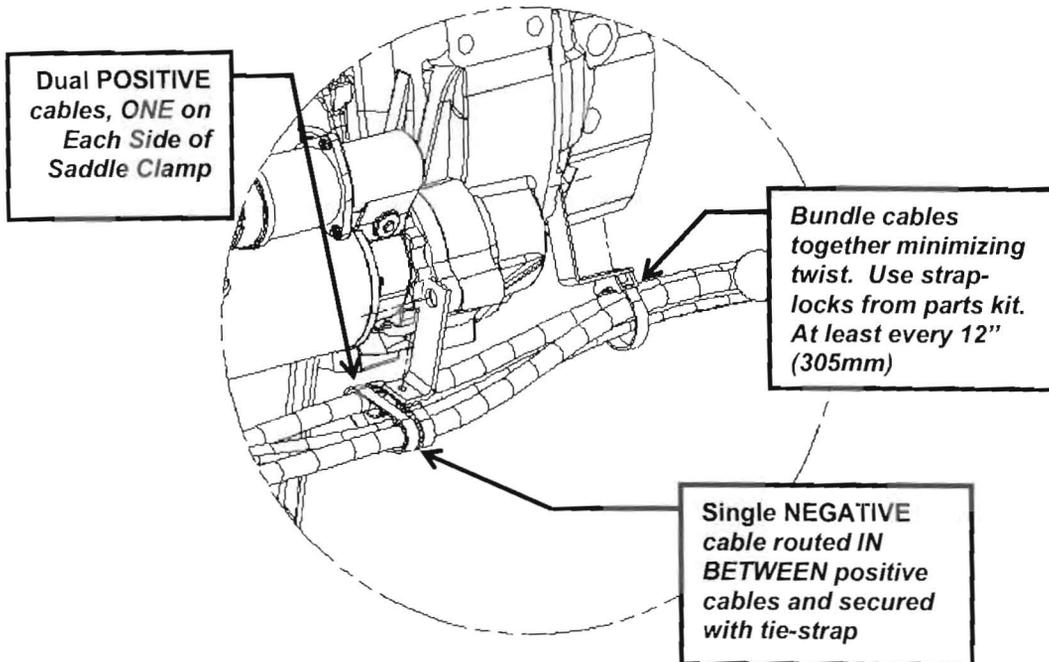
Figure 24
 9100, 9200, 9400 & 9900
 C10, C11, C12 & C13
 Back of Cab Battery Box NO Belly Band
 Forward Portion of Routing Same as Figure 23

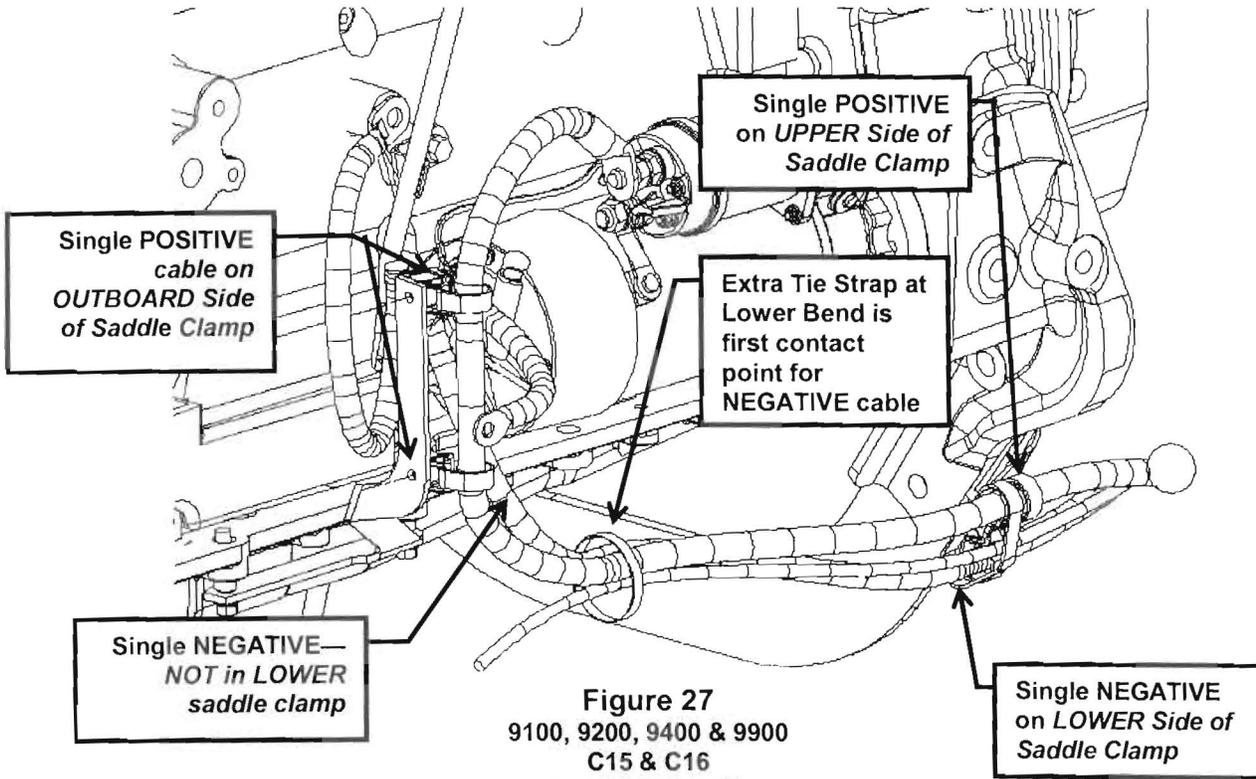
Figure 27
 9100, 9200, 9400 & 9900
 C15 & C16
 Under Cab Battery Box, with Belly Band

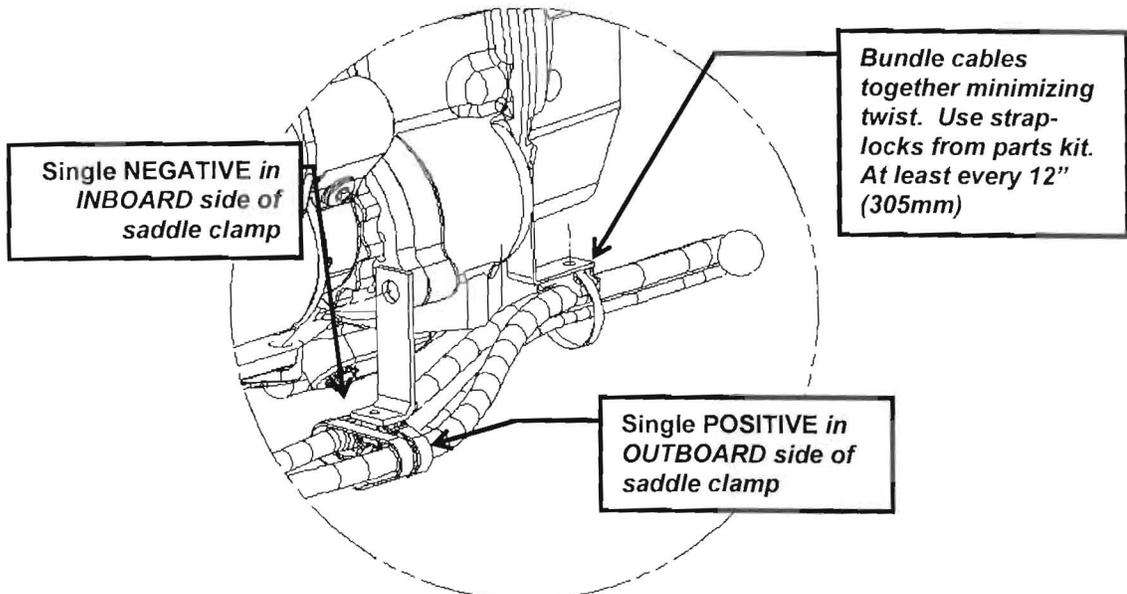
Figure 28
 9100, 9200, 9400 & 9900
 C15 & C16
 Under Cab Battery Box, NO Belly Band
 Forward Portion of Routing Same as Figure 27

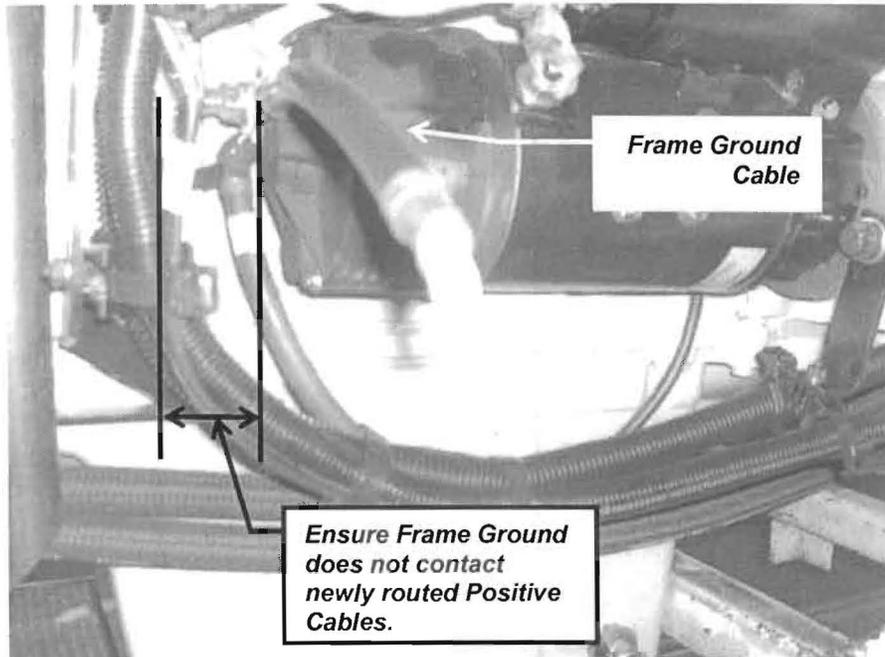
Figure 32 – Frame Rail Removed for Clarity

- Ensure cables are not in contact.

TO PREVENT CHAFING OF THE POSITIVE CABLES AGAINST THE FRAME GROUND CABLE (SEE FIGURE 31), PLEASE ENSURE FRAME GROUND CABLE IS NOT IN CONTACT WITH THE NEWLY ROUTED POSITIVE CABLES, SEE FIGURE 32.
