EA-02-034

## **INTERIM REPORT -- VRTC-DCD2037 (EA02-034)**

### **Tests of the Bosch Brakes (ZOPS) on a 2001 Monaco Holiday Rambler Ambassador Motorhome**

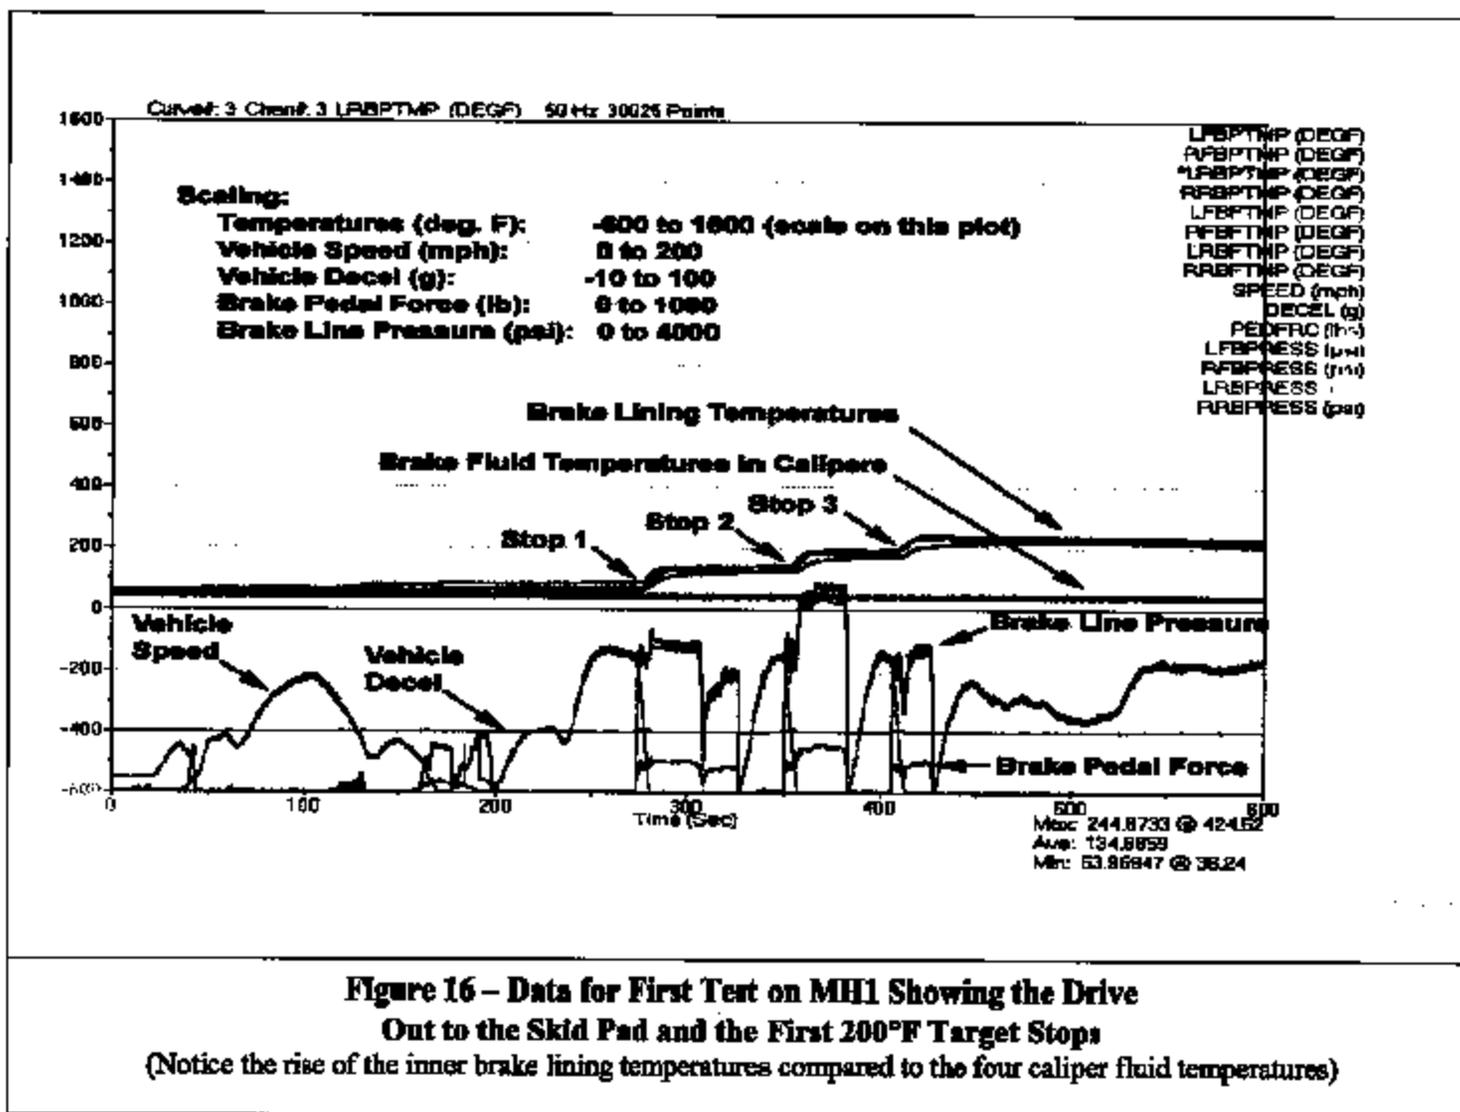
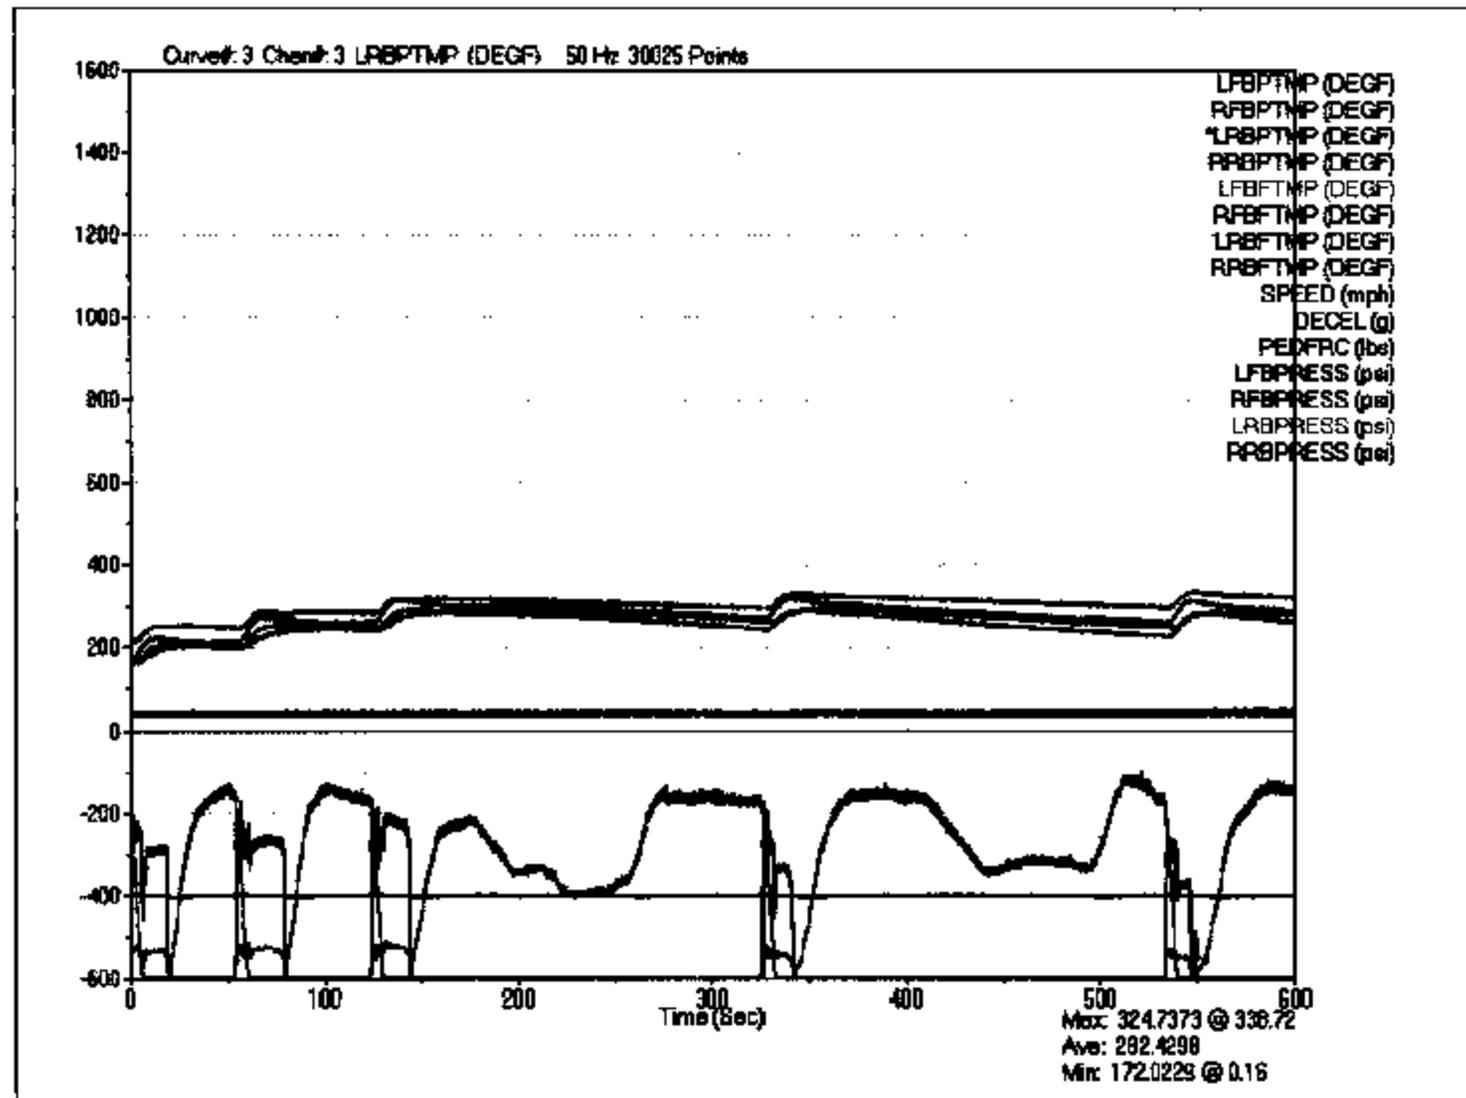
**Figure 15 – Left Rear Wheel Fire at 55 Minutes into the First Test on MH1**

The vehicle was then stopped for 1 minute and all four wheel temperatures started to drop. As the vehicle was driven away, a wheel fire flamed up as shown in Figure 15. Note: In the upper view of the figure, the camera auto-iris circuitry had malfunctioned so the picture is relatively dark. The camera was replaced before the next test. The lower view in Figure 15, taken using from the replacement camera, shows the same field of view for comparison. The trailing arm is in the right bottom corner, the rear axle is across the left side, and one-half of the caliper is near the center of the picture. The video images are clearer than the picture transferred from the video for Figure 15.

**Note:** In the upper view, the auto-iris circuitry of the videotape camera malfunctioned during this test. The lower view, from the replacement camera, shows the same field of view for comparison.

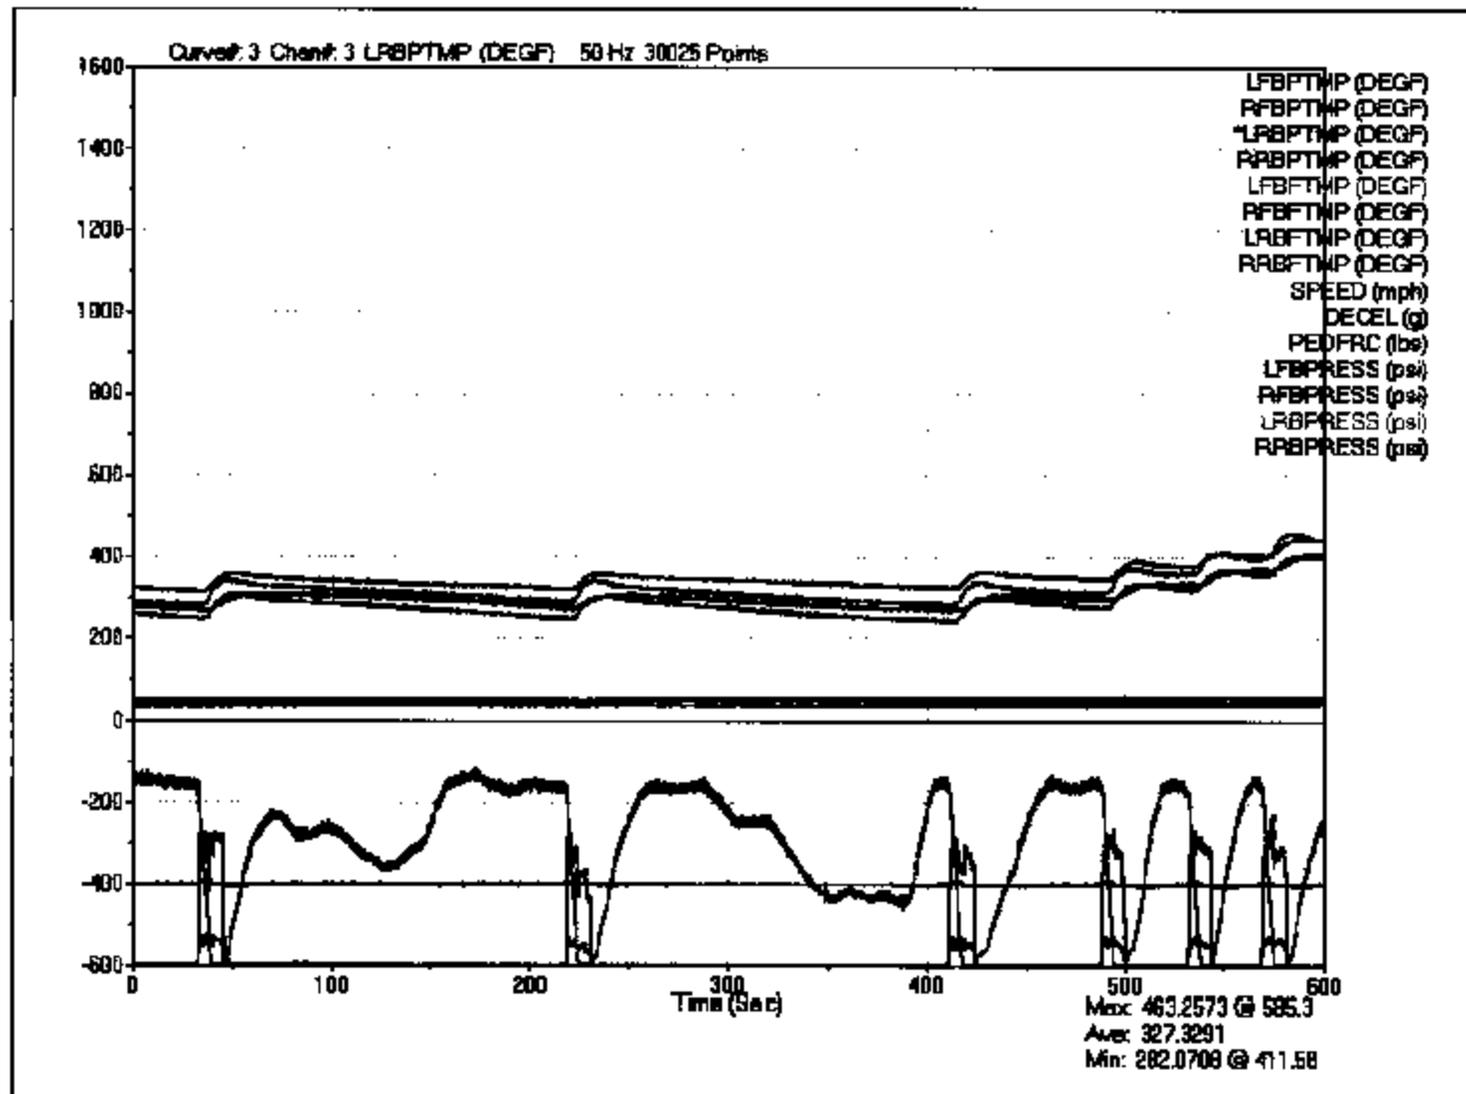
**Figure 17 – Data for First Test on MH1 Showing the 300°F Target Stops**  
 (Notice the left rear inner brake lining temperatures are running lower than the right rear and the brake fluid temperatures are 40 to 50°F)

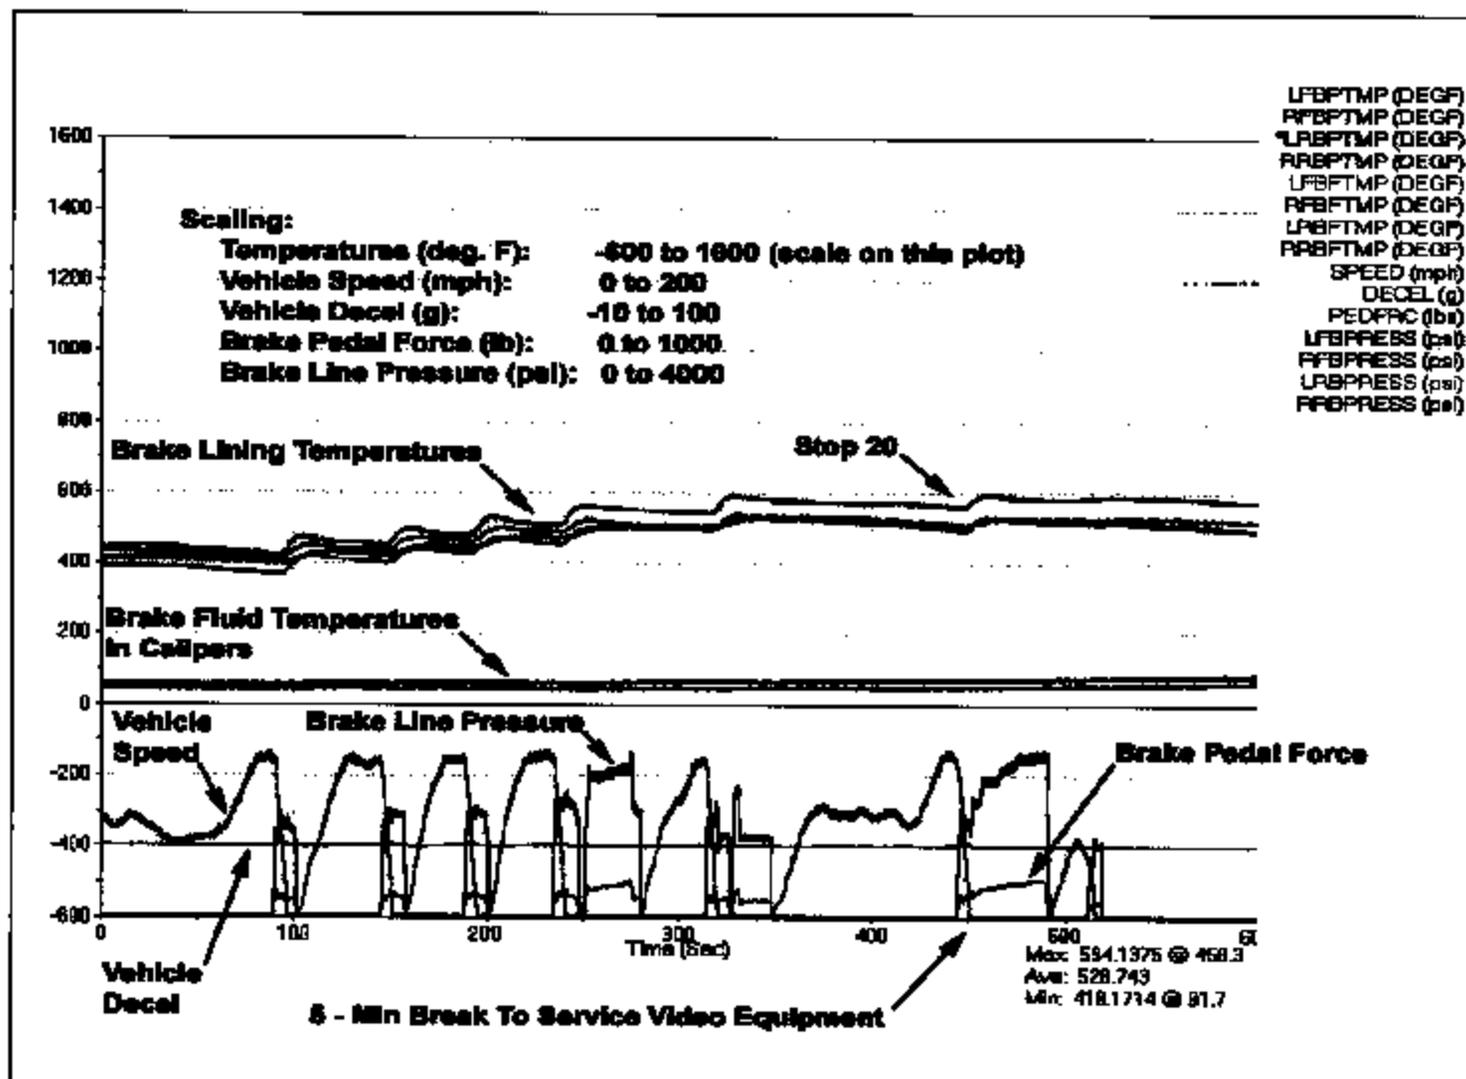
**Figure 18 – Data for First Test on MH1 Showing the 400°F Target Stops**  
 (Notice minimal heat buildup in the brake fluid inside the caliper)

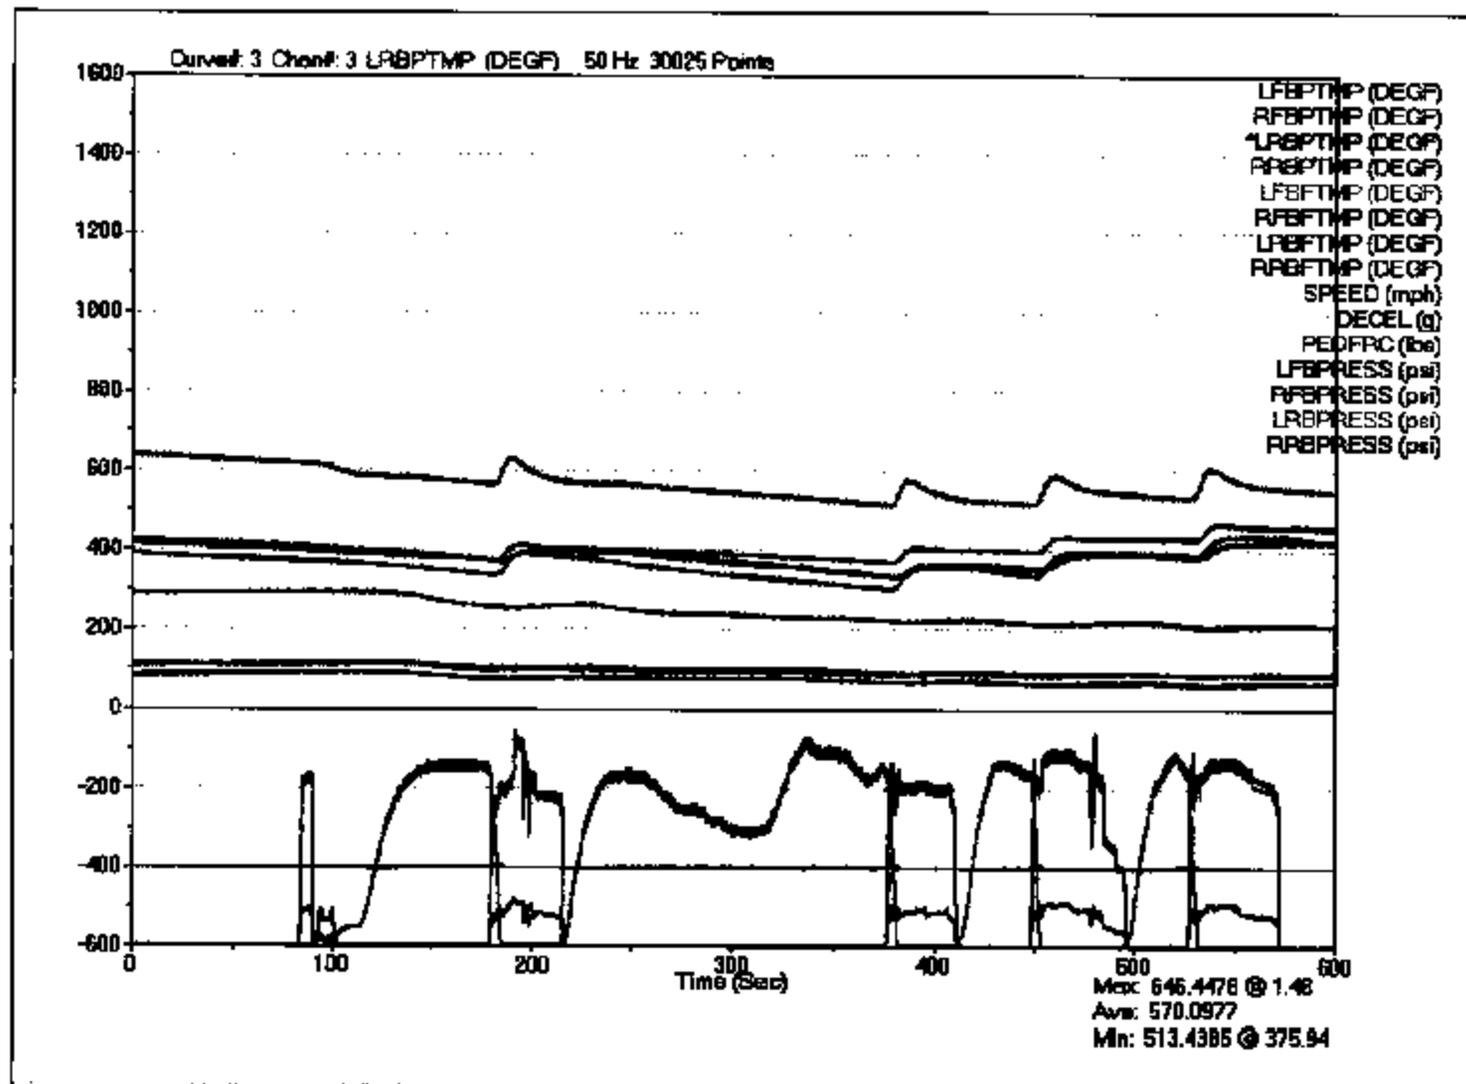
**Figure 23 –Data for First Test on MH1 Showing the Temperature of the Left Rear Lining Declining as Additional Braking Does Not Restart the Event (Notice the left rear brake fluid temperature rising to 306°F)**
