Mazda North American Operations

SUBJECT: 2007-2009 CX-9 Power-Adjustable Driver's Seat Voluntary Safety Recall 5309B

CX-9 POWER ADJUSTABLE DRIVER'S SEAT RECALL 5309B

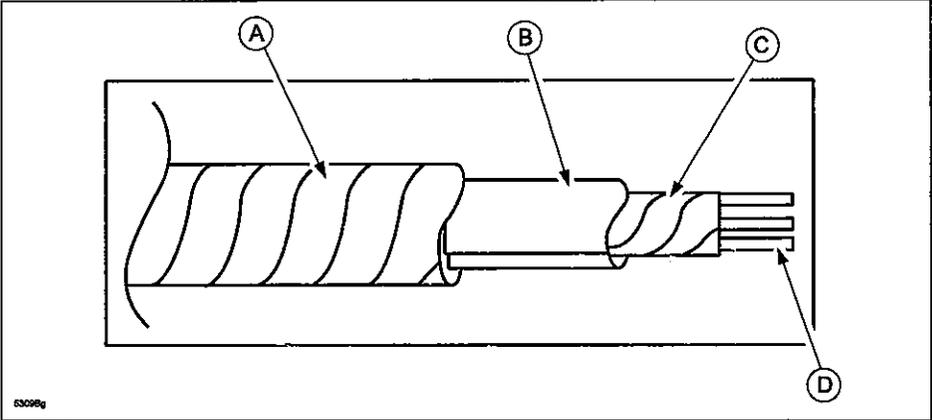
NOTE: The following diagram shows the parts of the wire harness.
A: PVC Tape (External)
B: PVC Tube
C: PVC Tape (Internal)
D: Electric Wire

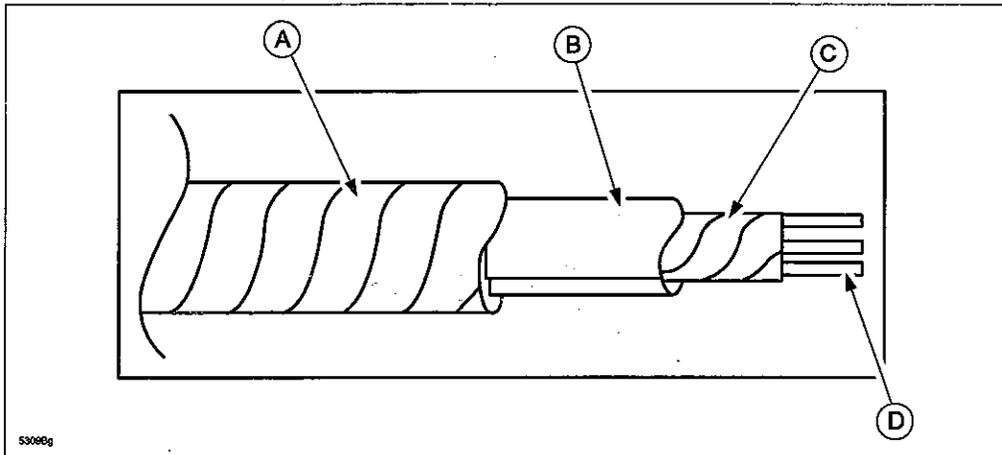
NOTE: The following diagram shows the parts of the wire harness for the following steps.

- A: PVC Tape (External)
- B: PVC Tube
- C: PVC Tape (Internal)
- D: Electric Wire

1. Remove external PVC tape.

2. Temporarily detach the PVC tube.
