# UPDATE

SUBJECT:		No: <b>SR-89-002</b>	
<b>LOWER BALL JOINT — SAFETY RECALL CAMPAIGN</b>		DATE: <b>June, 1999</b>	
		MODEL: <b>See below</b>	
CIRCULATE TO:	<input checked="" type="checkbox"/> GENERAL MANAGER	<input checked="" type="checkbox"/> PARTS MANAGER	<input checked="" type="checkbox"/> TECHNICIAN
<input checked="" type="checkbox"/> SERVICE ADVISOR	<input checked="" type="checkbox"/> SERVICE MANAGER	<input checked="" type="checkbox"/> WARRANTY PROCESSOR	<input checked="" type="checkbox"/> SALES MANAGER

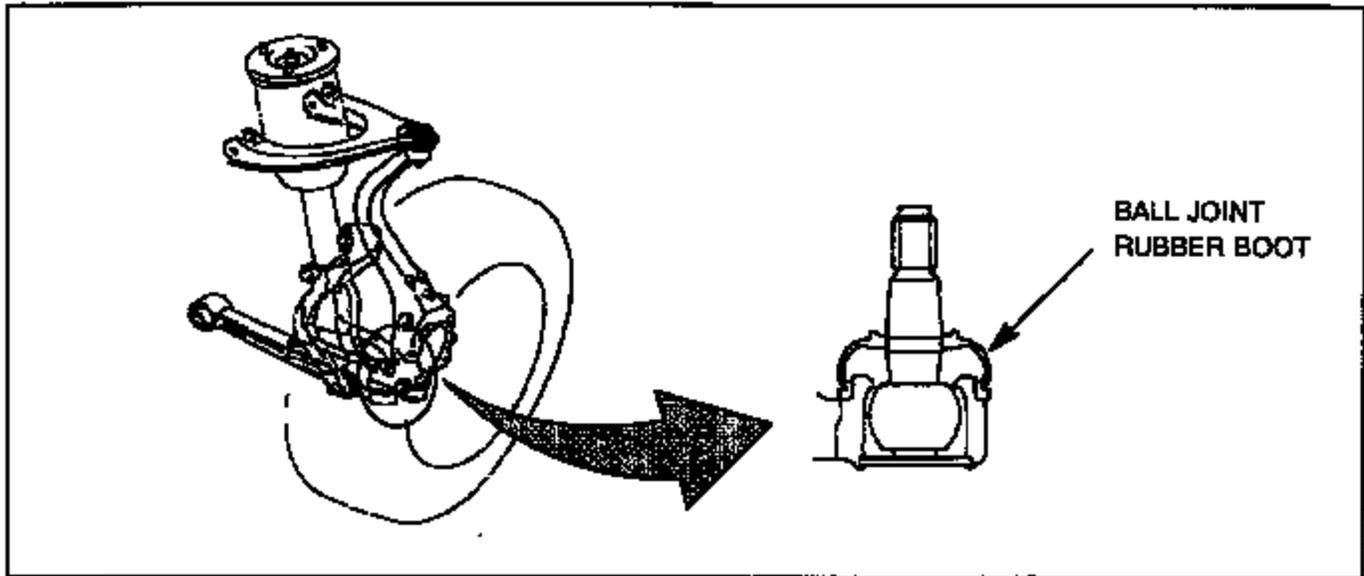
2. Inspect the lateral lower arm ball joint rubber boot on both sides for cracks and damage. Gently push the boot in with your fingers. Do not remove any parts for the inspection. Damage to the boot is evident if any cuts or tearing are observed or if grease comes out when it is pushed in.
3. If the rubber boot is not damaged, repeat the inspection on the other side of the vehicle. If the boot is not damaged on either side of the vehicle, this campaign procedure is complete.

4. If the rubber boot is damaged, replace the lateral lower arm assembly, using the parts listed in the PARTS INFORMATION section of this bulletin. Refer to the installation instructions in Group 33A of the appropriate service manual.
