Date	Number	Page
08/12/09	SC0341	1(4)

BFI Front Axle Beam

SC0341, BFI Front Axle Beam

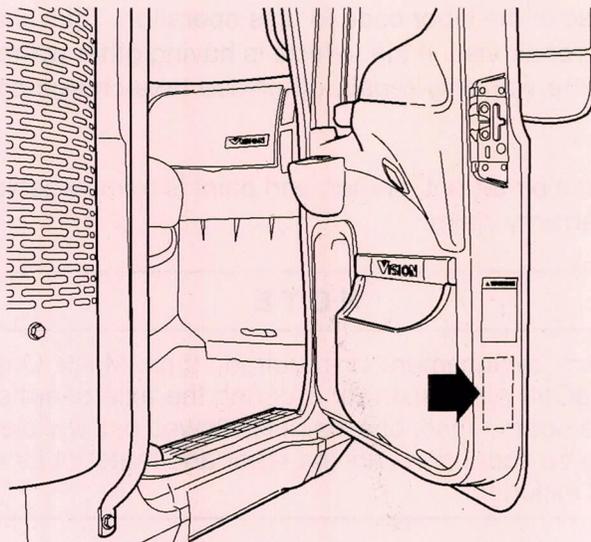
To signify that the campaign has been completed, use a permanent-type marker (such as a Sharpie®) to write the campaign number (SC339) and completion date in the spaces provided on the Campaign Completion Label located on the lower edge (below the door latch) of the passenger-side door. If a label is not already affixed to the door, apply a label (part No. TS897) and supply the information as required. Campaign Completion labels are available in packs of 50 and can be ordered by faxing a completed BR313 to Pacesetters Business Services at 610-264-9465.
