Date	Number	Page
09/4/09	<b>SC0341</b>	1(5)

## Front Axle Beam

### SC0341, Front Axle Beam

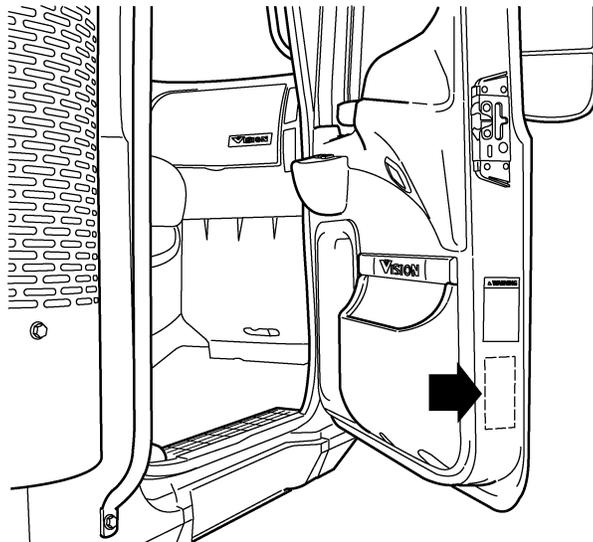
703153a

To signify that the campaign has been completed, use a permanent-type marker (such as a Sharpie®) to write the campaign number (SC0341) and completion date in the spaces provided on the Campaign Completion Label located on the lower edge (below the door latch) of the passenger-side door. If a label is not already affixed to the door, apply a label (part No. TS897) and supply the information as required. Campaign Completion labels are available in packs of 50 and can be ordered by faxing a completed BR313 to Pacesetters Business Services at 610-264-9465.
