SUBJECT: Recall Campaign 094 - Front Passenger Seat Belt Tension Sensor Wiring Harness - TSB# 10-01-008

HYUNDAI Technical Service Bulletin

Group	CAMPAIGN
Number	10-01-008
Date	FEBRUARY, 2010
Model	AZERA 2006 ~ 2009

Subject: **FRONT PASSENGER SEAT BELT AND BTS WIRE FIXING CLIP REPLACEMENT - DTC B1489/B1495 (CAMPAIGN 094)**

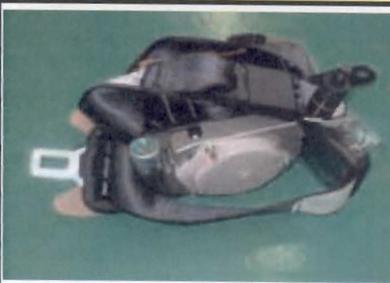
Front passenger seat belt pretensioner assembly.

Production Date	Part Name	Color	Part No.	Figure
Start of production ~ Aug. 21, 2006	Front RH seat belt	Beige	88820-3L500J9QQH

Black	88820-3L500WKQQH	
		Gray	88820-3L500X6QQH	
Aug. 22, 2006 ~ Oct. 10, 2008		Beige	88820-3L610J9QQH	
		Black	88820-3L610WKQQH	
		Gray	88820-3L610X6QQH

10. Remove the seat belt pretensioner mounting screw (G) and bolt (H), disconnect the BTS wire harness connector and then replace the seat belt pretensioner assembly with the newly supplied part.
