Subject: Information Report, NHTSA No. 99V-295

Recall Campaign Information

Subject: ConMet Preset Greased Front Hubs
FL246AB U.S.
FC246AB Canada

Recall Bulletin

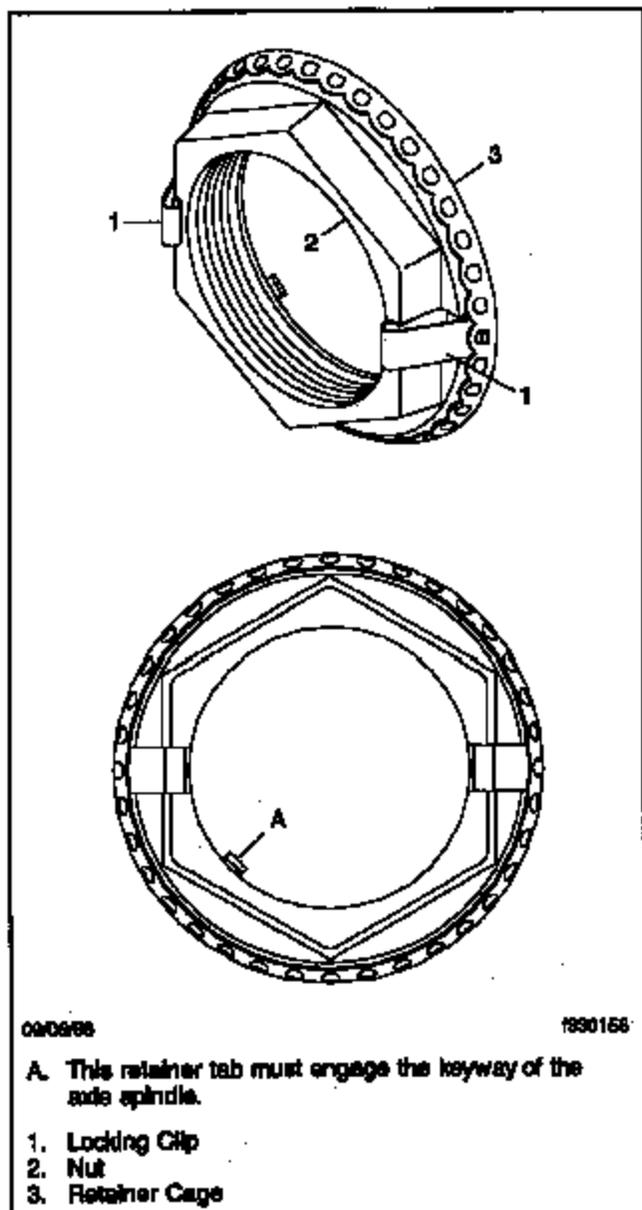
Fig. 3, Axlok Retaining Nut, Eaton Front Axle

2. Remove the Axlok nut (see Fig. 3 or Fig. 4).

8. Install the Axlok retaining nut (see Fig. 3 or Fig. 4) onto the axle spindle.
9. Tighten the retaining nut 250 lbf-ft (339 N-m). Do not back off the retaining nut. The nut should lock in place when you remove the wrench. If it does not, advance it until it does.

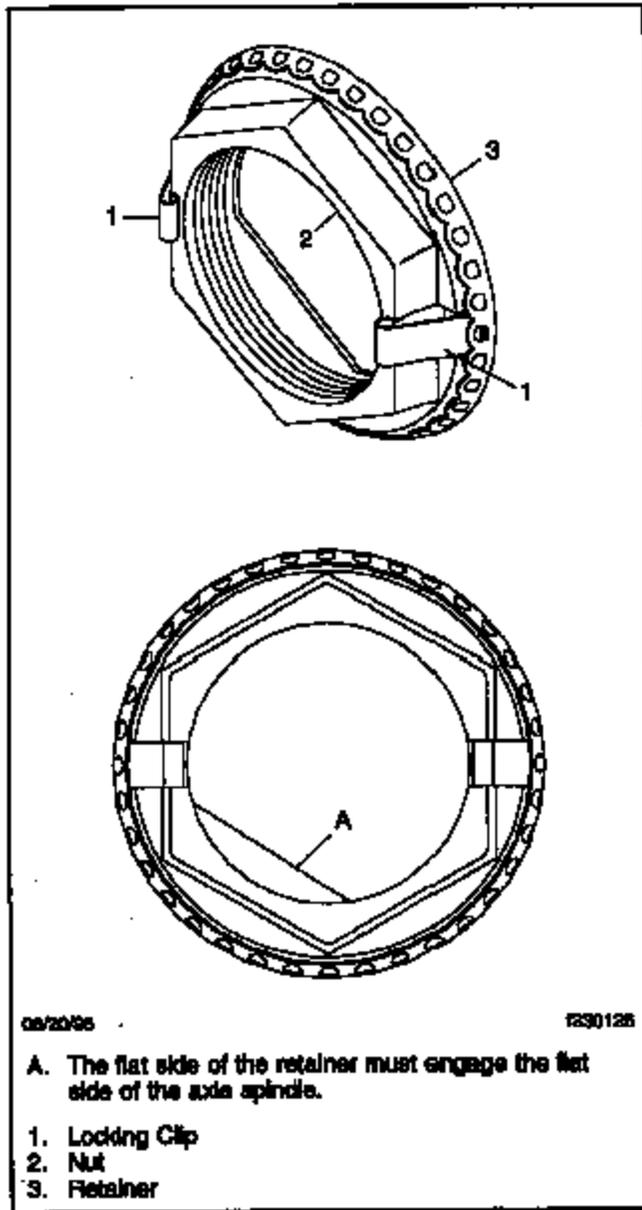
Fig. 4, Axlok Retaining Nut, Meritor Front Axle
