DEALER OPERATIONAL INFORMATION FOR 'STICKY ACCELERATOR PEDAL' RECALL

As of January 28, 2010

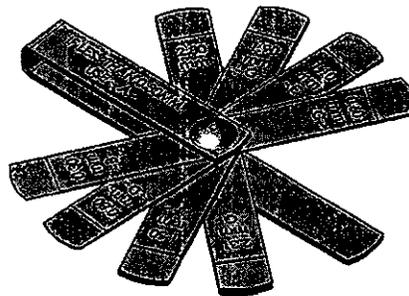
ID: 00002-4BLFG-1 Feeler Gauge: This tool is used to assist technicians in the proper selection of the precision-cut steel reinforcement bar ("reinforcement bar") that will increase the clearance in between the internal mechanisms in the pedal assembly.

In support of the Safety Recall (Special Service Campaign) A0A, TMS has developed a new Feeler Gauge set that will assist your dealers in quickly and accurately identifying the correct precision-cut steel reinforcement bar ("reinforcement bar") to use during the repair.

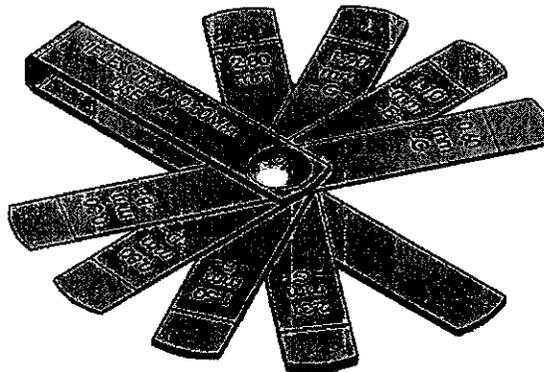
ID: 00002-4BLFG Feeler Gauge: This tool is used to assist technicians in the proper selection of the precision-cut steel reinforcement bar ("reinforcement bar") that will increase the clearance in between the internal mechanisms in the pedal assembly.

In support of the Safety Recall (Special Service Campaign) A0A, TMS has developed a new Feeler Gauge set that will assist your dealer in quickly and accurately identifying the correct precision-cut steel reinforcement bar ("reinforcement bar") to use during the repair.
