**Re: ArvinMeritor FF981 series non-drive steer axle hubs
NHTSA Recall No.: 03V-125
Peterbilt Recall No.: 303-A**

SUBJECT: SAFETY RECALL #303-A
ARVIN MERITOR FRONT AXLE MODEL FF981 with SKF UNITIZED HUBS
EXPIRATION DATE: NONE

Technical Bulletin

Unitized Wheel-End Assembly Inspection with a Dial Indicator Replacement Hub Inspection Spindle and O-Ring Installation Hubcap Installation All Meritor Front Non-Drive Steer Axles with Unitized Wheel Ends

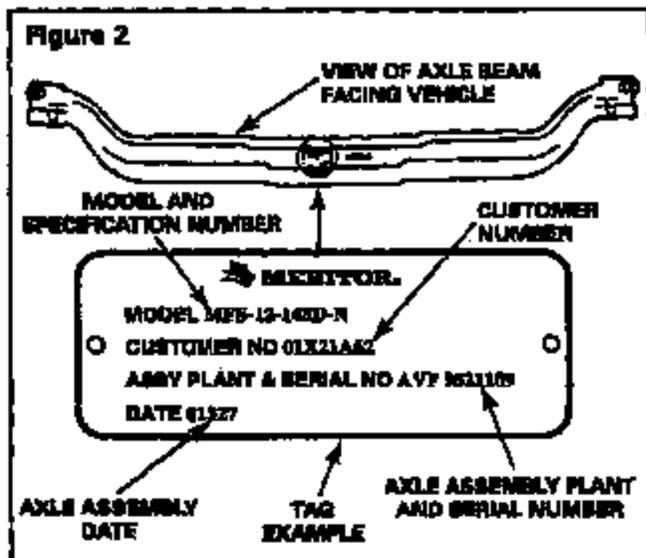
If the hubcaps are missing, you can use the axle model number to determine if the axle is equipped with unitized wheel ends. To identify the model number, refer to the axle identification plate on the front of the beam. Figure 2.

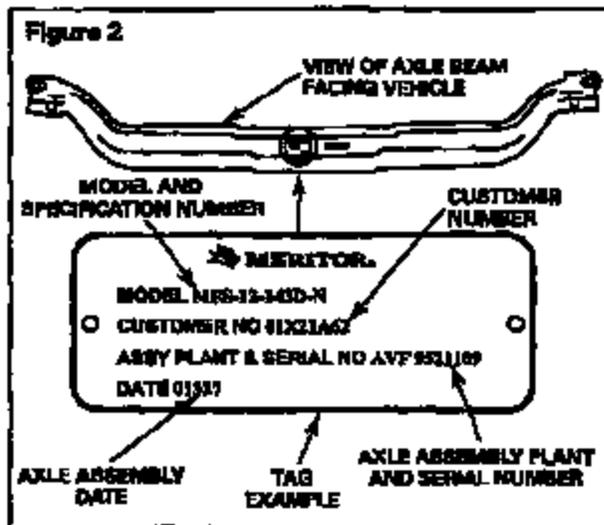
If the hubcaps are missing, you can use the axle model number to determine if the axle is equipped with unitized wheel ends. To identify the model number, refer to the axle identification plate on the front of the beam. Figure 2.
