ITB10-033a

August 25, 2010

VOLUNTARY SAFETY RECALL CAMPAIGN EQUIPMENT / SERVICE PARTS SUSPENSION LOWER LINK

CAMPAIGN ID #: PC050
NHTSA #: 10E-019
APPLIED VEHICLES: 2004 - 2010 QX56 (JA60)

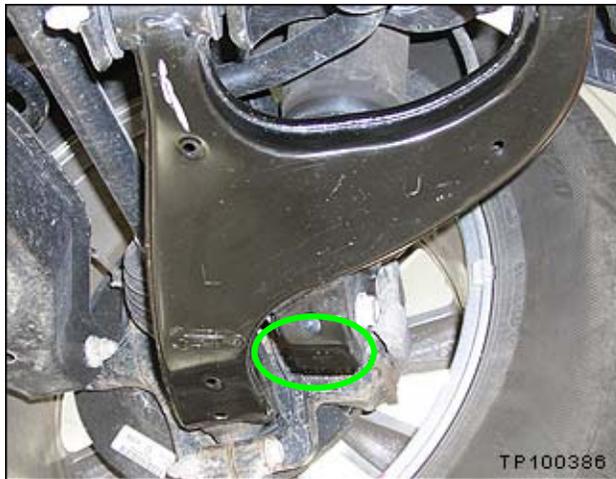
1. Raise the vehicle.
2. Locate and write down the "Lot Number" stamped on the bottom side of the suspension lower links.
 - Refer to the Lot Number Locations below.
 - Inspect front and rear (all 4) lower links.
3. Compare the Lot Number of each lower link to the Lot Number examples on the next page.

- First two positions match one of the above: NG, replace only that link
 - Compare the Lot Number from each link.
 - Replace **only** the link(s) with a match to one or the examples above.
- No match to the examples above: OK, do not replace link
 - Compare the Lot Number from each link.
 - Do not replace link if there is not a match to one of the examples above.
- All links check OK: No further action needed.
