DP92-017:NEF-12jad
Supplement
November 17, 1992

Robert H. Munson
Director
Automotive Safety Office
Environmental and Safety
Engineering Staff

Subject: DP92-017:NEF-12jad

This supplements our letter dated October 30, 1992, and contains our answer to Question No. 4 and the remainder of our answer to Question Nos. 2 and 3 of your September 21, 1992 letter concerning the Institute for Injury Reduction petition regarding alleged "inadvertent" seat belt buckle "unlatching" from inertial forces.

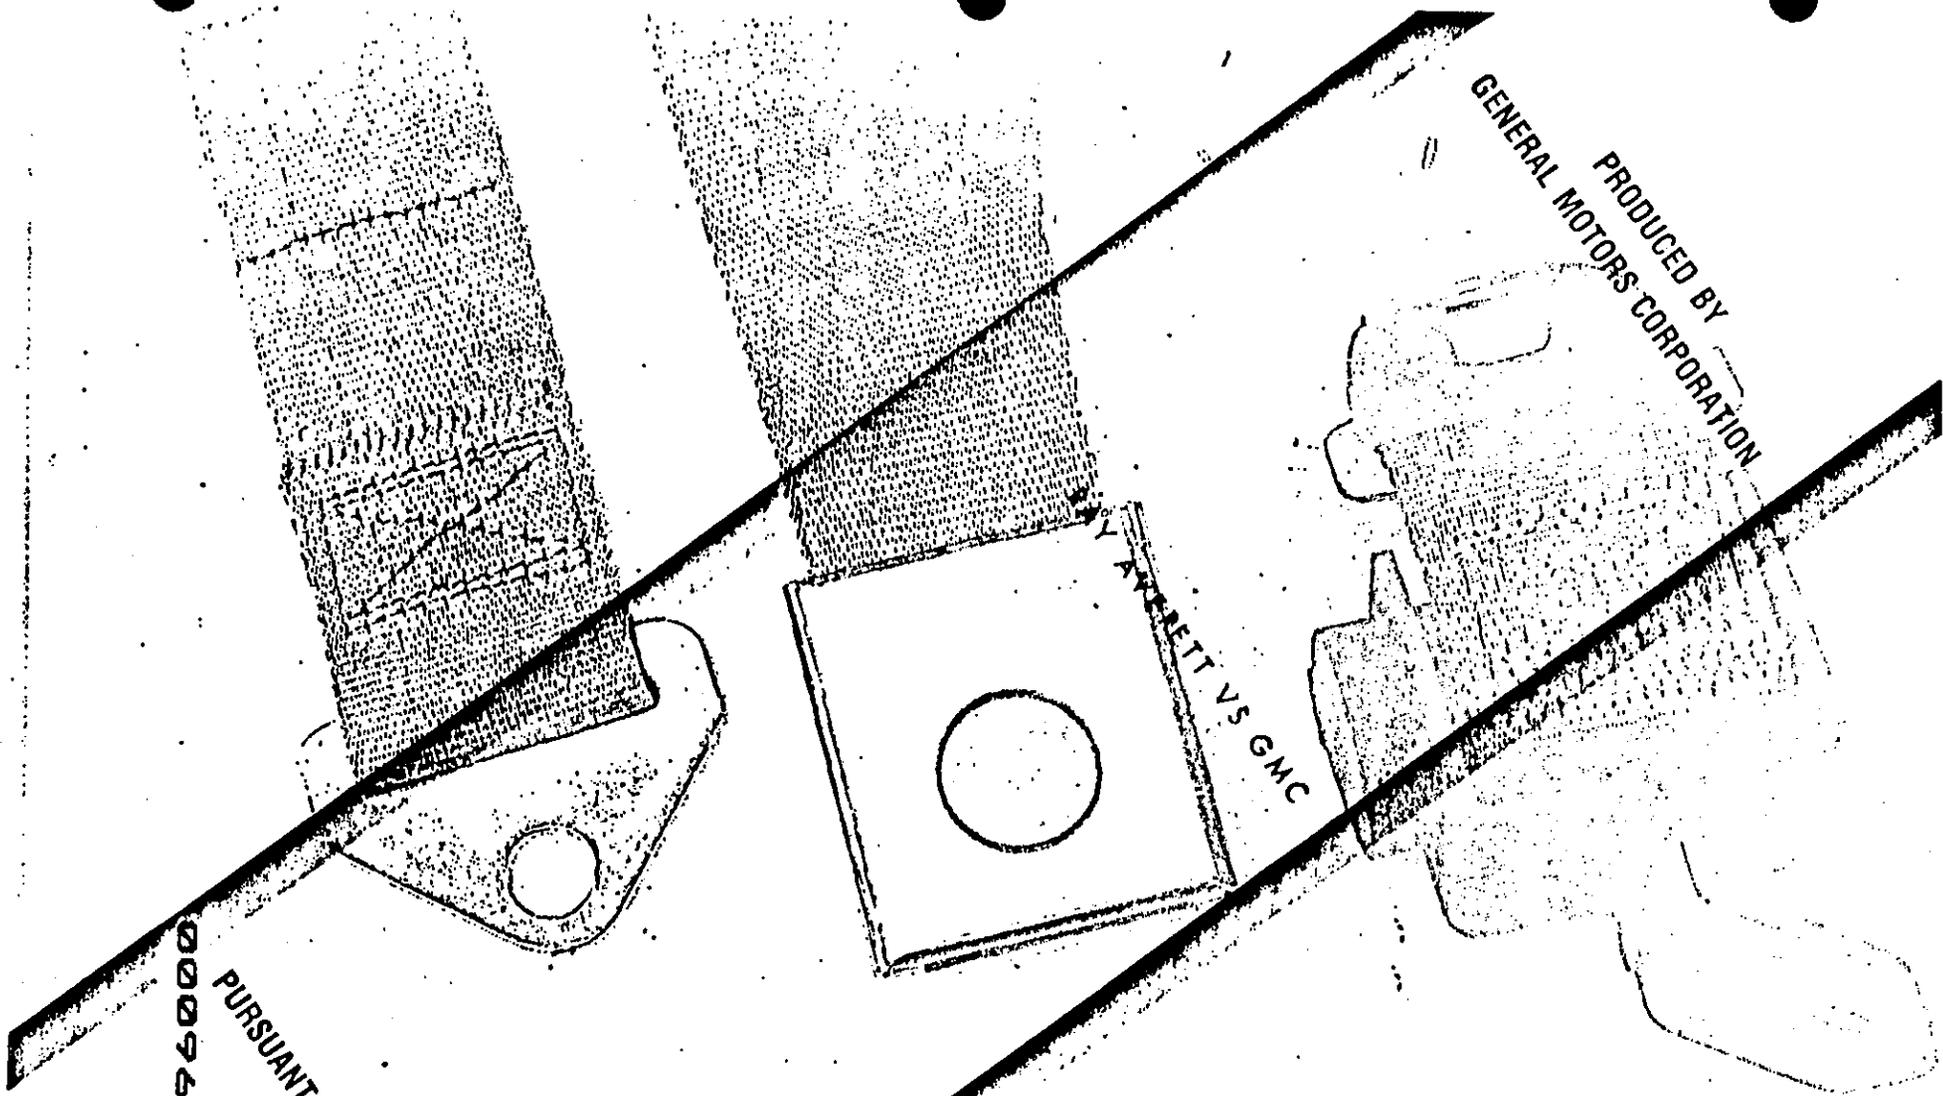
64629.066	GENERAL MOTORS PROVING GROUND	Report No. PG-10463
FIGURE 1	1965 Cadillac Seat Belt Assembly

The 1965 Cadillac belt assembly supplied by Fisher Body Division was significantly different from the current (1964) version. The "D" ring unlatches by depressing the button recessed in the buckle cover and the integral retractor assembly has been revised to facilitate mounting on the horizontal (top) surface of the rocker panel. The frame of the retractor is designed so that the belt webbing is oriented at 55° relative to the retractor mounting plane. The usual decorative cover on the retractor was not installed for this test. Figure 1 shows the belt assembly.

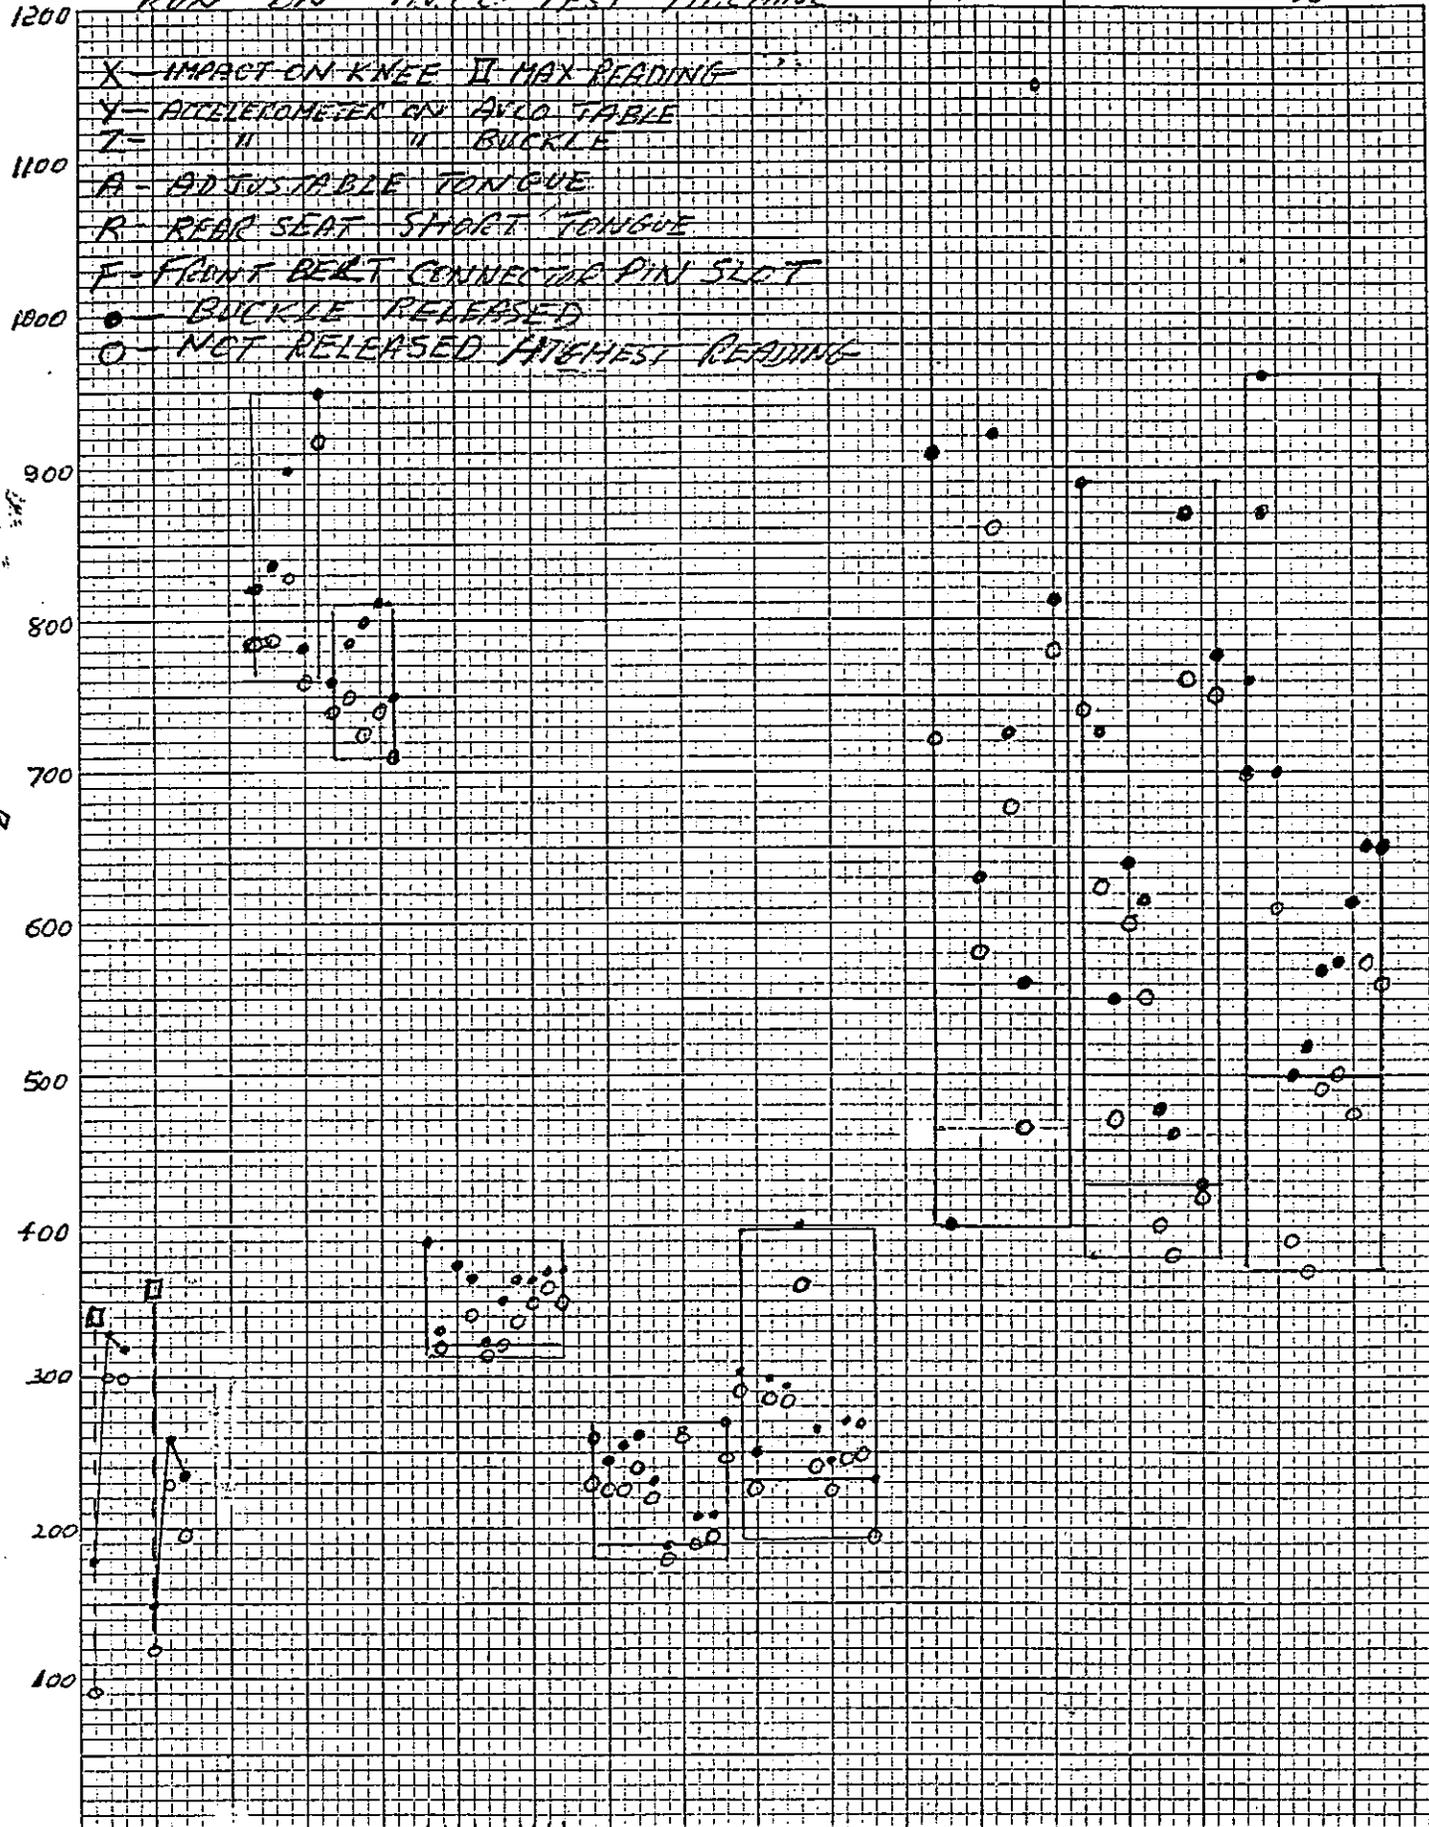
GRAPH SHOWING G READINGS
FOR VARIOUS TYPE BUCKLES.
RUN ON AVCC TEST MACHINE

BUCKLE TYPE	TONGUE TYPE	SAMPLE NO	RELEASED "G"		IMPACT DURATION	BUCKLE RELEASE WITH 150LB. LOAD	REMARKS
			NO	YES			
Standard	Adjustable	OK-1	825	780	2 m.s. (approx)	15.8 lb.	Buckle not possible to release by parlor trick
		OK-2	840	780	2 m.s. (approx)	19.8 lb.	
		OK-3	900	830	2 m.s. (approx)	22.0 lb.	
		OK-4	760	760	2 m.s. (approx)	18.2 lb.	
		OK-5	950	920	2 m.s. (approx)	27.2 lb.	
Standard	Adjustable	PT-1	760	740	2 m.s. (approx)	22.0 lb.	Buckles easy to release by parlor trick
		PT-2	835	800	2 m.s. (approx)	21.8 lb.	
		PT-3	800	725	2 m.s. (approx)	18.2 lb.	
		PT-4	810	740	2 m.s. (approx)	24.8 lb.	
		PT-5	750	710	2 m.s. (approx)	18.8 lb.
