00V-076 (01)

Technical BULLETIN

RECALL

YZF-R1K, KC, L, LC; YZF-R6L, LC, M, MC FACTORY MODIFICATION CAMPAIGN

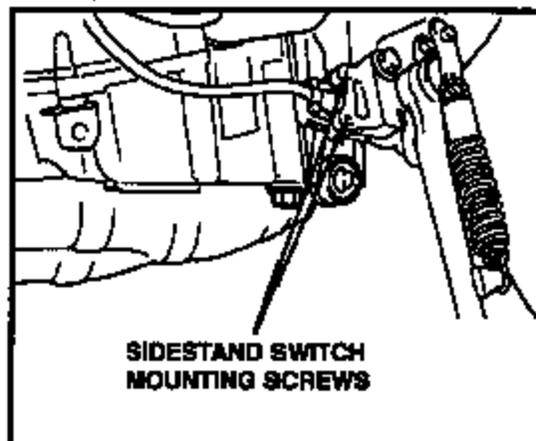
Yamaha Motor Corporation, U.S.A. has determined that a defect which relates to motor vehicle safety exists in 1998 and 1999 YZF-R1 motorcycles, and also in 1999 and certain 2000 YZF-R6 motorcycles. The screws holding the sidestand switch may loosen and fall out due to engine heat and vibration. If this happens, the sidestand switch would not function correctly, so it would be possible to ride the motorcycle with the sidestand in the down position. This condition would increase the risk that the sidestand could hit the ground during a turn, which could cause loss of control and an accident/crash with resulting personal injury or death.

To correct this defect, Yamaha is initiating a Factory Modification Campaign. Affected units must have the screws holding the sidestand switch replaced with a combination of bolts and nuts which will hold the switch securely. Due to changes in the way fuel-tank overflow and breather hoses are routed on late-production YZF-R1 units, there are two different Bolt Kits. Order the correct Bolt Kit for the unit being modified as described in this bulletin.
