//ALL HMA-BST3D 04/23/04 04/26/04 04/27/04
TO: All Hyundai Dealership Service and Parts Managers
FROM: Service
SUBJECT: Campaign 067 - Vapor Tube Hose Clamp Position on certain
2004 Model Year Elantras.

Subject VAPOR TUBE HOSE CLAMP POSITION CAMPAIGN 067	Group CAMPAIGN
	Number 04-01-004
	Date APRIL, 2004
	Model 2004 ELANTRA

Group	CAMPAIGN
Number	04-01-004-1
Date	APRIL, 2004
Model	2004 ELANTRA

Subject	VAPOR TUBE HOSE CLAMP POSITION CAMPAIGN 067
---------	--

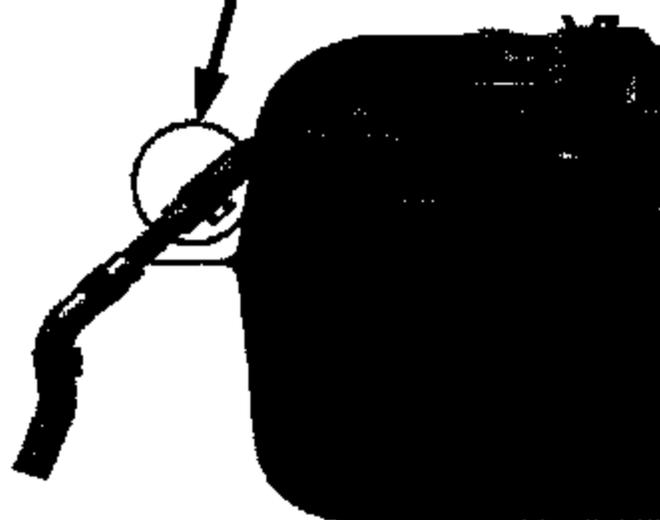
This bulletin describes how to inspect the position of a vapor tube hose clamp, and if necessary, how to reposition it to prevent contact with the fuel tank. The vapor tube hose clamp is located in the opening between the front upper side of the fuel tank and underbody cross member as shown.
