SUBJECT: Vehicle Recall Campaign - SC0282  
TRW Tie Rod Ends (00E-048.004) *00V-246.103*

SUBJECT: TRW TYPE 20 EDL BALL SOCKETS — FRONT STEER AXLES

## Service Bulletin #LNK-112

### EDL Socket Replacement (Tie Rods)

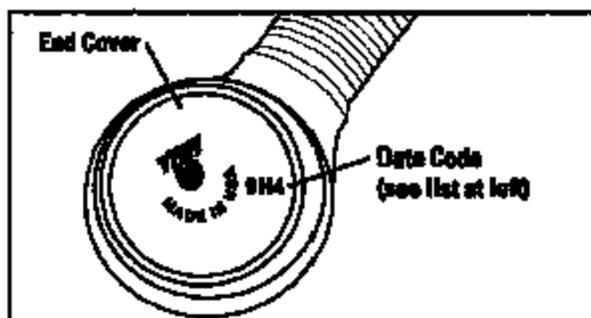
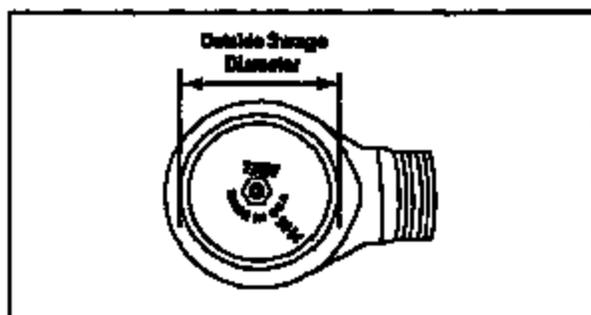
**NOTE:** Any socket with "DL" stamped into the end cover is a different design, and IS NOT part of this campaign.

**NOTE:** Only 20 size sockets are subject to this campaign. Make sure you are servicing the correct size socket.

**THEN** .... Both socket ends need to be replaced using this kit.
