| SUBJECT: LOWER BALL JOINT — SAFETY RECALL CAMPAIGN | | | No: SR-01-007 |
| | | | DATE: March, 2001 |

Mitsubishi Motor Sales of America, Inc. (MMSA) is voluntarily recalling affected vehicles for possible premature wear to the lower lateral arm ball joint assembly as a result of moisture intrusion. MMSA identified that the lower lateral arm ball joint may have other areas of leakage beyond the cut or torn boot that was the subject of safety recall bulletin SR-99-002. Such moisture intrusion could result in excessive ball joint clearances that could eventually result in ball joint separation.

1994-1998 Galant, 1995-1999 Eclipse, and 1996-1999 Eclipse Spyder models

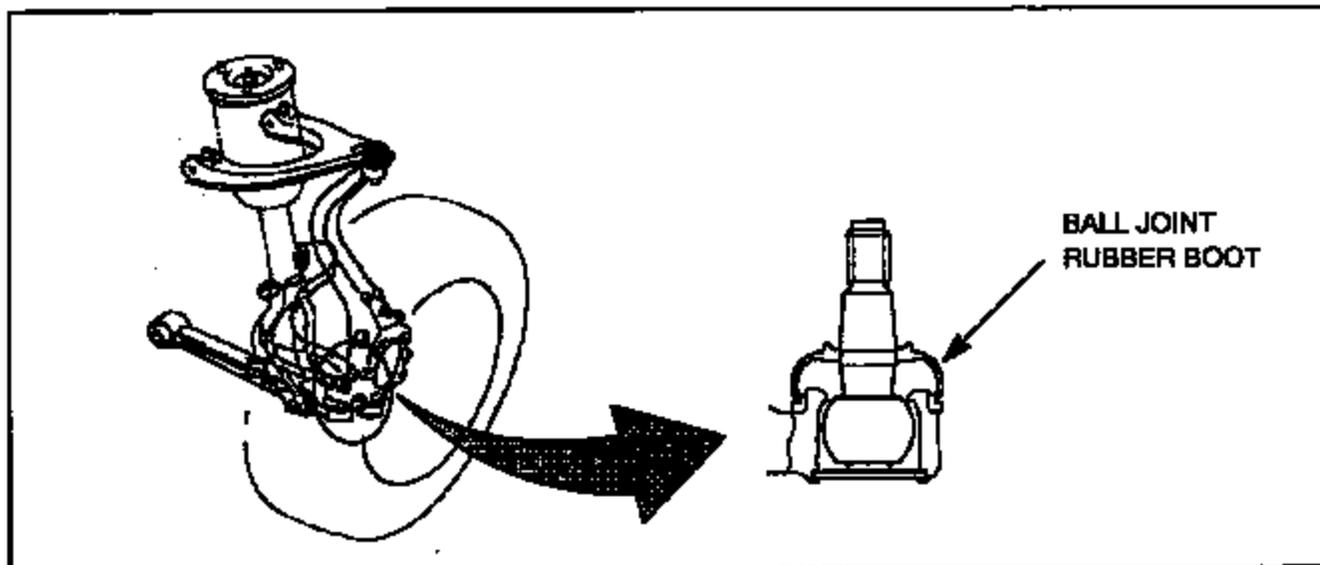
2. Inspect the lateral lower arm ball joint rubber boot on both sides for cracks and damage. Gently push the boot in with your fingers. Do not remove any parts for the inspection. Damage to the boot is evident if any cuts or tearing are observed, if grease comes out when it is pushed in, or if there are any other signs of leakage.
 - a. If the rubber boot is **not** damaged on either side of the vehicle, go to Steps 3 and 4 for ball joint inspection.
 - b. If the rubber boot is damaged, replace the lateral lower arm assembly, using the parts listed in the PARTS INFORMATION section of this bulletin. Go to Step 5 for lateral lower arm replacement instructions.

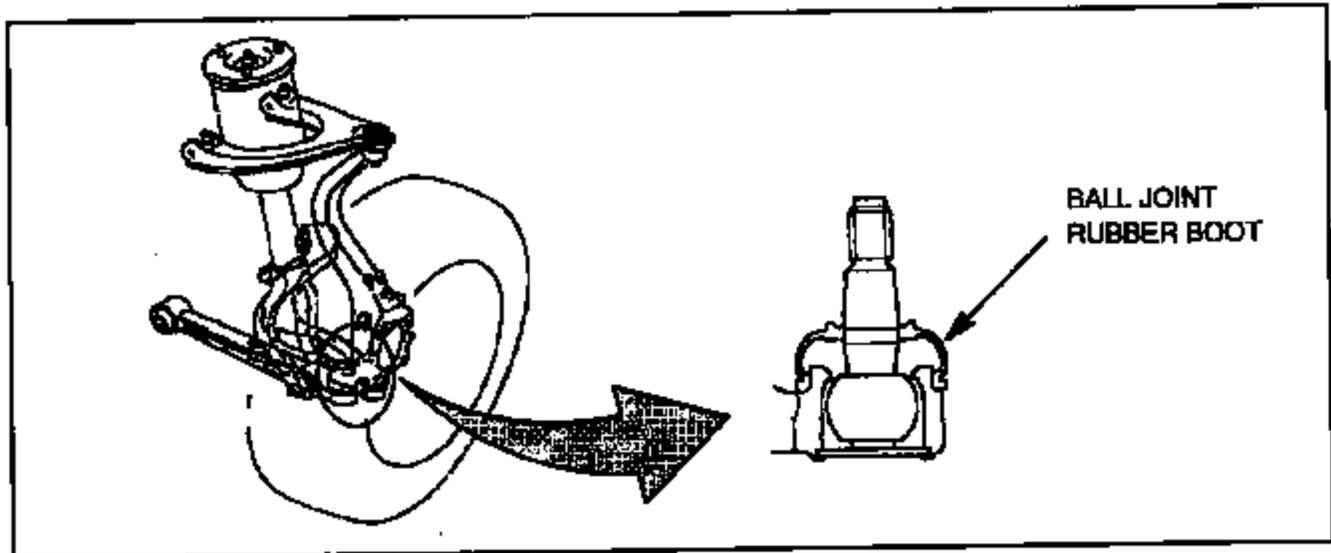
2. Inspect the lateral lower arm ball joint rubber boot on both sides for cracks and damage. Gently push the boot in with your fingers. Do not remove any parts for the inspection. Damage to the boot is evident if any cuts or tearing are observed, if grease comes out when it is pushed in, or if there are any other signs of leakage.
 - a. If the rubber boot is **not** damaged on either side of the vehicle, go to Step 4 for ball joint free play inspection.
 - b. If the rubber boot is damaged, replace the lateral lower arm assembly, using the parts listed in the PARTS INFORMATION section of this bulletin. Go to Step 5 for lateral lower arm replacement instructions.
