Service Recall Bulletin - 96S48 Supplement #1

Attachment IV - Technical Instructions (Rail Inspection/Replacement)

1990-92 PROBE PASSIVE RESTRAINT (MOTORIZED) SEAT BELT SYSTEM
 REPLACEMENT OF LEFT SIDE RAIL (96S48) –
 INSPECTION/REPLACEMENT OF RIGHT SIDE (96S99)

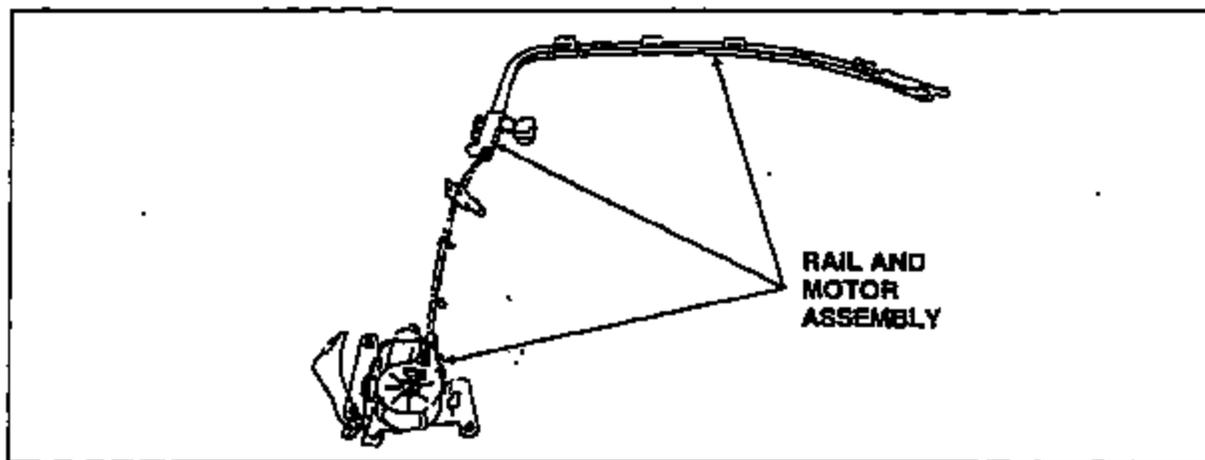
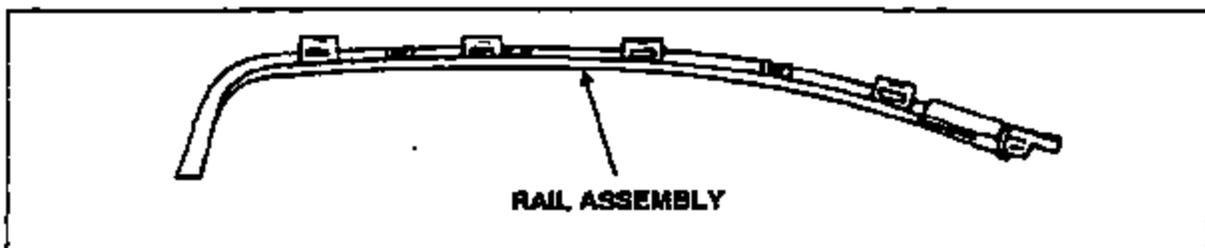
PASSIVE SEAT BELT DIAGNOSTIC FLOW CHART (PERFORM ON EACH SIDE)

Only the right side rail will be inspected. The left side rail must be replaced.

Refer to the following flow chart to determine the necessary service action.

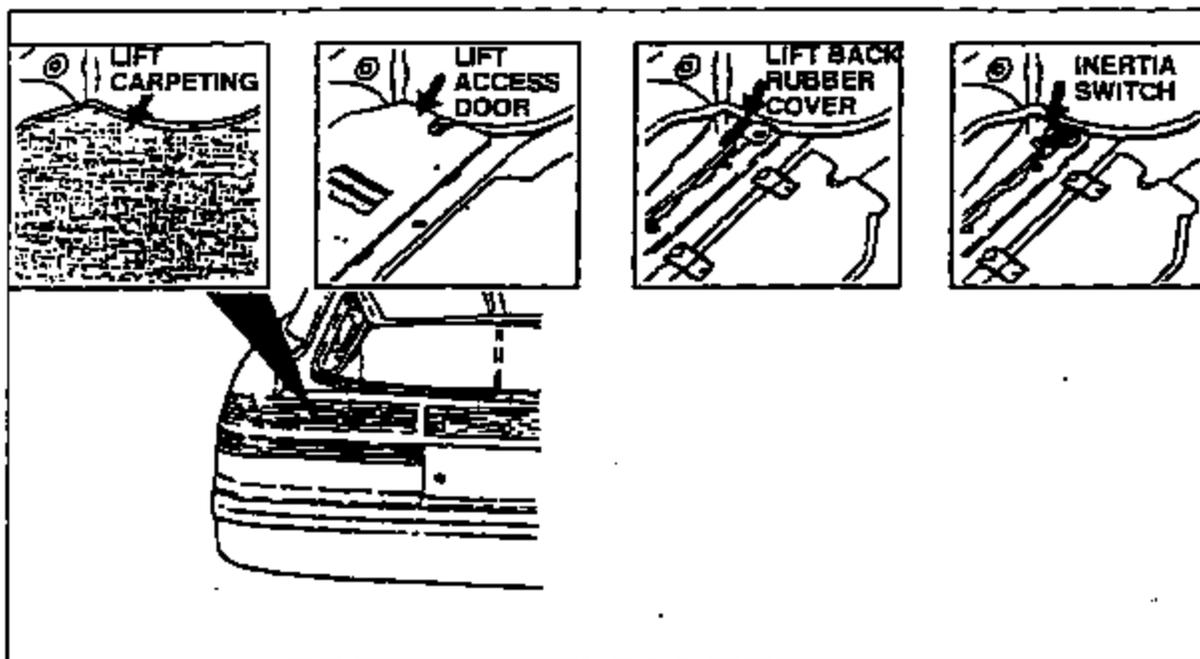
FIGURE 1

A water contaminated inertia switch (fuel pump shut-off switch) may cause the passive restraint belts to remain in the "B" pillar position.

1. Install a memory saver and disconnect the battery negative cable.
2. Locate and access the inertia switch. See Figure 1.
