Note Log: 96548
Period: 07/23/97 12:32:35 thru 09/25/97 14:33:31

Subject: PART NUMBERS F72Z 61610D44 B AND F72Z 61610D45 B

1990-92 PROBE PASSIVE RESTRAINT (MOTORIZED) SEAT BELT SYSTEM REPLACEMENT OF LEFT SIDE RAIL (96S48) - INSPECTION/REPLACEMENT OF RIGHT SIDE (96S99)

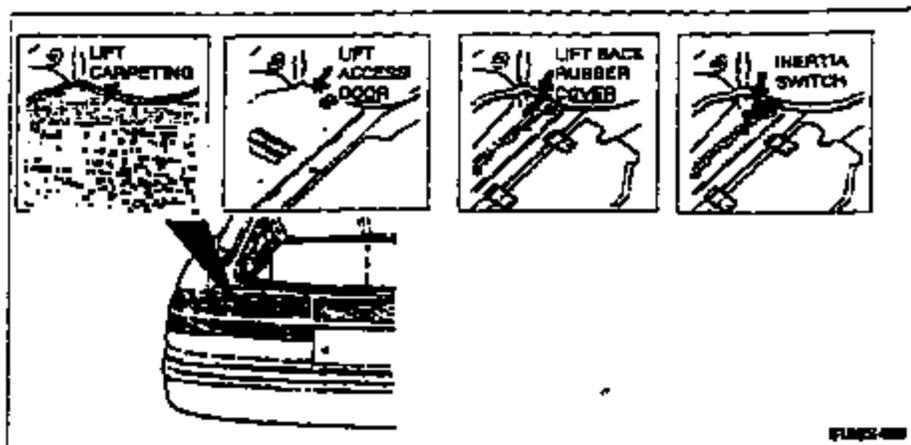
Figure 1

A water contaminated inertia switch (fuel pump shut-off switch) may cause the passive restraint belts to remain in the "B" pillar position.

1. Install a memory saver and disconnect the battery negative cable.
2. Locate and access the inertia switch. See Figure 1.
