**INVESTIGATION OF FUEL TANK CRACKS  
1998-2005 SUZUKI VL1500 MOTORCYCLES**

**NHTSA Defect Investigation PE05-031  
Suzuki / NHTSA Meeting  
November 3, 2005**

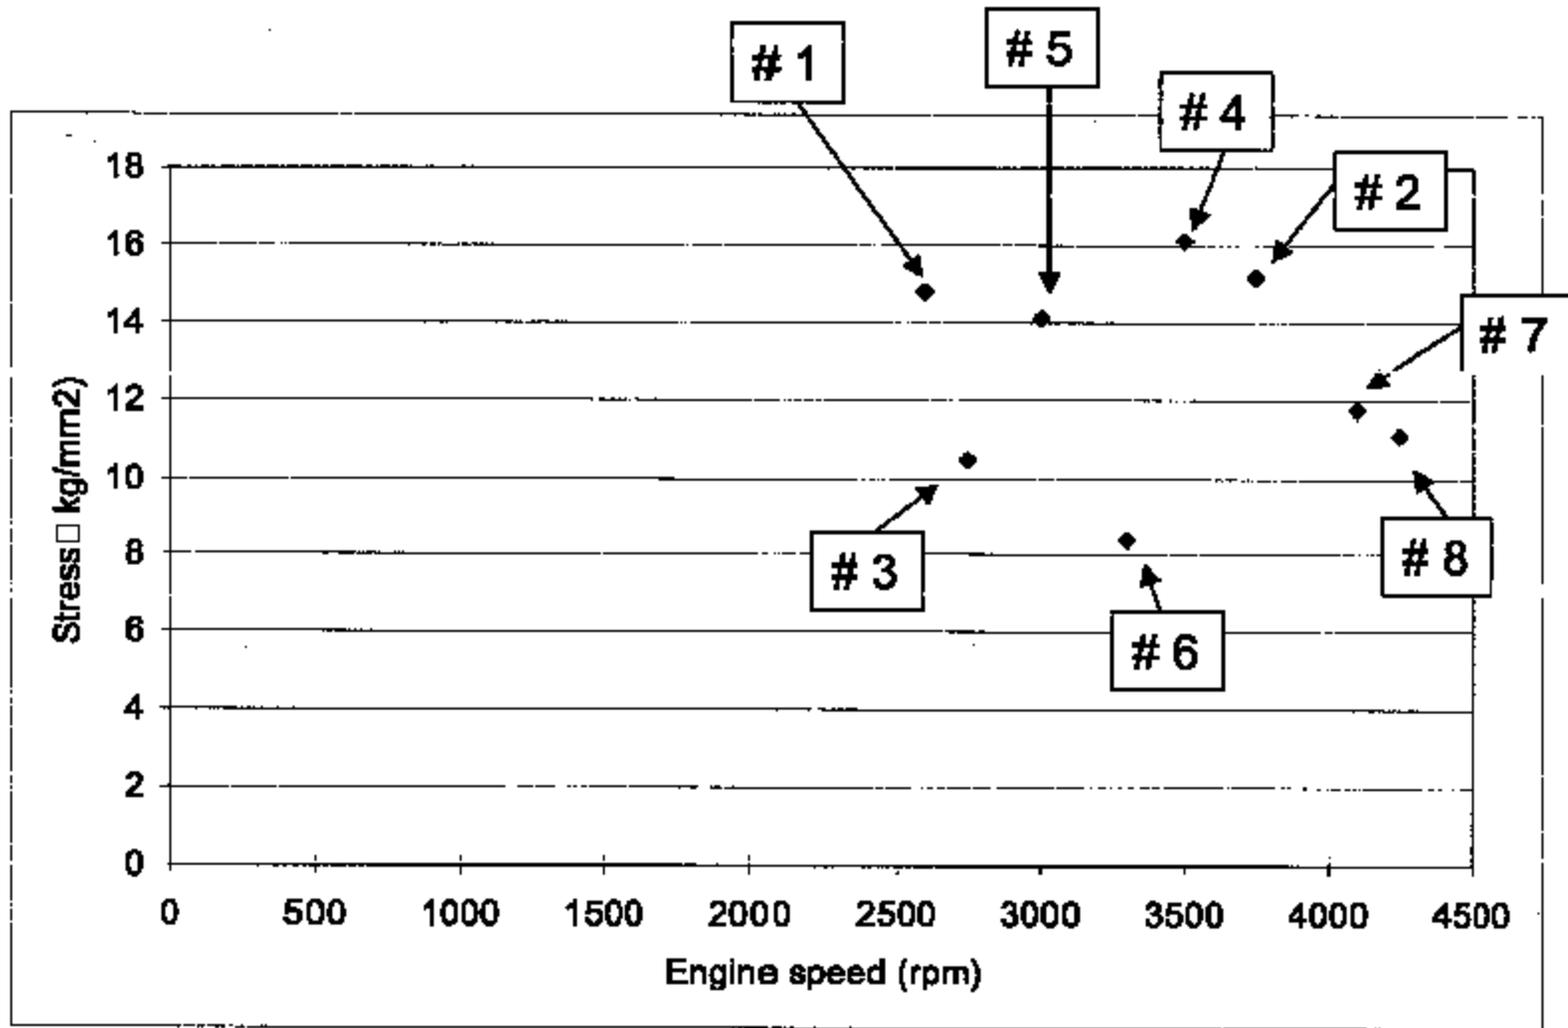
- HIGHEST STRESS MEASURED AT RIGHT FRONT MOUNTING LOCATION
- NO-LOAD ENGINE SPEED INCREASE
- 52 CONDITIONS EVALUATED

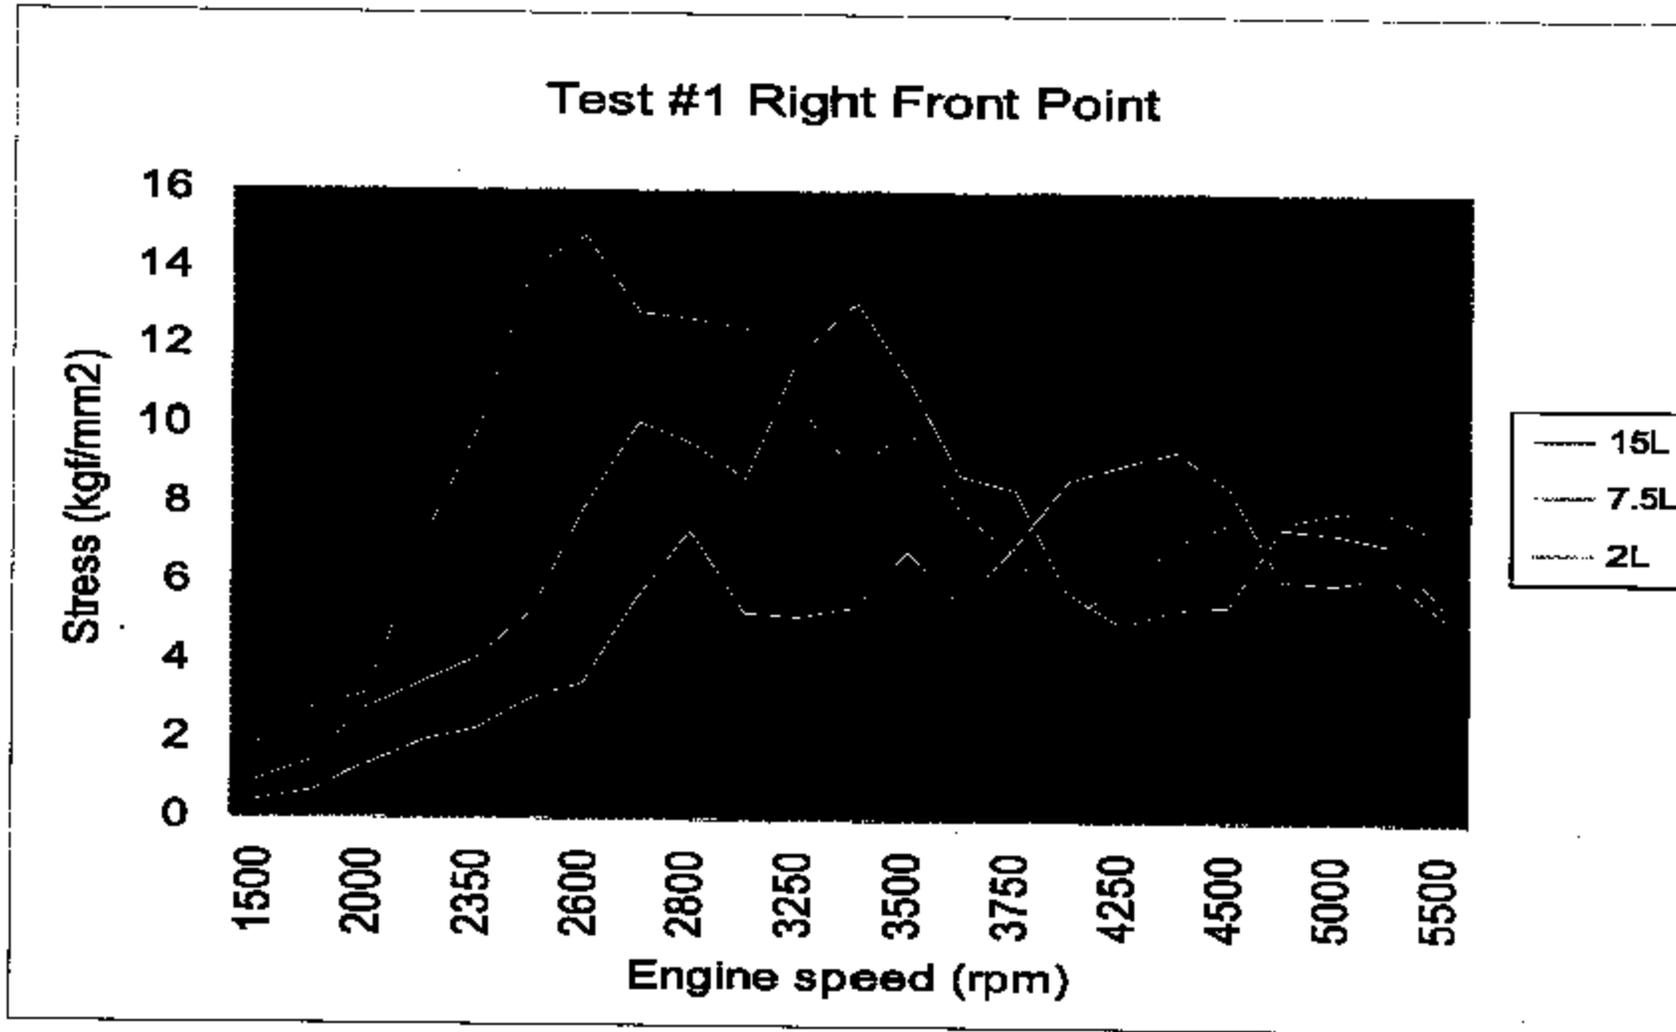
- **STRESS LEVEL DEPENDS ON ENGINE SPEED AND FUEL LEVEL**
  - Peak observed at 2750 rpm with full tank
  - Peak observed at 3500 rpm with 11 liters of fuel
- **MOST STRESS PEAKS ARE LESS THAN 15 kgf/mm<sup>2</sup>**
- **IN RARE CASES, STRESS LEVEL OF 16 kgf/mm<sup>2</sup> OBSERVED**
  - 2 out of 52 conditions
