AUTOCAR SAFETY RECALL A-0603 NHTSA RECALL 06V-167 May 2006

ATTENTION:	SERVICE MANAGERS / PARTS MANAGERS
SUBJECT:	Axilok Spindle Nut Tabs
VEHICLES AFFECTED:	Certain WX, WXR and WXLL 2006 model-year, heavy-duty Class 8 vehicles equipped with Hendrickson Lift Axles, shipped between November 9, 2004 and April 25, 2006 with serial numbers in the range 201463 through 203515.

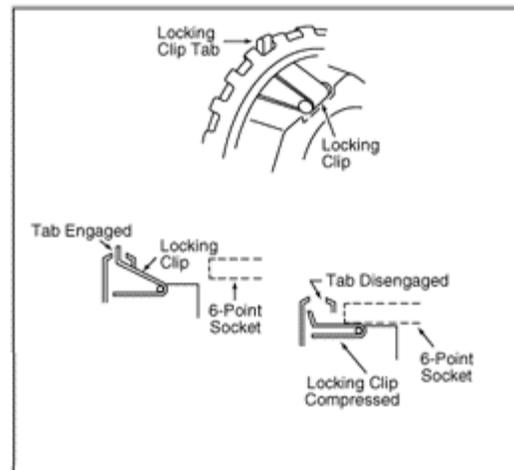
FIGURE 2.

Checking Position of Locking Clip Tabs

- Each locking clip should be securely fastened to the nut body and have a rivet that passes through the top of the locking clip body.
- Each locking clip should have a locking clip tab protruding completely through the retainer cage adjustment slot (when properly aligned and not compressed by a socket). Refer to Figures 2, 4 and 5.
- Locking clips should not be bent, cracked or broken.

If locking clip tabs do not protrude through the adjustment slots, rotate Axilok slightly clockwise. Refer to Figures 2, 4 and 5. If locking clip(s) are broken, replace Axilok and repeat installation procedures.

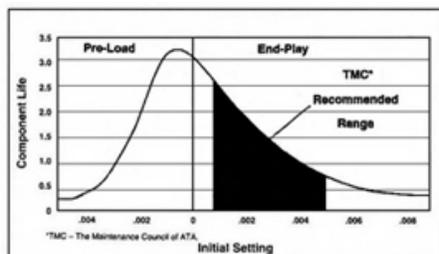
Figure 6

Recommended End Play Range

- Back off 1/2 turn.
- Tighten to final torque while rotating hub. Refer to Table 1.
- Back off 1/8 turn. This will provide end play. Refer to Figure 6.
