# TECHNICAL SERVICE BULLETIN

Bulletin Number: V-06-02  
Model Years: 2006

### SUBJECT: Rear Axle Failure on 2006 Vegas<sup>®</sup>, Vegas Eight Ball<sup>™</sup> and Kingpin<sup>™</sup>

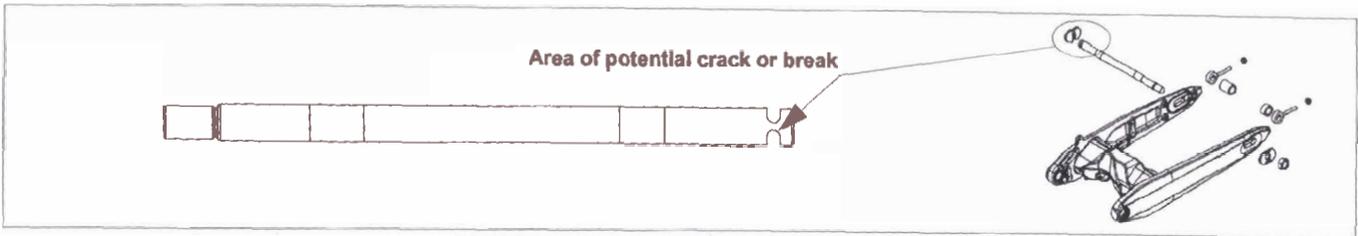
Victory has become aware of rear axle failures caused by a material problem on the 2006 models listed above which are equipped with a retainer plate style rear axle. Some rear axles could crack or break at the retainer plate groove during operation, which could cause a loss of control, increasing the risk of a crash.

1. Contact owners of delivered units immediately and make arrangements to perform this warranty repair.
2. Replace the axle on all affected vehicles in your inventory with new axle P/N 5135743. **DO NOT** operate or sell an affected vehicle until this bulletin has been completed.
3. File a warranty claim for affected units immediately after completion of this bulletin. Follow warranty claim filing procedures on page 2.
