FREIGHTLINER
LLC

Re: NVS-214bby / PE06-033

This letter responds to the above referenced request for information concerning missing or broken welds on the steering columns of certain Freightliner Century Class and Columbia trucks.

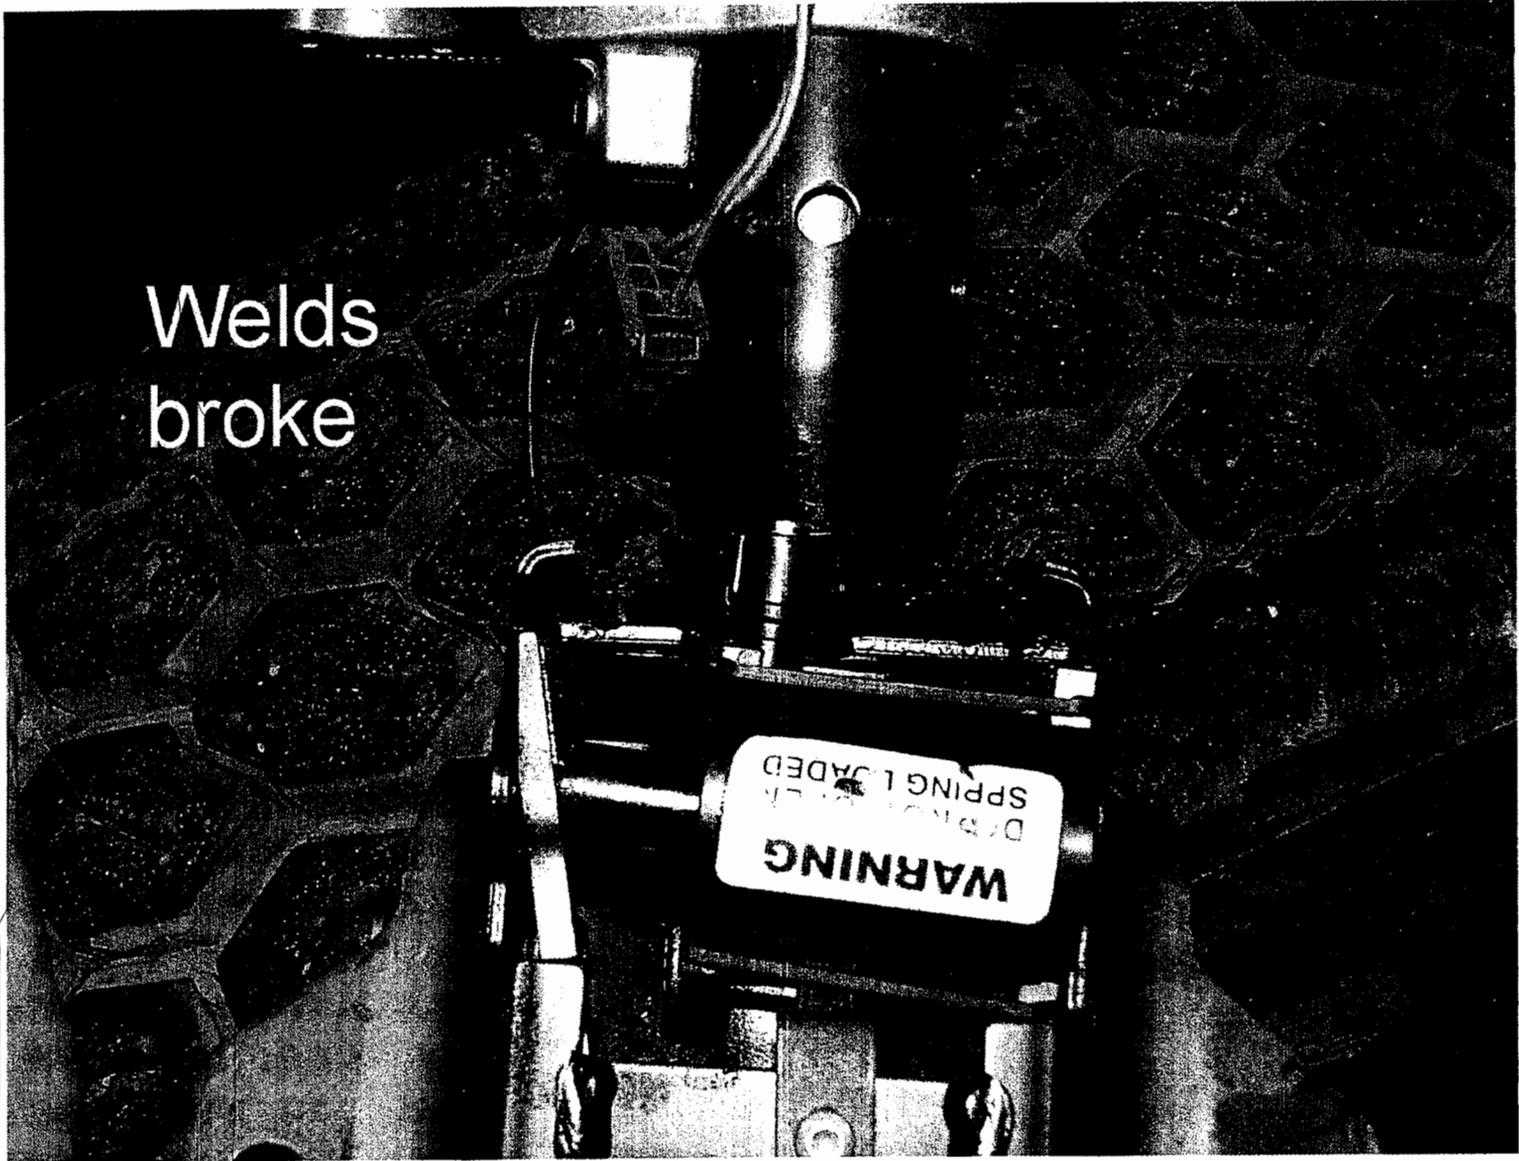
Welds
broke

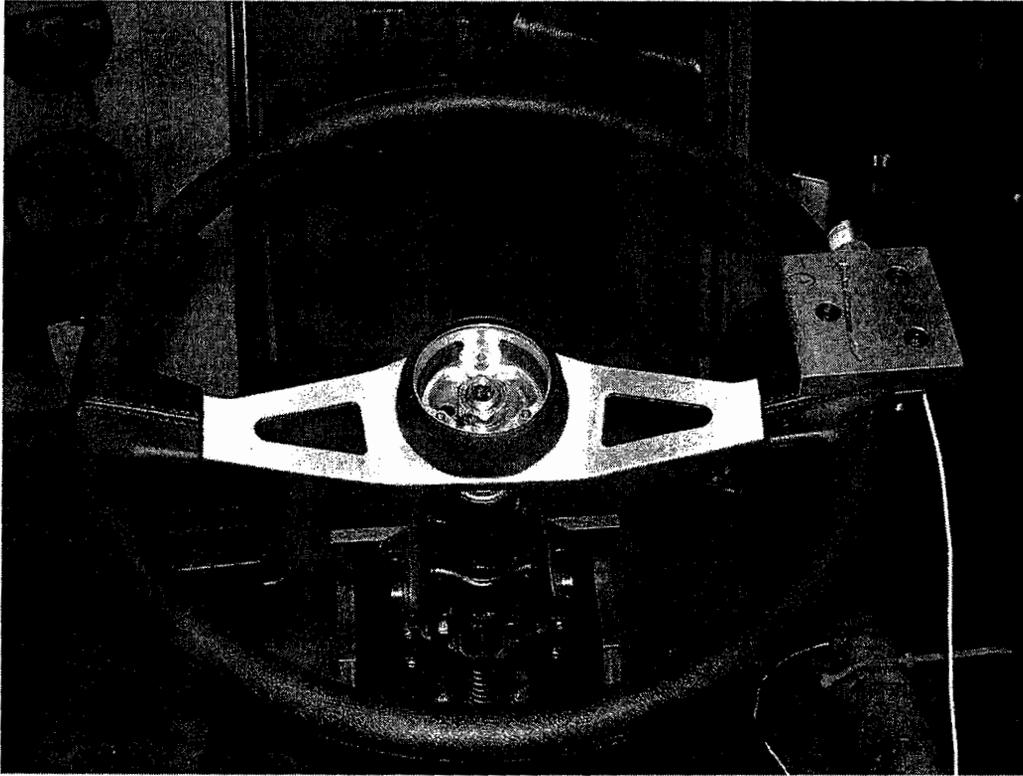
<i>Note</i>		<i>Operator</i>
<i>Date</i>	<i>Time</i>	<i>Cycle Count</i>	<i>Status</i>		
11/27/06	8:27 AM	0	OK		Fox, Jason
11/27/06	8:31 AM	21,840	Failed	Upper Shaft Weld Broke	Sieger, Jamie

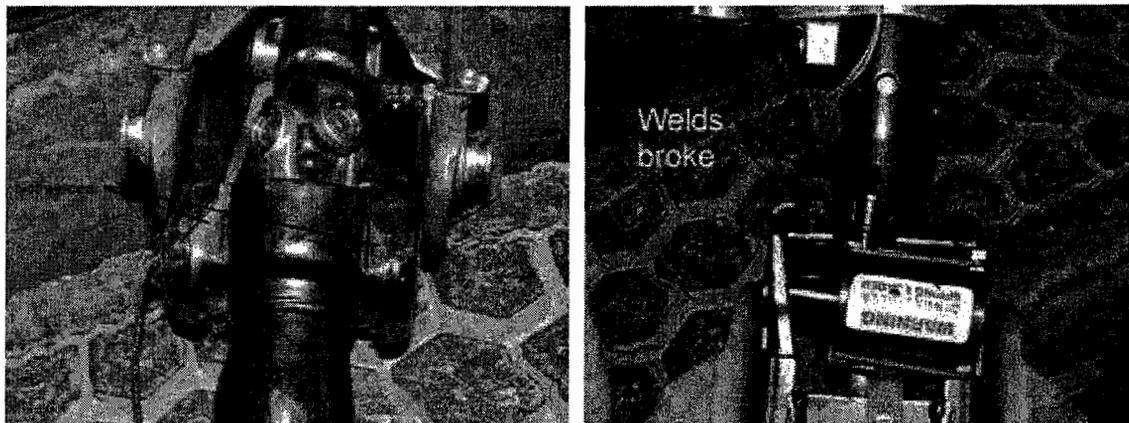
The specific failure being investigated is the separation of the upper tube assembly from the side channels due to two missing welds causing failure of the two remaining welds, which may also have inadequate penetration.

This failure results in a considerable amount of fore-aft and side to side play of the steering wheel.
