**ENGINEERING ANALYSIS EA92-041**

**GENERAL MOTORS PICKUP TRUCK DEFECT INVESTIGATION**

**ENGINEERING ANALYSIS REPORT AND  
INITIAL DECISION THAT THE SUBJECT VEHICLES  
CONTAIN A SAFETY-RELATED DEFECT**

**October 17, 1994**

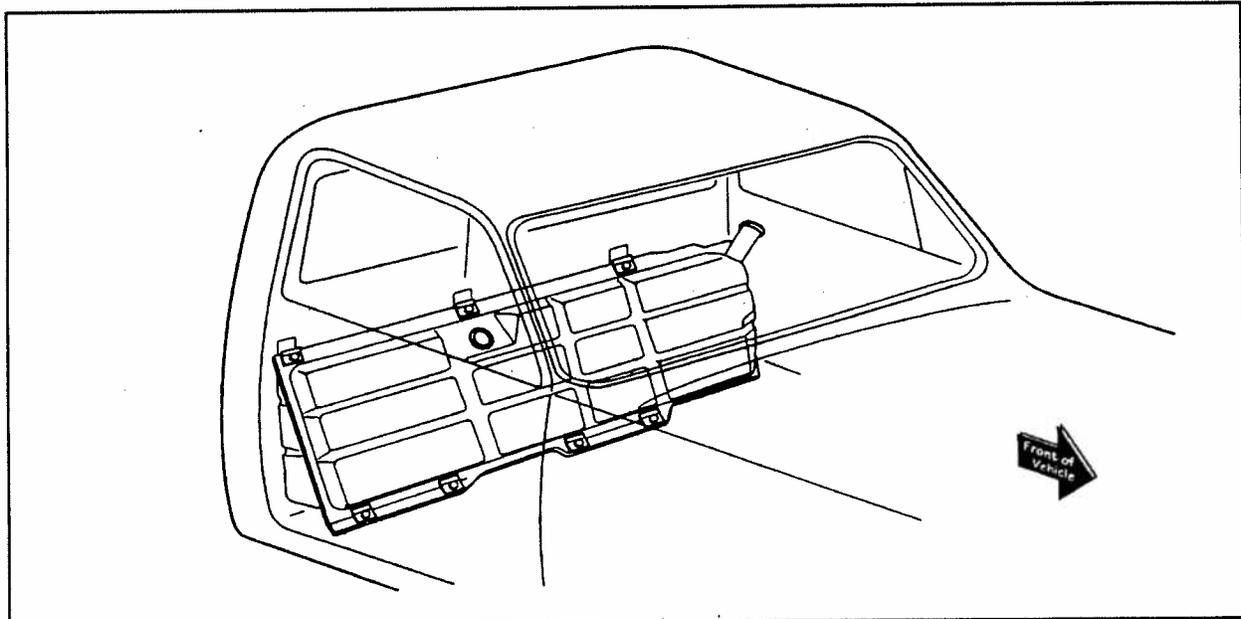
**Figure 1.** Location of Fuel Tank in Subject Vehicles (Outside Frame)

The fuel tanks in the subject vehicles are mounted outboard of the main frame rails, as shown in Figure 1. Prior to 1973, the standard fuel tank in GM's full-sized pickups was located inside the vehicle cab (Figure 2). Beginning in 1970, owners could have Chevrolet or GMC dealers install one or two 18.5 gallon auxiliary tanks outside of the frame rails. Also in 1971, there was a factory-installed optional auxiliary tank which could be located behind the rear axle between the frame rails. GM stated in its October 9, 1992 response to ODI's first information request (DP #12, at page 40), that this was offered to provide
