# TOYOTA CUSTOMER SERVICES

Volume: XIV  
Number: TC07-022  
Date: 12/14/2007  
 Action  
 Retain  
 Information

SUBJECT: SAFETY RECALL (SPECIAL SERVICE CAMPAIGN) – 70G  
(2007 MODEL YEAR TUNDRA 4WD REAR PROPELLER SHAFT)

**Special Service Campaign 70G  
2007 Model Year Tundra 4WD Rear Propeller Shaft  
SAFETY RECALL NOTICE**

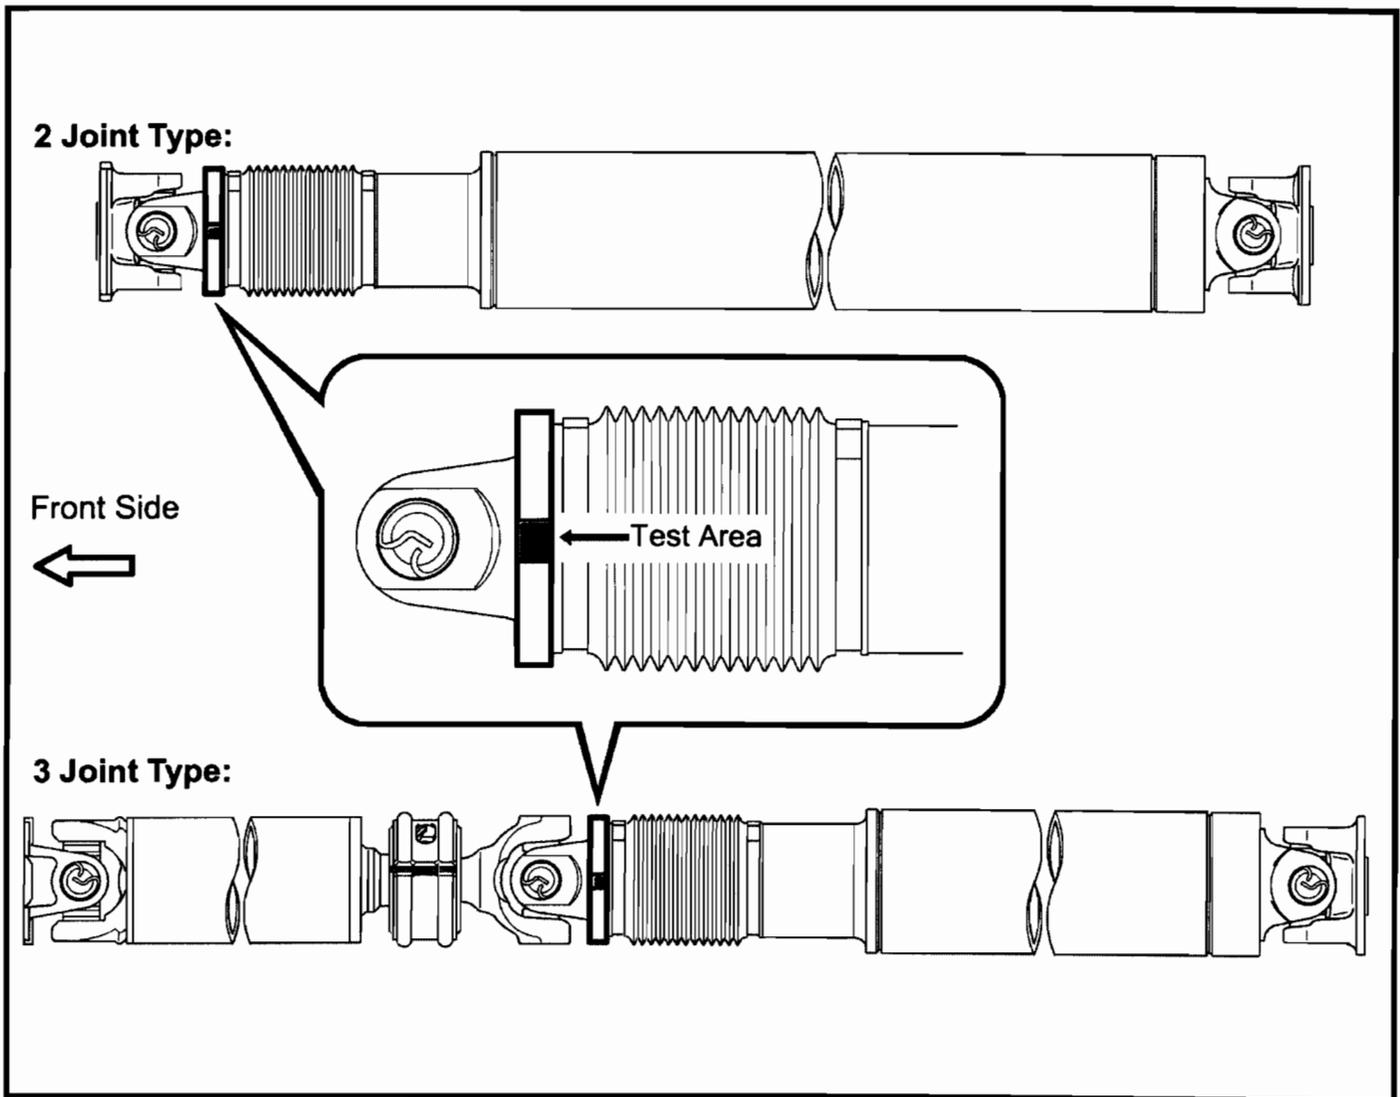
### A. INSPECT THE AFFECTED JOINT ON THE REAR PROPELLER SHAFT

On certain 2007 model year Tundra 4WD vehicles, a joint in the Rear Propeller Shaft may have been improperly heat treated, resulting in insufficient hardness. In this condition, a section of the Rear Propeller Shaft may separate at the joint.

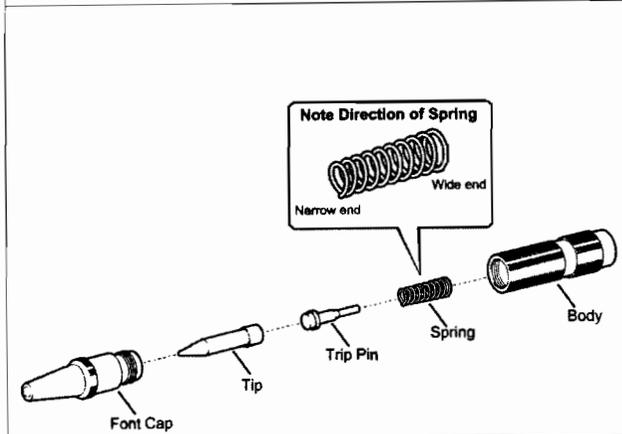
Tip will mushroom after use.

- Ensure the Center Punch is assembled correctly after replacing the testing tip. (See picture on the left).
- Because the center punch has an adjustable force setting, it is important to make sure the rear portion of the center punch is tightened completely (clockwise). This will ensure the proper force is used for every test.
- **DO NOT** disassemble the rear portion of the center punch.

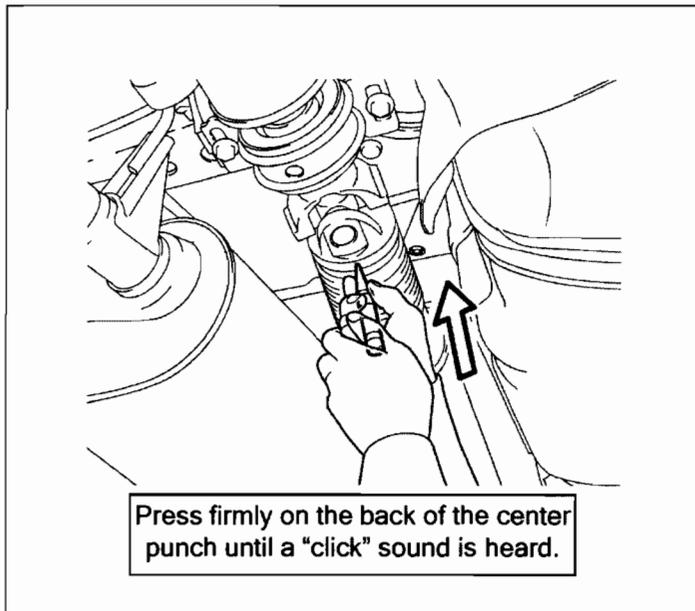
- Use only sandpaper that is 120 grit or finer to remove the paint.
- Be certain to only sand the collar section below the joint attachment hole.
- **DO NOT** sand anything else besides the collar sections below the joint attachment hole.
- If the paint is not sanded off completely the test will produce a false reading.

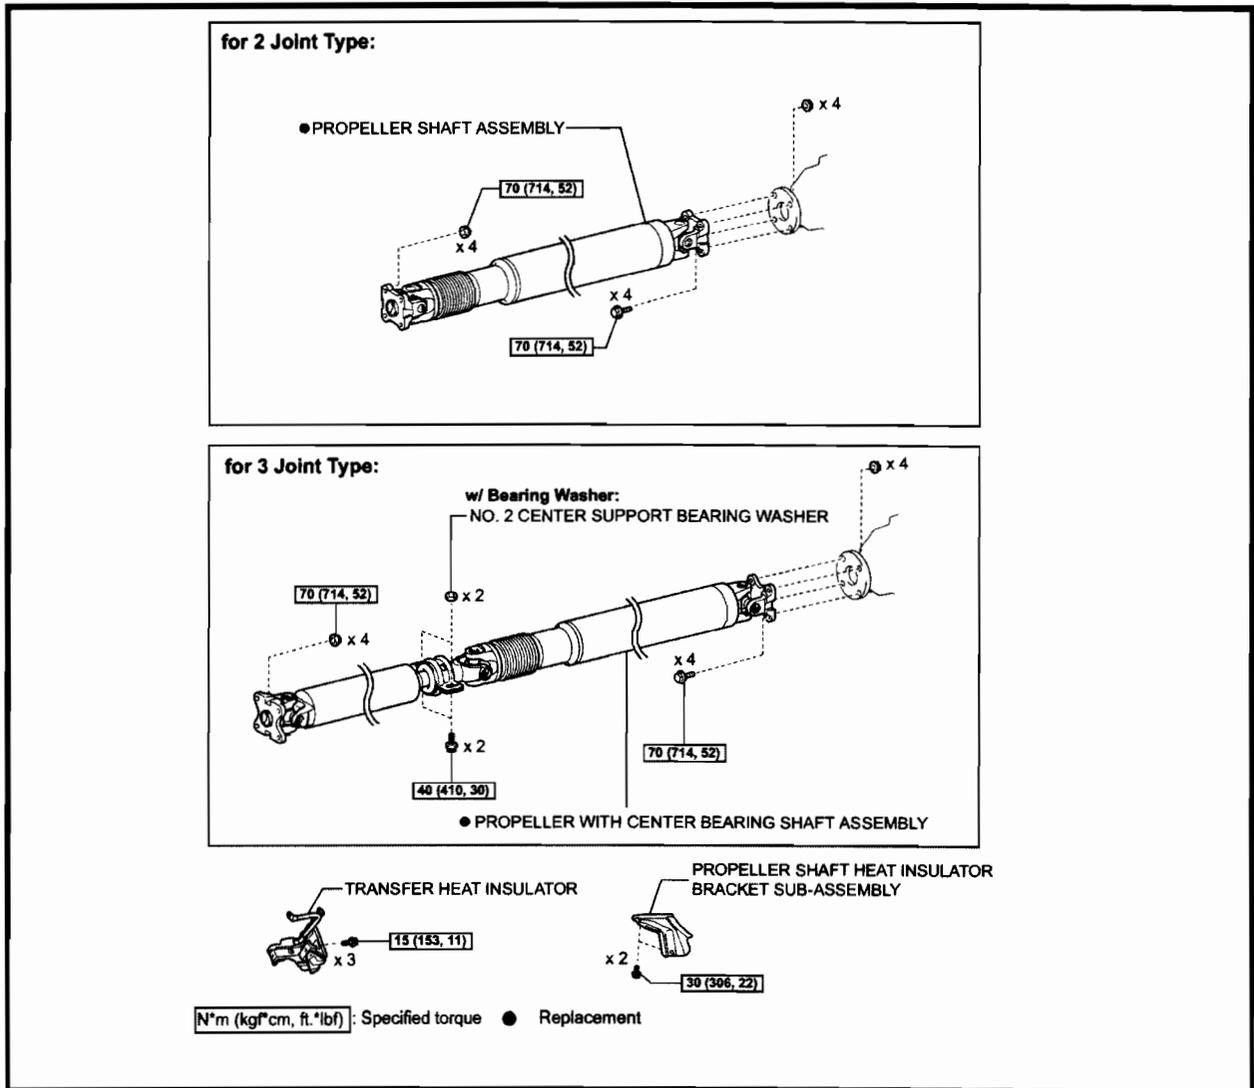
There will be a clear indentation about the size of the center punch tip if the propeller shaft needs to be replaced.

- Not all vehicles will require replacement of the Rear Propeller Shaft.
- Approximately 7% of the affected vehicles will require replacement.

If an **INDENTATION** is left, replace the rear propeller shaft. Proceed to the **SUPPLEMENT** section.
