FL614

NHTSA #11V-514

SECOND REVISED INTERIM RECALL BULLETIN

Subject: Rack and Pinion Steering Pinion Bearings

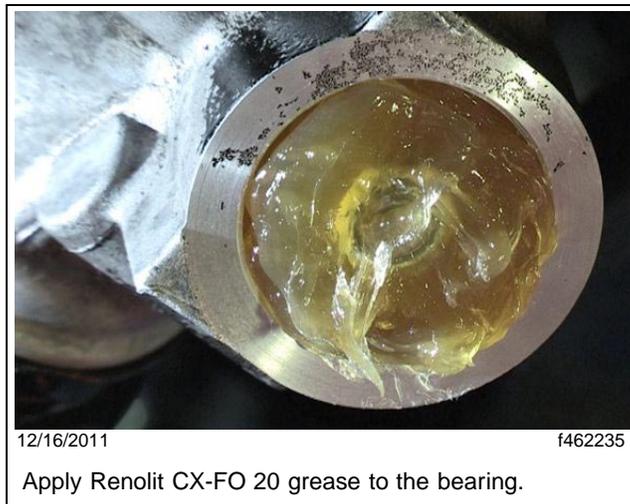
Fig. 18, Greased Bearing

1. Fill the ball bearing and hexnut to slightly above flush with Renolit CX-FO 20 grease. See **Fig. 18**.

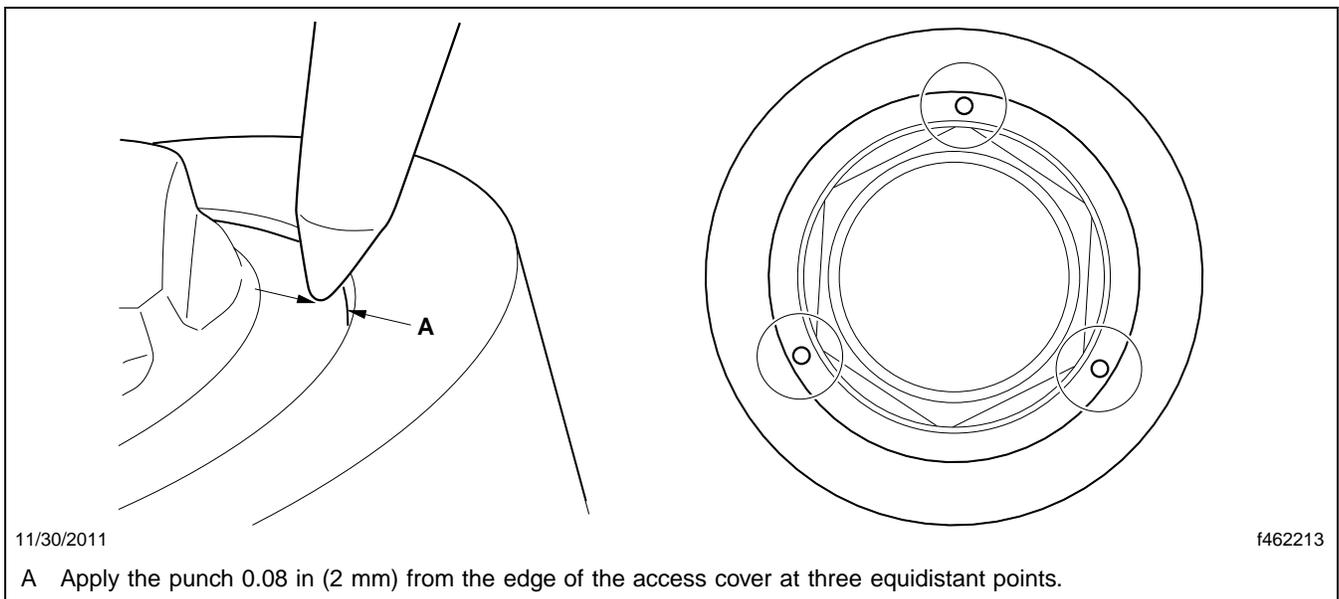
Fig. 19, Center Punch the Bearing Access Cover

When pre-marking the three stake marks on the bearing access cover, lightly tap the cover with the center punch. Heavy punch marks may deform the threads of the cover, which could lead to steering gear damage.

2. Place the new ball bearing access cover on a bench or table. Using a center punch, lightly tap three small equidistant punch marks on the outside of the cap. See **Fig. 19**. Each mark should be approximately 0.08 in (2 mm) from the outer edge of the cover.
3. Fill the inside of the new bearing access cover to slightly above flush with Renolit CX-FO 20 grease. See **Fig. 20**. Save the remaining grease.

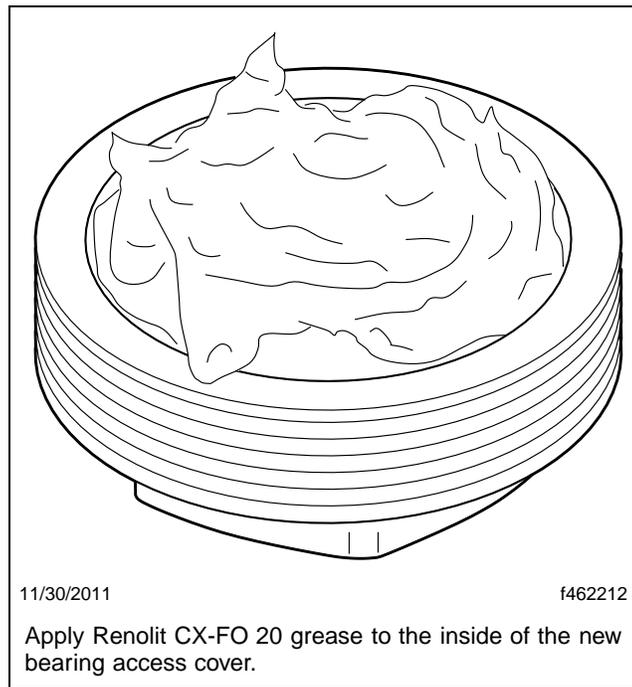
Fig. 20, Greased Bearing Access Cover
