Volvo Trucks North America

SUBJECT: VN Sleeper Window
MODEL(S): VNL, 660/770
ISSUED BY: Ken Moore
APPROVED: Guenter Schlottmann

Big G Express Sleeper Window Failures

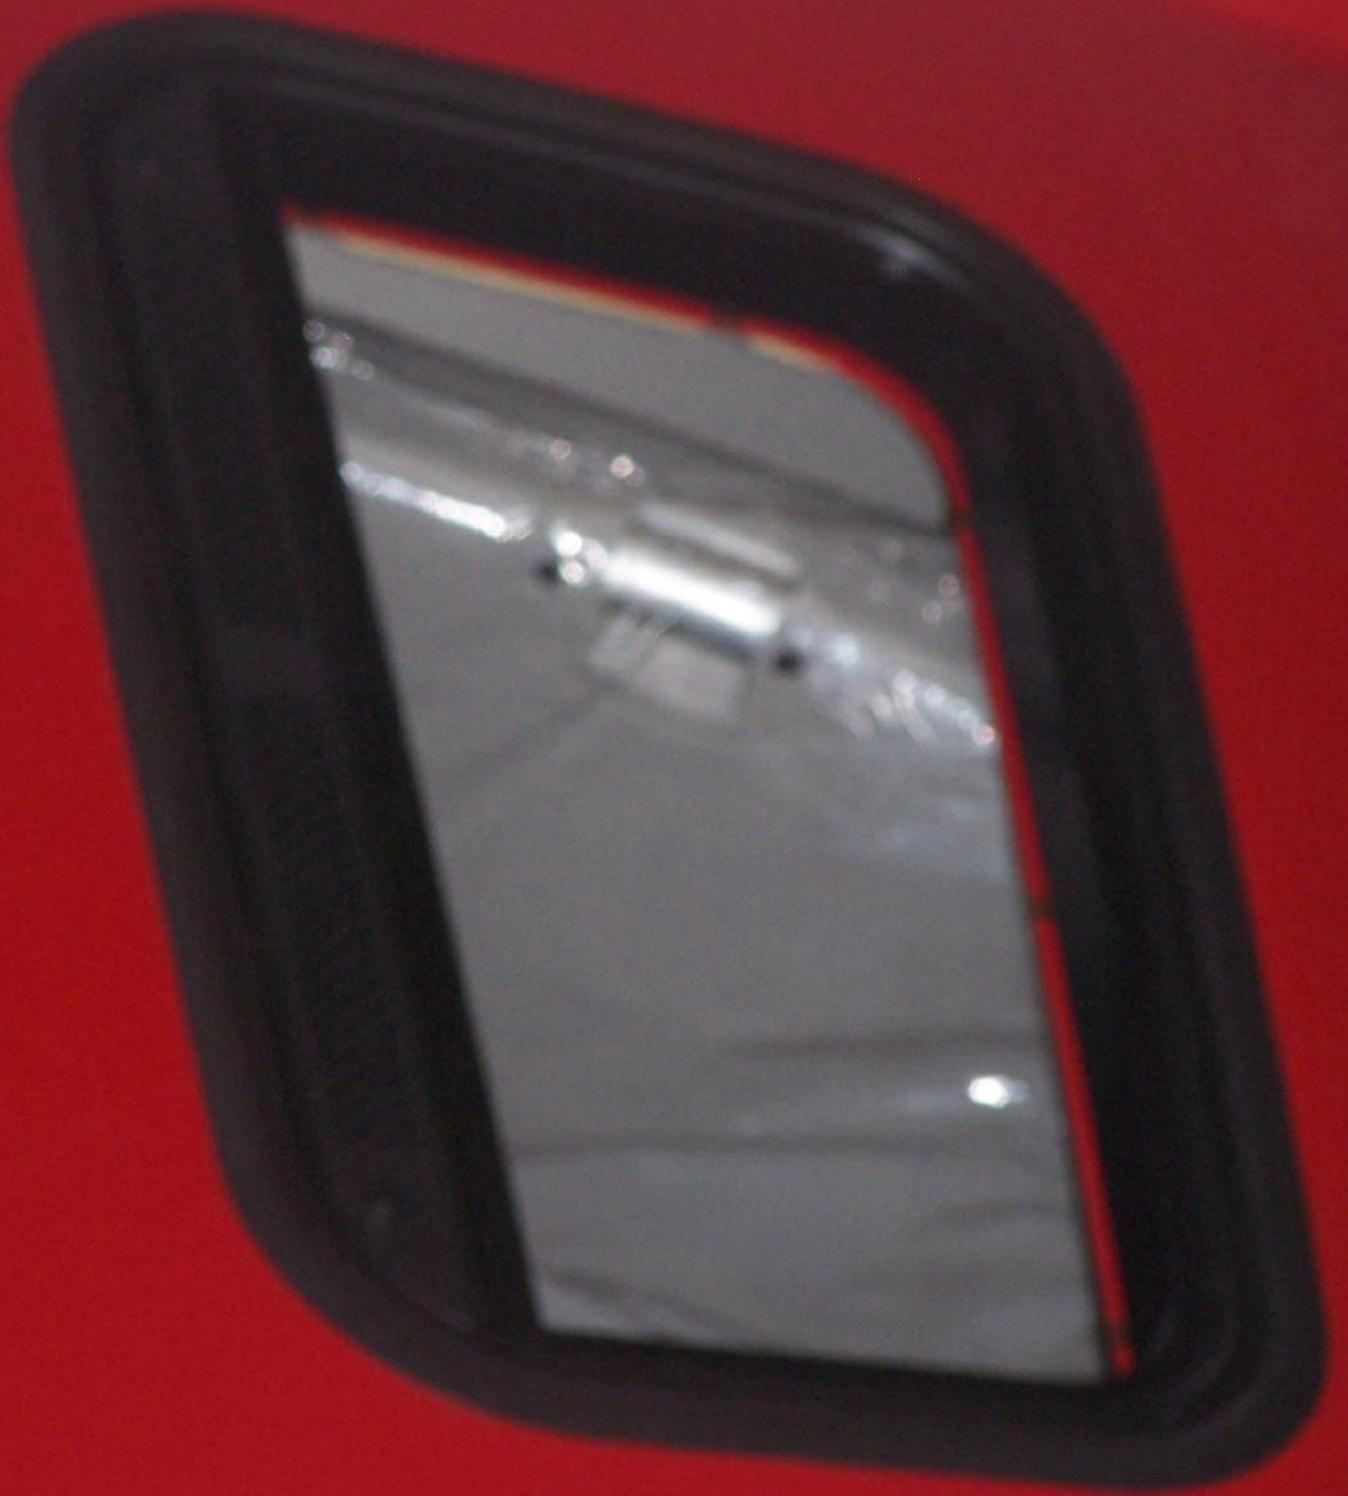
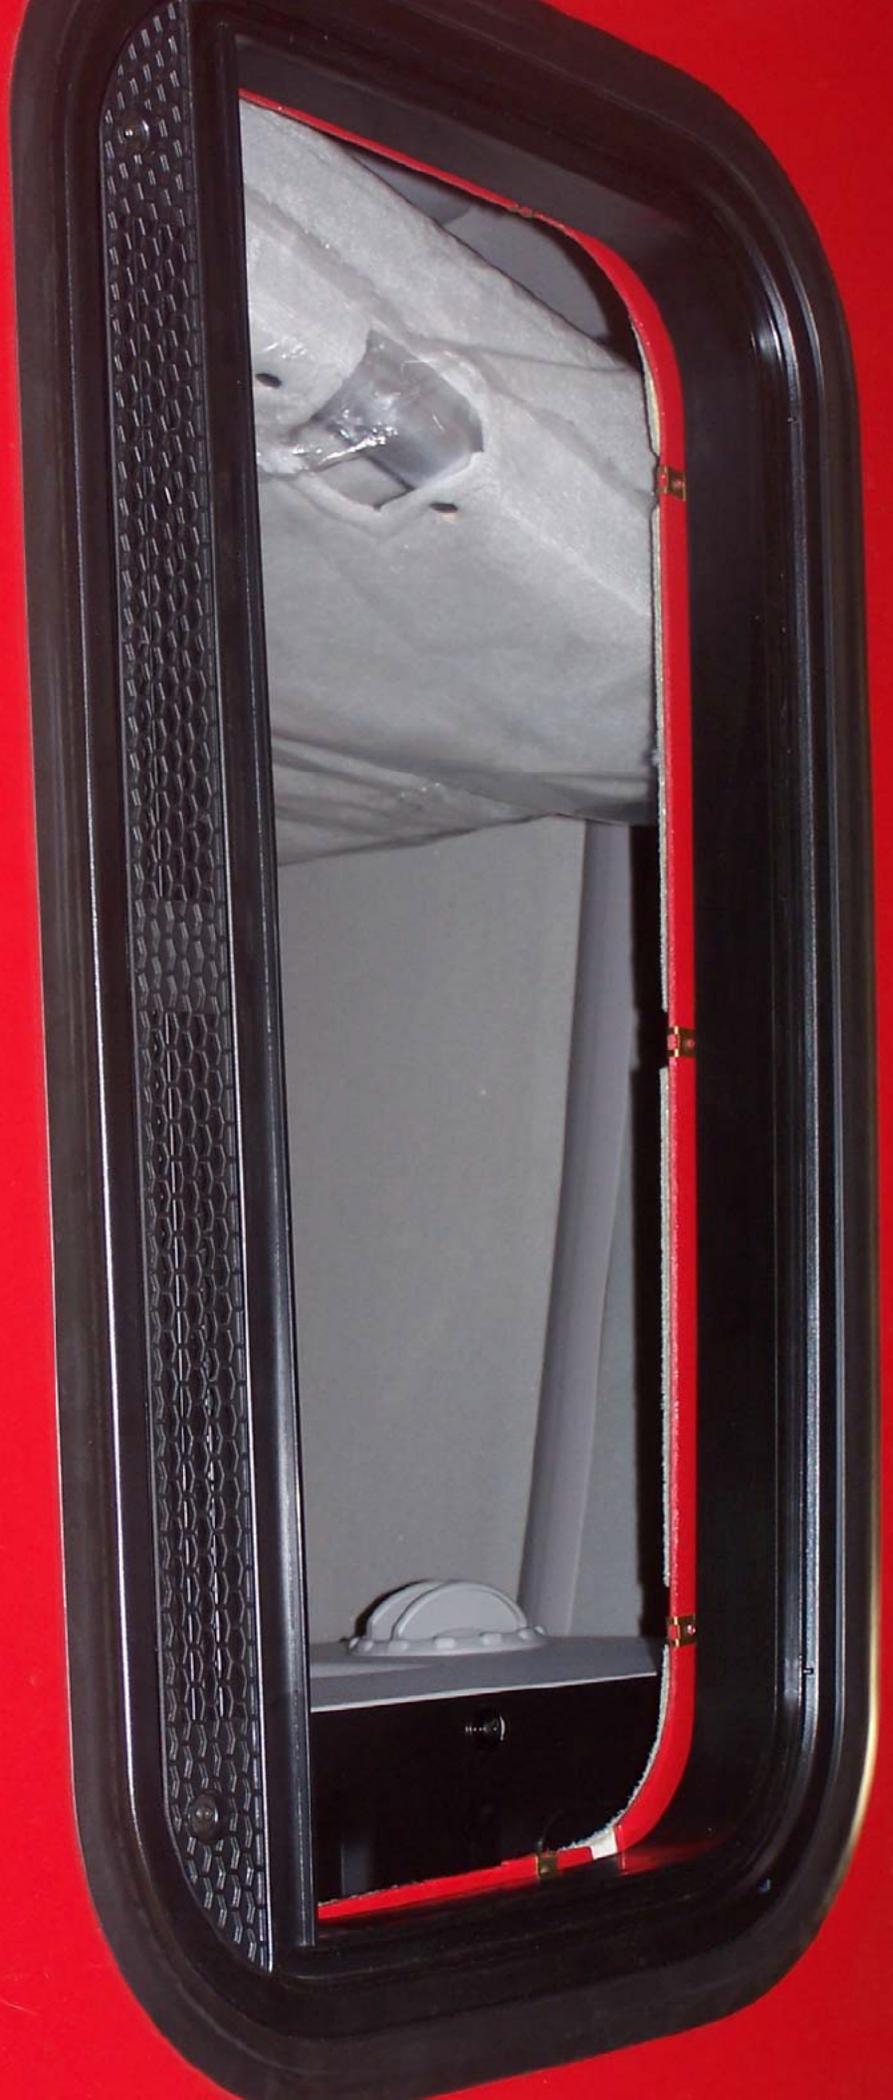
Created	Created By	Activity Type	Description
08/24/2009 18:08:27	JEREMIAH BOWLES	Web Response	will have to contact cab and paint and try and get this info that a reliability group
08/24/2009 16:55:46	SIEBEL ADMINISTRATOR	Notes	An attachment with filename '2010 cab window 002' has been added.
08/24/2009 16:55:18	JOSE TREJO	Web Update	pics requested
08/24/2009 16:54:46	SIEBEL ADMINISTRATOR	Notes	An attachment with filename '2010 cab window 001' has been added.
08/24/2009 16:39:24	FRANKLIN SMALL	Web Response	attach pictures of window you are talking about.

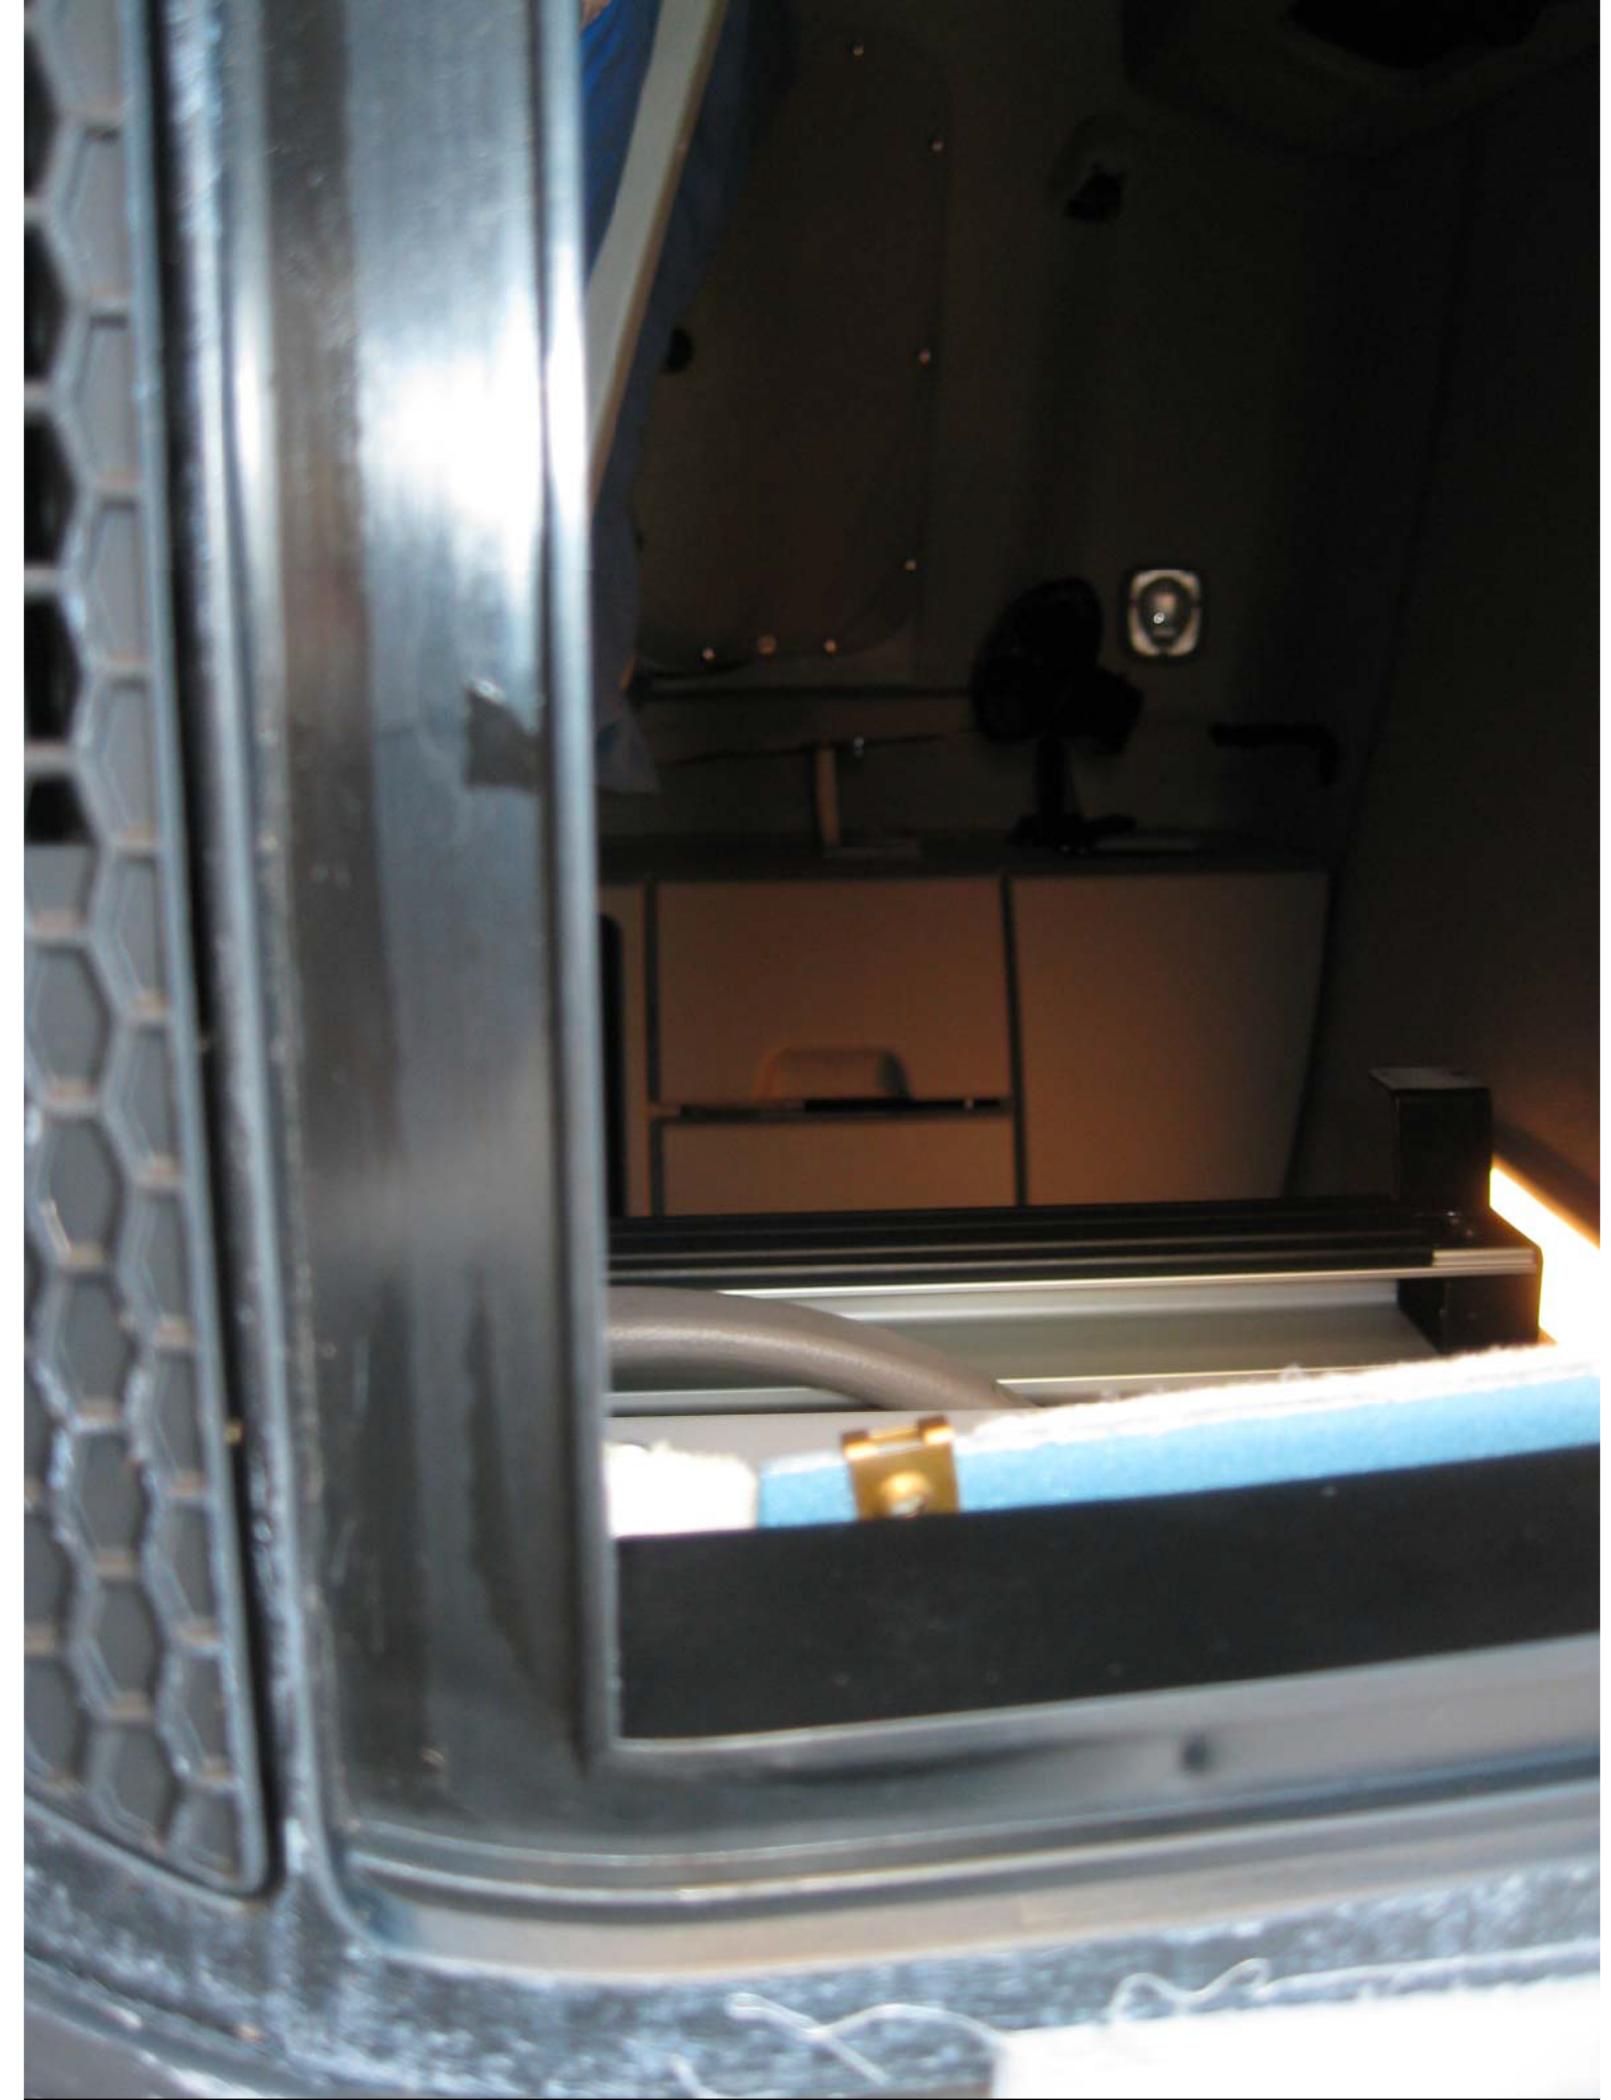
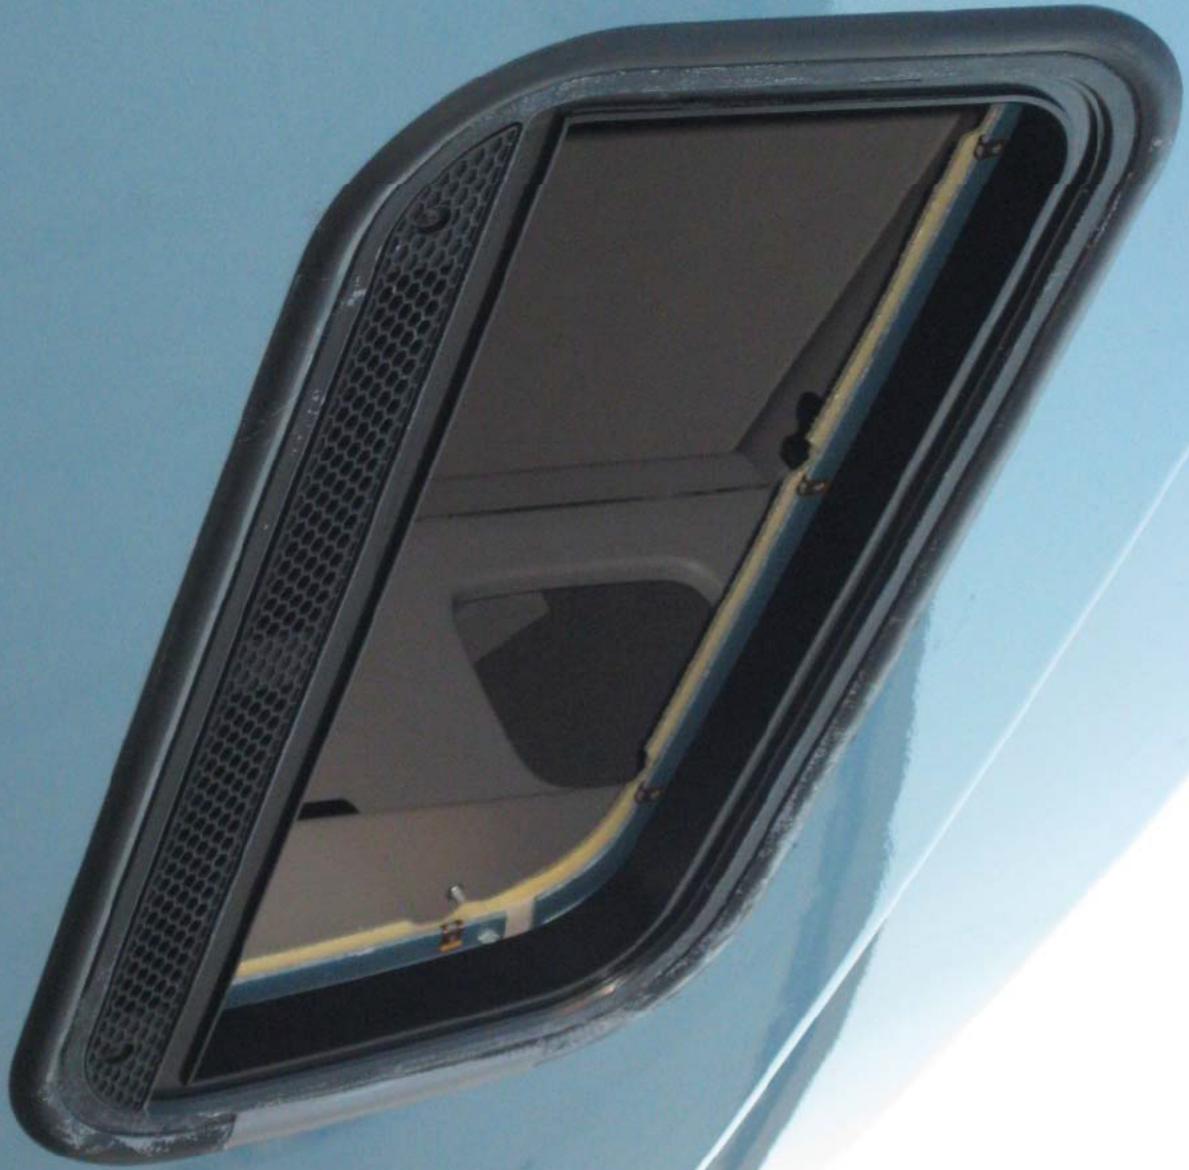
Created	Created By	Activity Type	Description
11/06/2009 18:06:58	DAVID HILL	Web Response	That's as close as we have to a bulletin. Repair as needed
11/06/2009 18:00:46	ELIAS MARTINEZ	Web Update	I am familiar with this bulletin. the issue that we have is that the driver was driving down the hwy after we had followed this procedure and the glass fell out of the assy and was lost.
11/06/2009 18:00:01	SIEBEL ADMINISTRATOR	Notes	An attachment with filename 'PV776-88928200, Sleeper Ventilation Window Replace' has been added.
11/06/2009 17:59:14	DAVID HILL	Web Response	see tha attachment
11/06/2009 17:54:06	ELIAS MARTINEZ	Web Update	unable to pull up any where. can you add an attachment?
11/06/2009 17:39:56	DAVID HILL	Response	See SB 844-03 PV776-88928200 for reference
11/06/2009 17:39:29	DAVID HILL	Response	na
11/06/2009 17:36:59	SIEBEL ADMINISTRATOR	Notes	An attachment with filename 'IMG_0083' has been added.

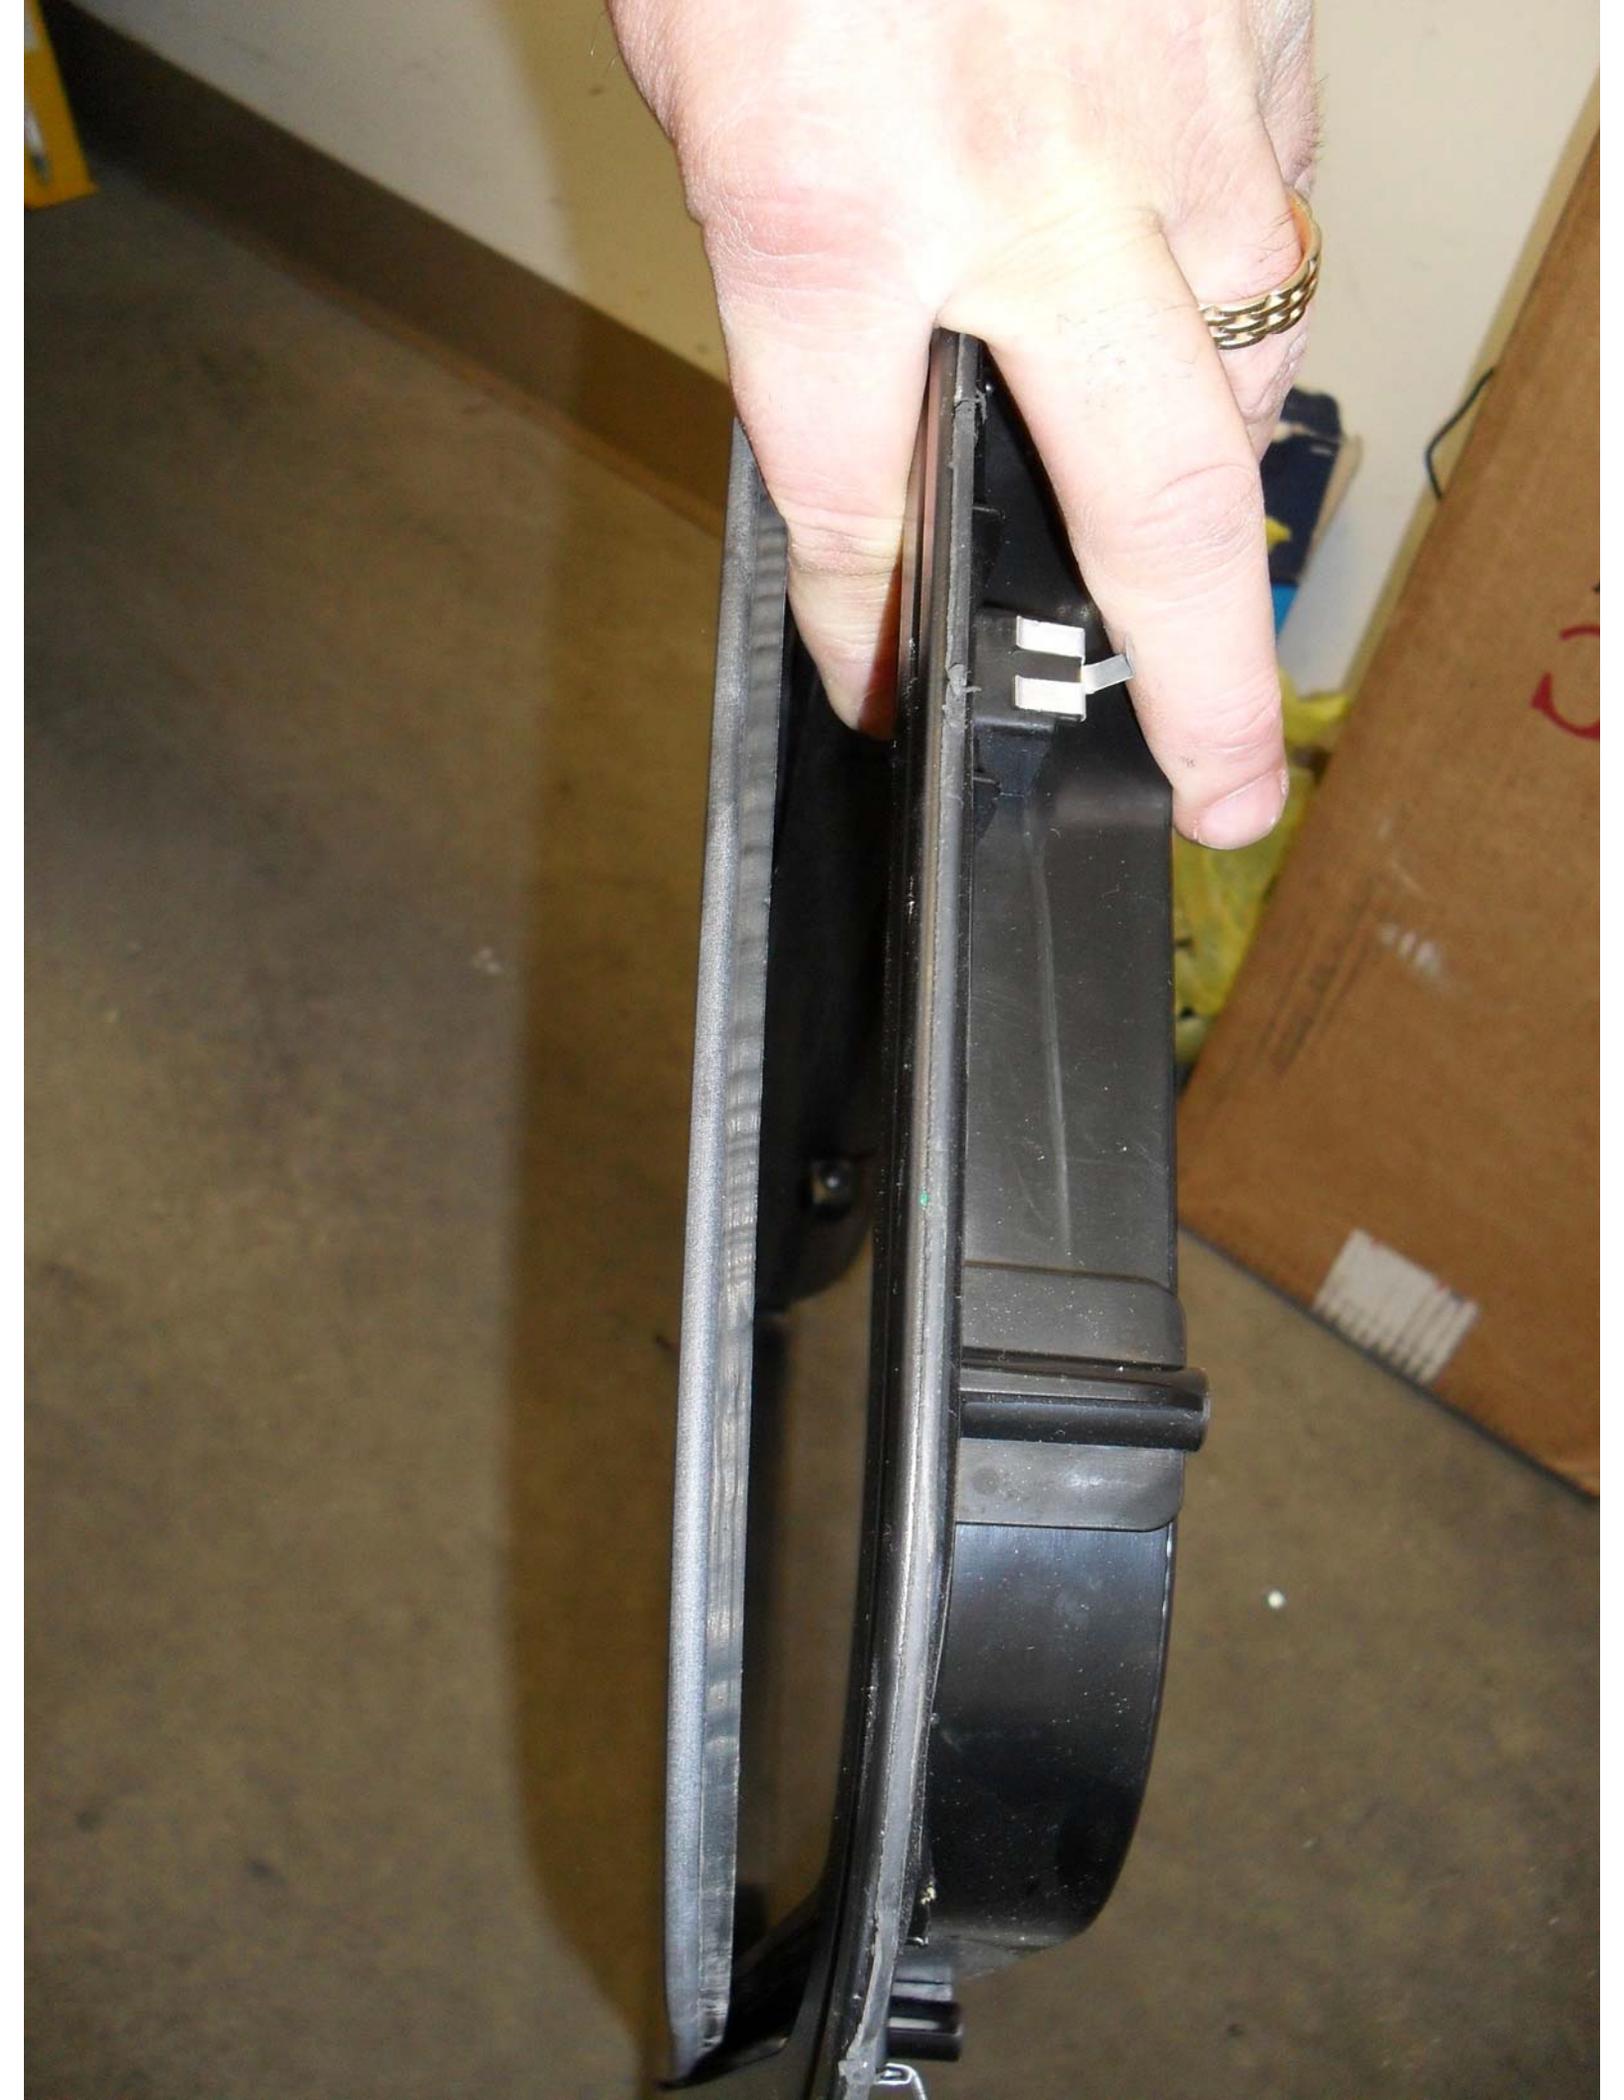
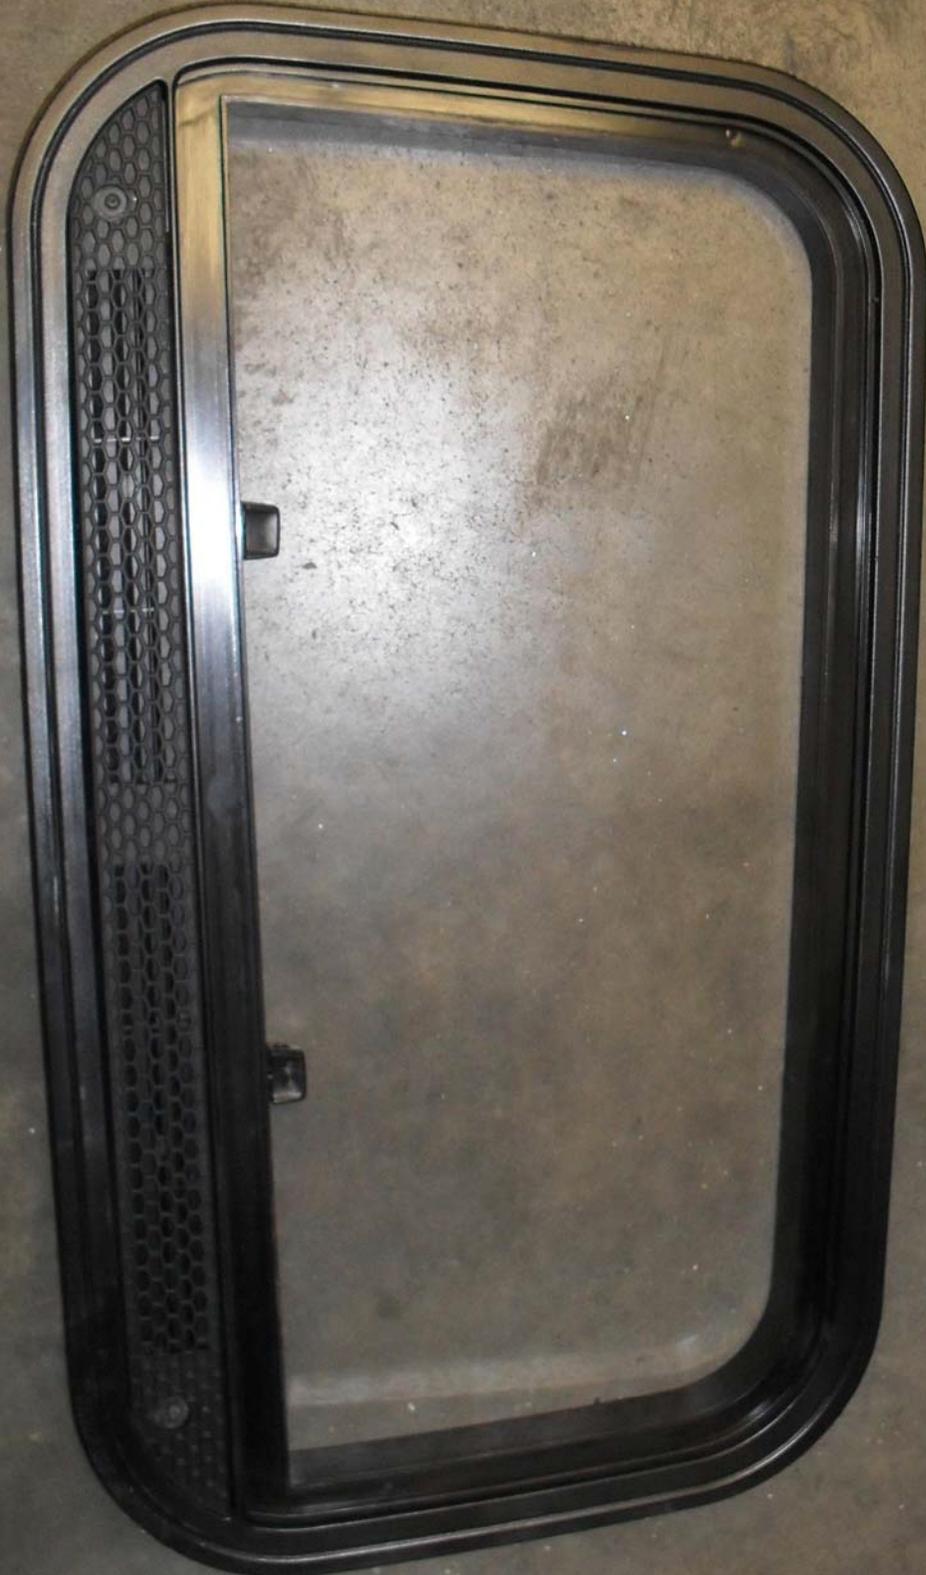
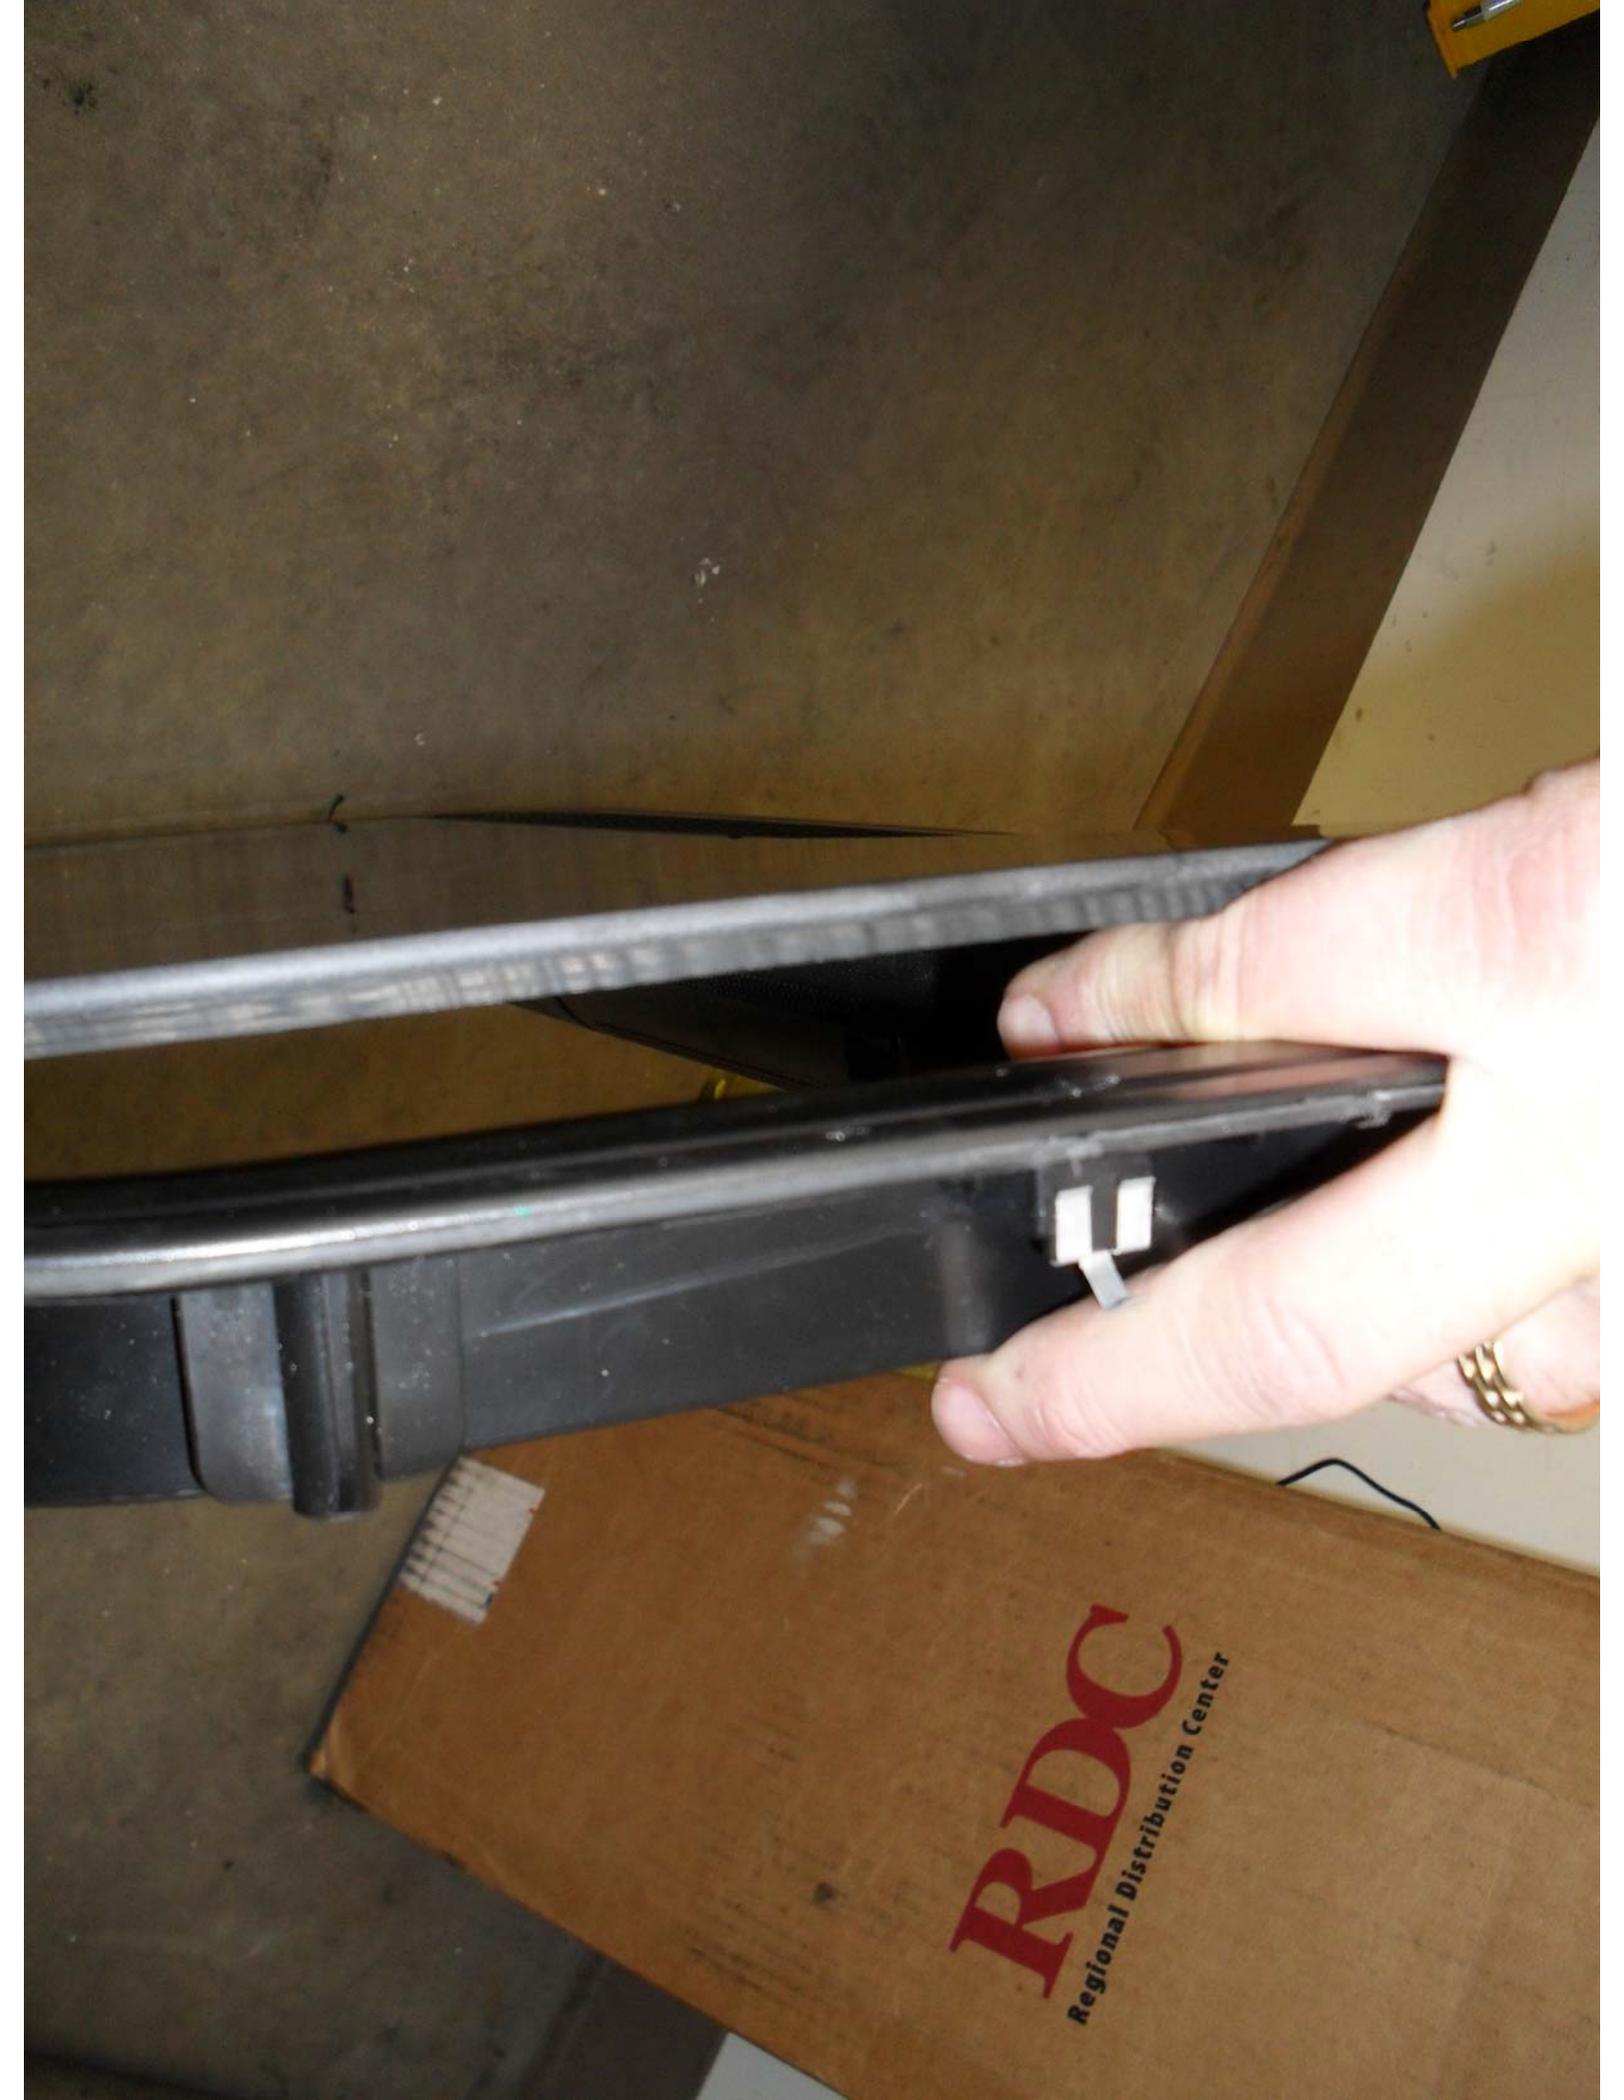
Created	Created By	Activity Type	Description
06/21/2010 10:30:43	TONY AKERS	Response	Loose glass addressed with RVXX1001.
01/08/2010 13:34:56	TONY AKERS	Response	Reference QJ 1-1347051717
01/07/2010 13:40:20	CAROL WHITLEY	Email - Outbound	Hi JR, Customer just provided pictures today. This is the customer issue I spoke you about. I will be visiting this customer Jan 20th and if you can provide incite to this issue it would be great. As we agreed I will pick up the frame and return it on my way back from Richmond on Jan 21st if not 22nd. See pictures in this case. Thanks, Carol The following service request has been assigned to you: Service Request Number: 1-1373970548 Date Opened : 2010-01-07 13:21:50 Severity : 2-High Product : VNL Chassis Id : N VIN/Serial #: 4V4NC9EJ3AN Summary : Glass falling out of side window Description : Please note this is not a case of the frame coming loose and detaching from the cab. It the glass came out of teh frame. See pictures attached. Also note this window was replaced in a warranty repair for not being sealed and leak water from around the frame. ---SR Activities--- Comment: An attachment with filename 'MISC 018' has been added. Status: Done Creator: SIEBEL ADMINISTRATOR Created: 2010-01-07 13:40:19 ---SR Activities--- Comment: An attachment with filename 'MISC 017' has been added. Status: Done Creator: SIEBEL ADMINISTRATOR Created: 2010-01-07 13:38:18 ---SR Activities--- Comment: An attachment with filename 'MISC 016' has been added. Status: Done Creator: SIEBEL ADMINISTRATOR Created: 2010-01-07 13:26:06
