Volvo Trucks North America

SUBJECT: VN Sleeper Window
MODEL(S): VNL, 660/770
ISSUED BY: Ken Moore
APPROVED: Guenter Schlottmann

Big G Express Sleeper Window Failures

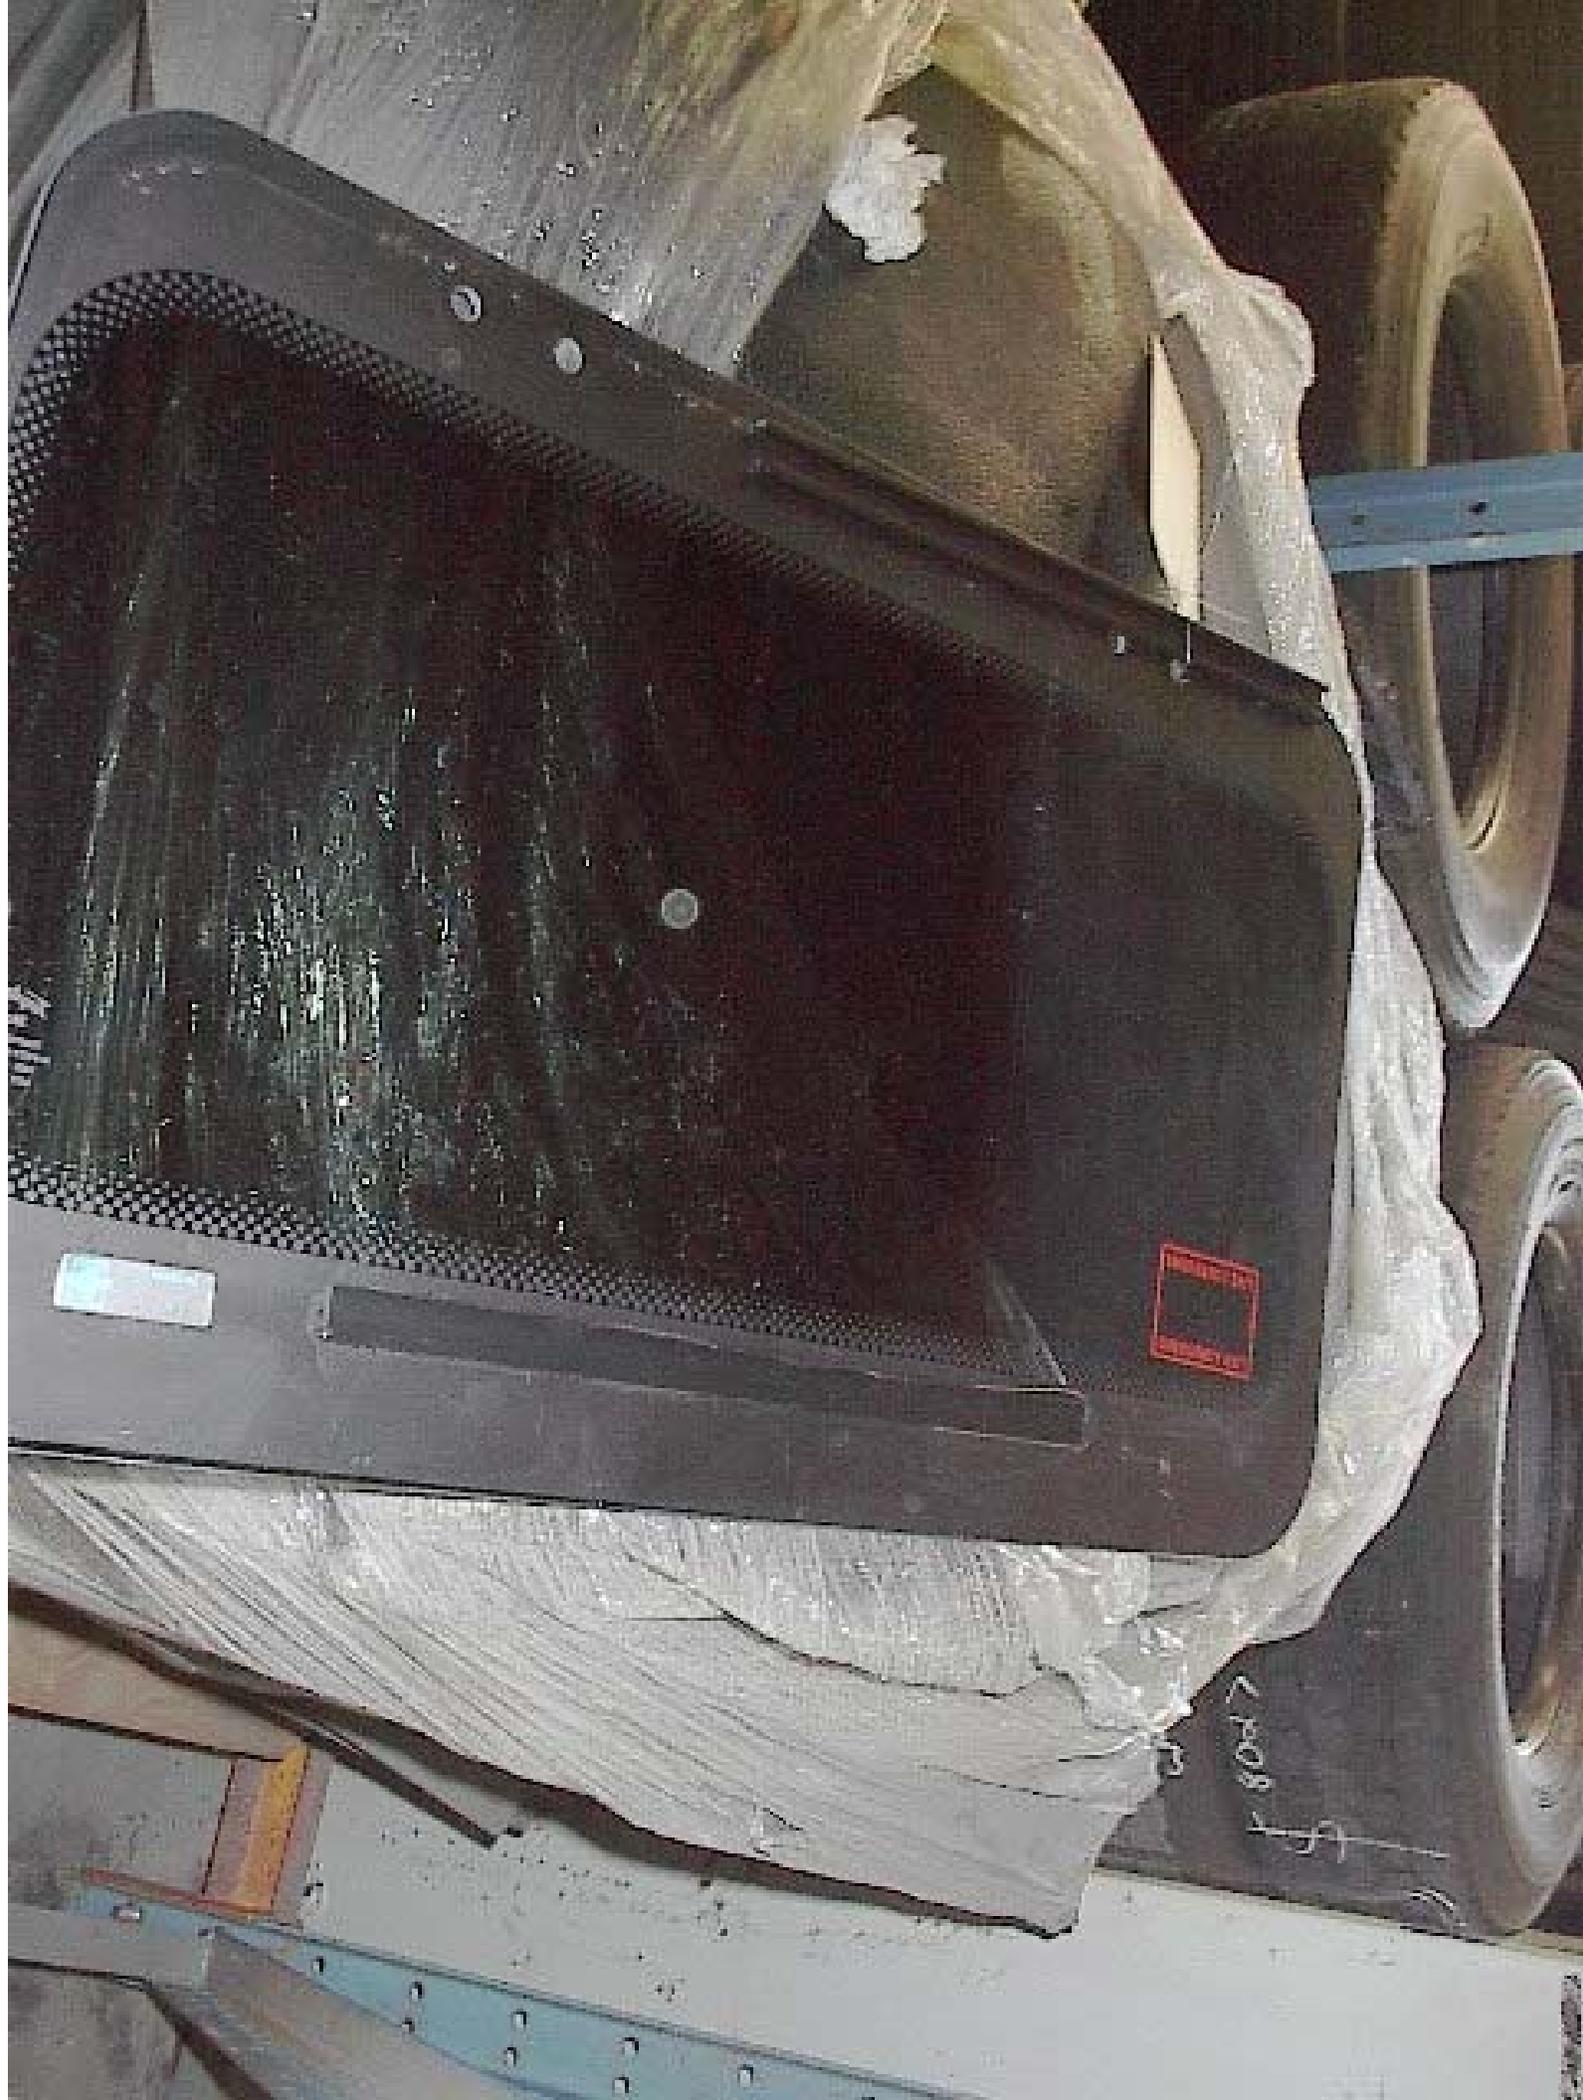
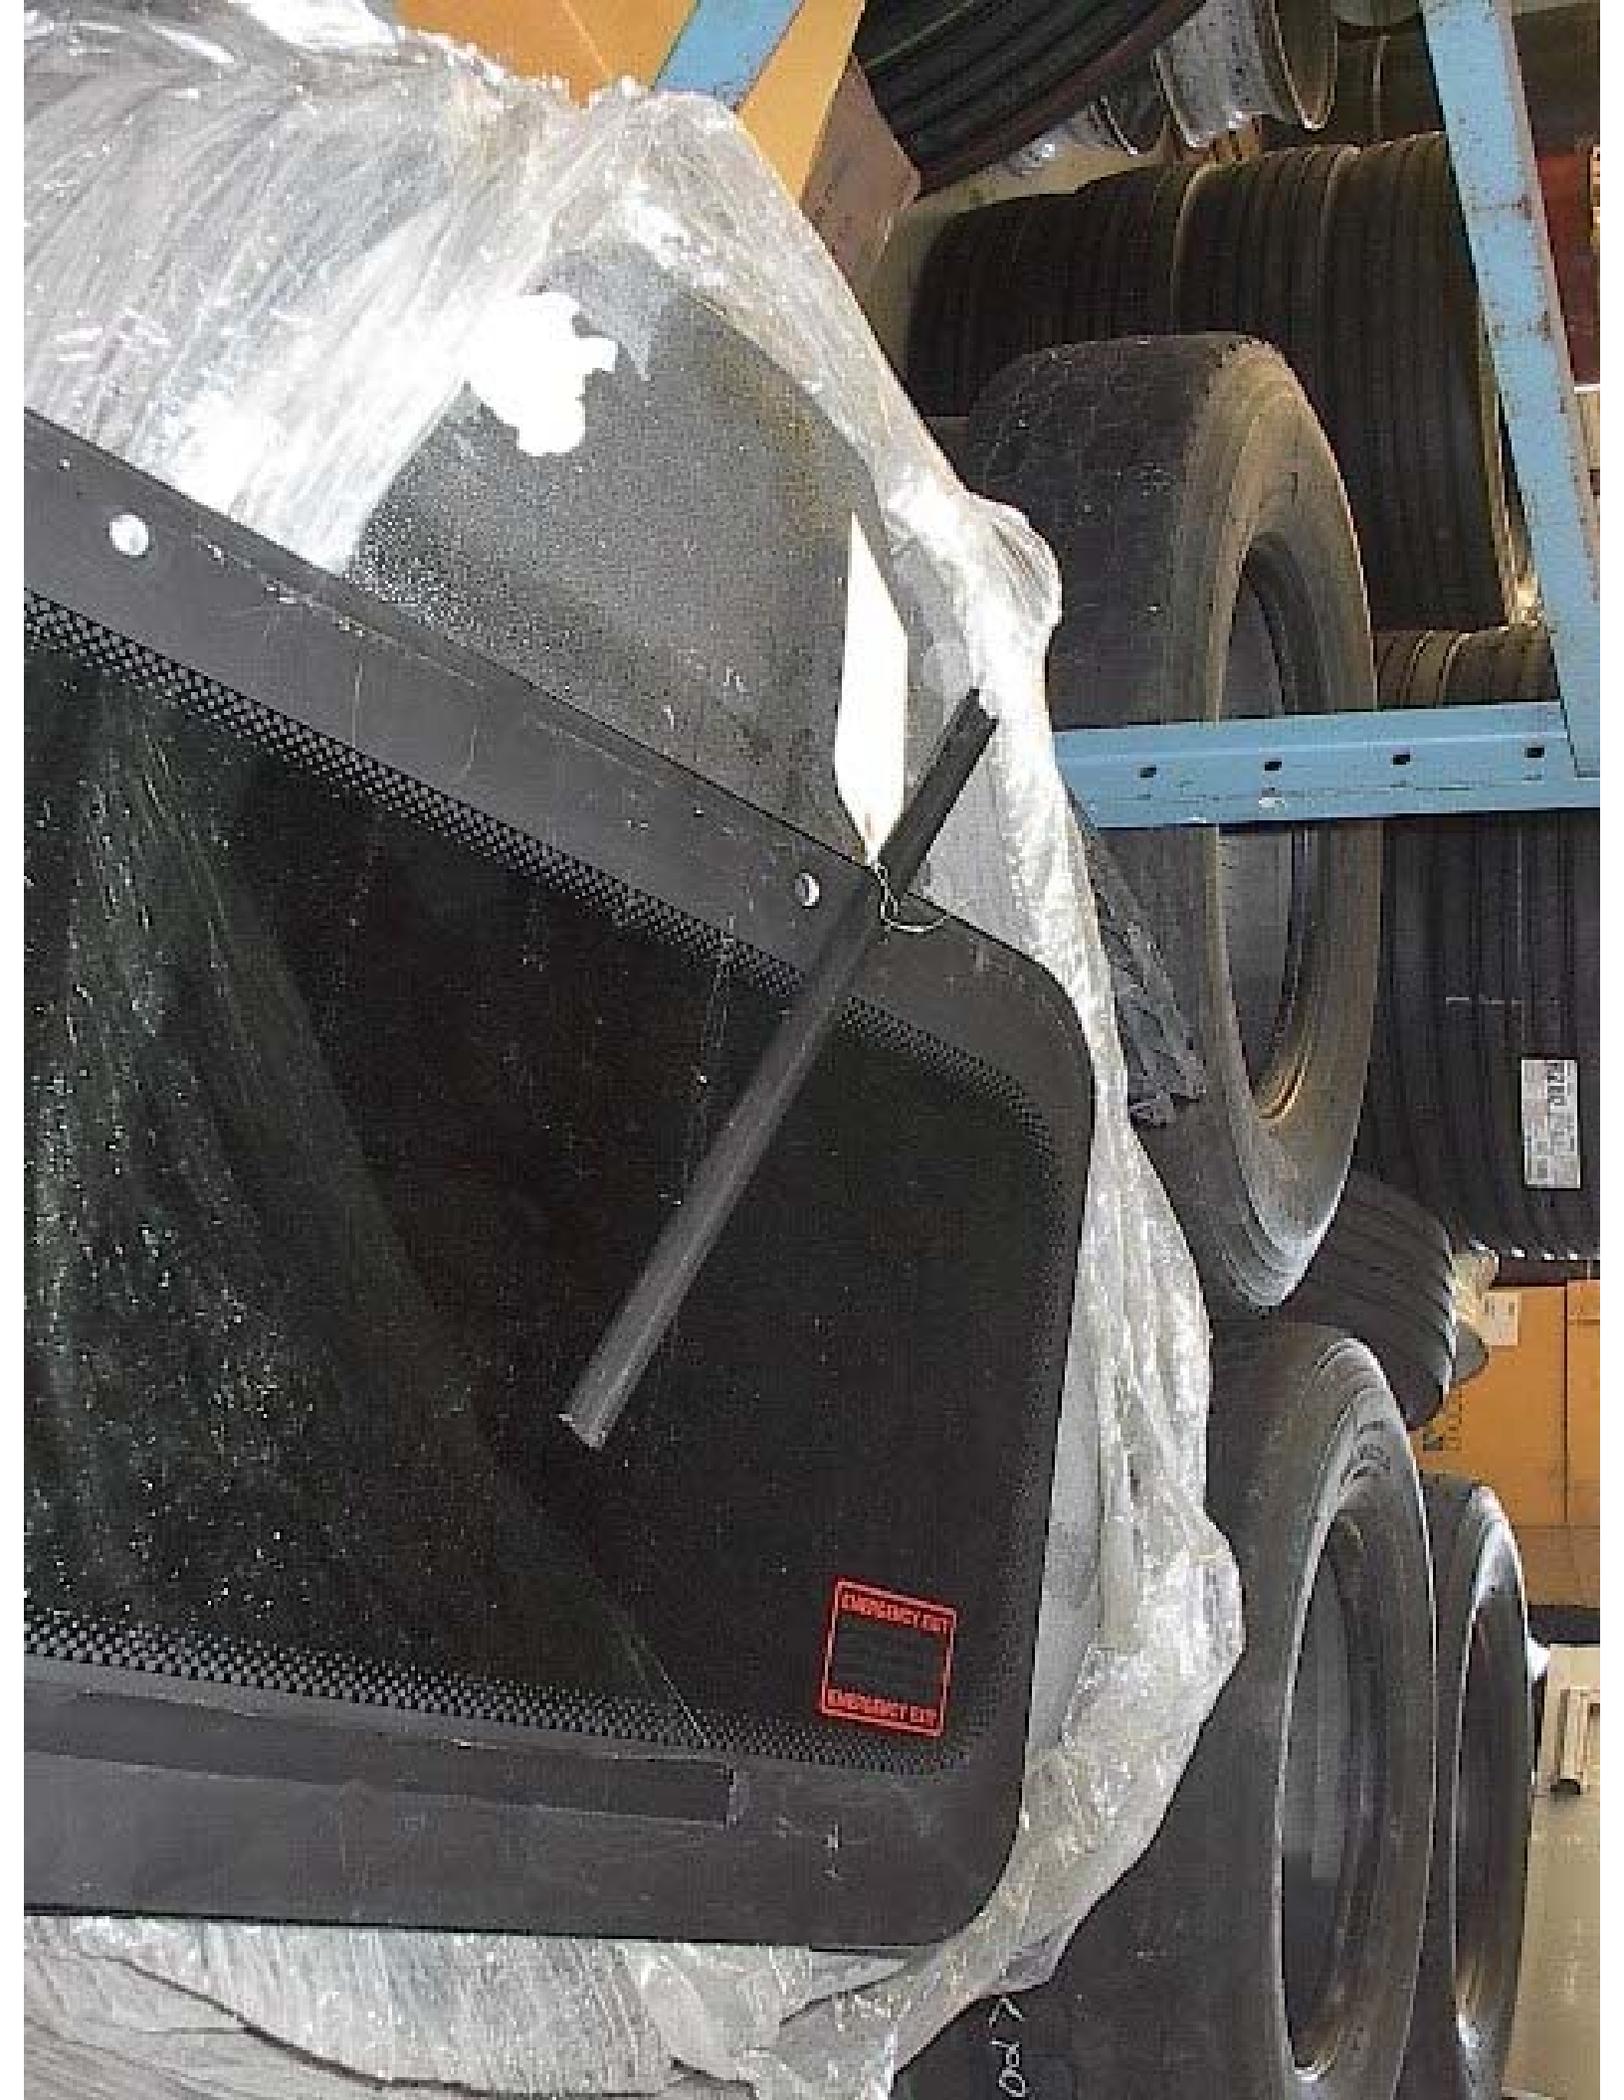
Raven Transport Upper Bunk Window Failing

Created	Created By	Activity Type	Description
02/26/2010 15:49:18	TONY AKERS	Response	Replace the failed window assemblies. Do not re-glue track to glass. Return windows to TMAC for review. Technical Material Analysis Center, 4100 Bob White Blvd., Pulaski, VA 24301. Attention: Tony Akers
02/26/2010 11:41:46	TONY AKERS	Investigation	Original part numbers listed in case are for the upper windows. Pictures depict lower window 21025118 RH and 21025116 LH.
02/24/2010 15:29:04	SIEBEL ADMINISTRATOR	Email - Inbound	GPS in Gboro 2/24/10. Tech Talk in the afternoon. Contact Tech Support for assistance @ 1-800-888-2039 Call cell 336-210-1180 if necessary.
02/24/2010 15:23:36	WESLEY MARSH	Email - Outbound	Tony & Guenter Here is product concern report following up Emails from 2/23/2010 regarding upper bunk side windows on 780 cab new Raven Trucks Falling off. Photos and email from Ed attached to case. Regards Wes Marsh Please, do not change the Subject line if you want to reply to this email. The following service request has been assigned to you: Service Request Number: 1-1388913561 Date Opened : 2010-02-24 15:15:05 Severity : 1-Critical Product : VNL Chassis Id : N VIN/Serial #: 4V4NC9EJ7AN Summary : Raven Transport Upper Bunk Window Failing Description : Recieved email on February 23, 2010 from Ed Larkins Disrector of Maintenance for Raven Transport reporting he has 2 new tractors vins 292277 aand 292273 that the upper bunk windows have fallen off the truck. See attached photos and email for details. Dealer 5315D has 1 failed assembly customer has the other. Ted Watucki is contact at 5315D. ---SR Activities--- Comment: An attachment with filename 'Raven Window A' has been added. Status: Done Creator: SIEBEL ADMINISTRATOR Created: 2010-02-24 15:17:25 ---SR Activities--- Comment: An attachment with filename 'Raven Window B' has been added. Status: Done Creator: SIEBEL ADMINISTRATOR Created: 2010-02-24 15:16:24 ---SR Activities--- Comment: An attachment with filename 'Raven Windows C' has been added. Status: Done Creator: SIEBEL ADMINISTRATOR Created: 2010-02-24 15:16:24

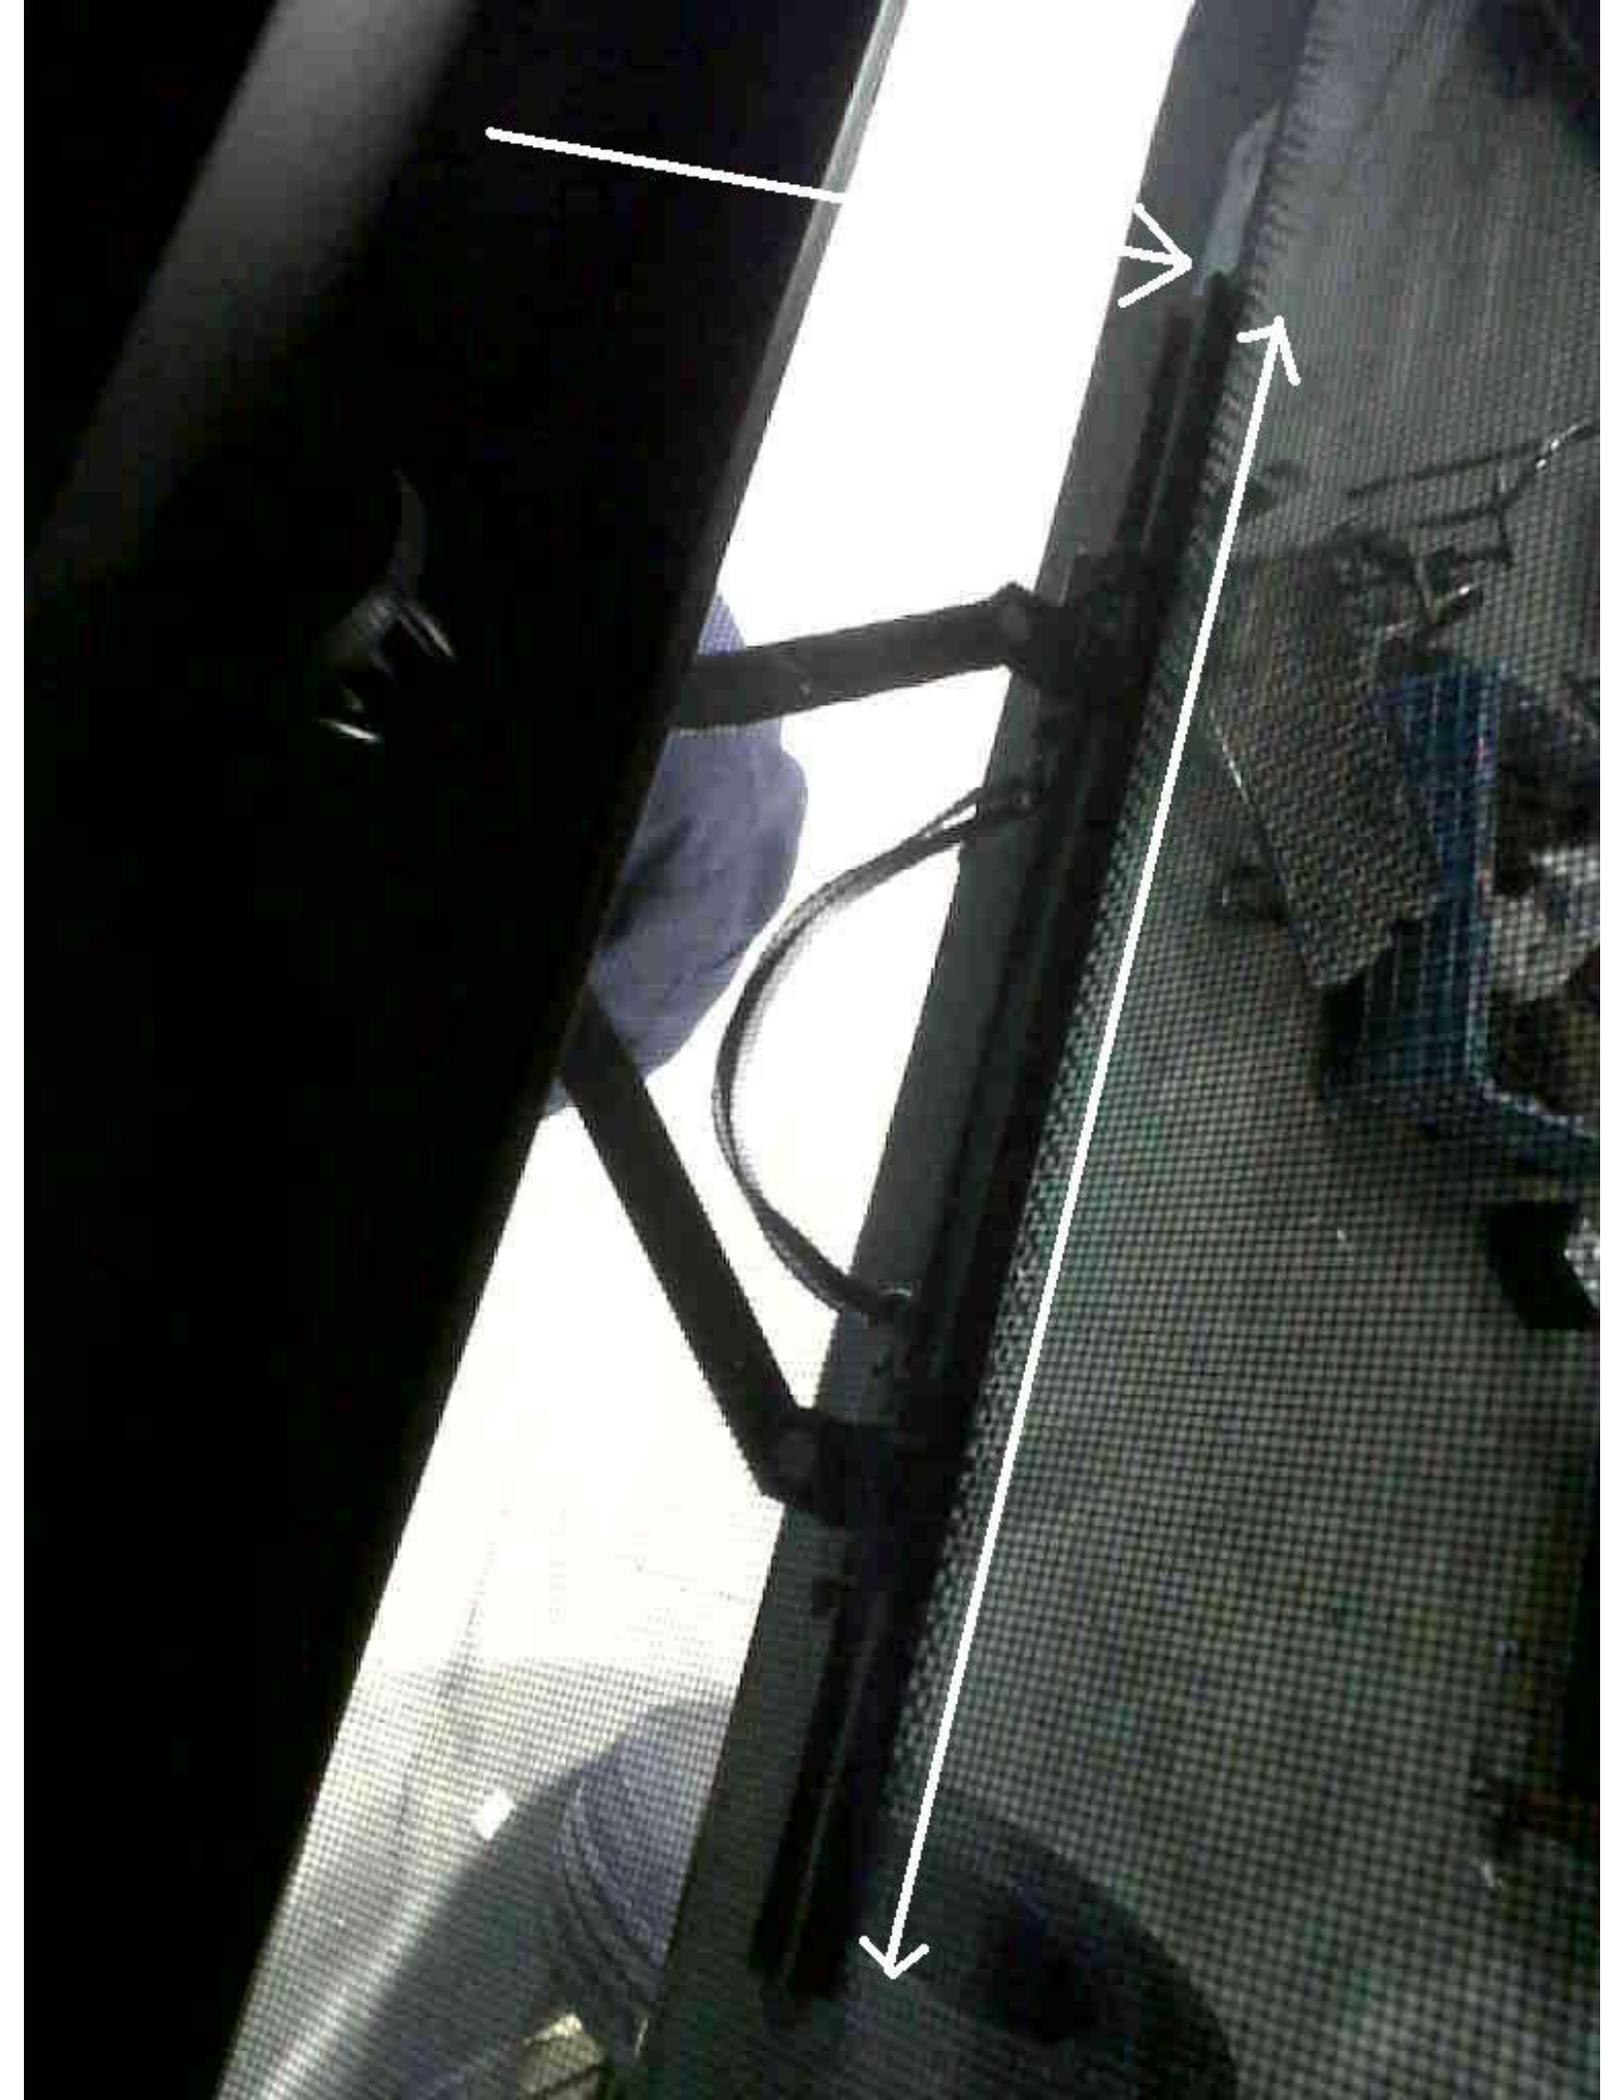
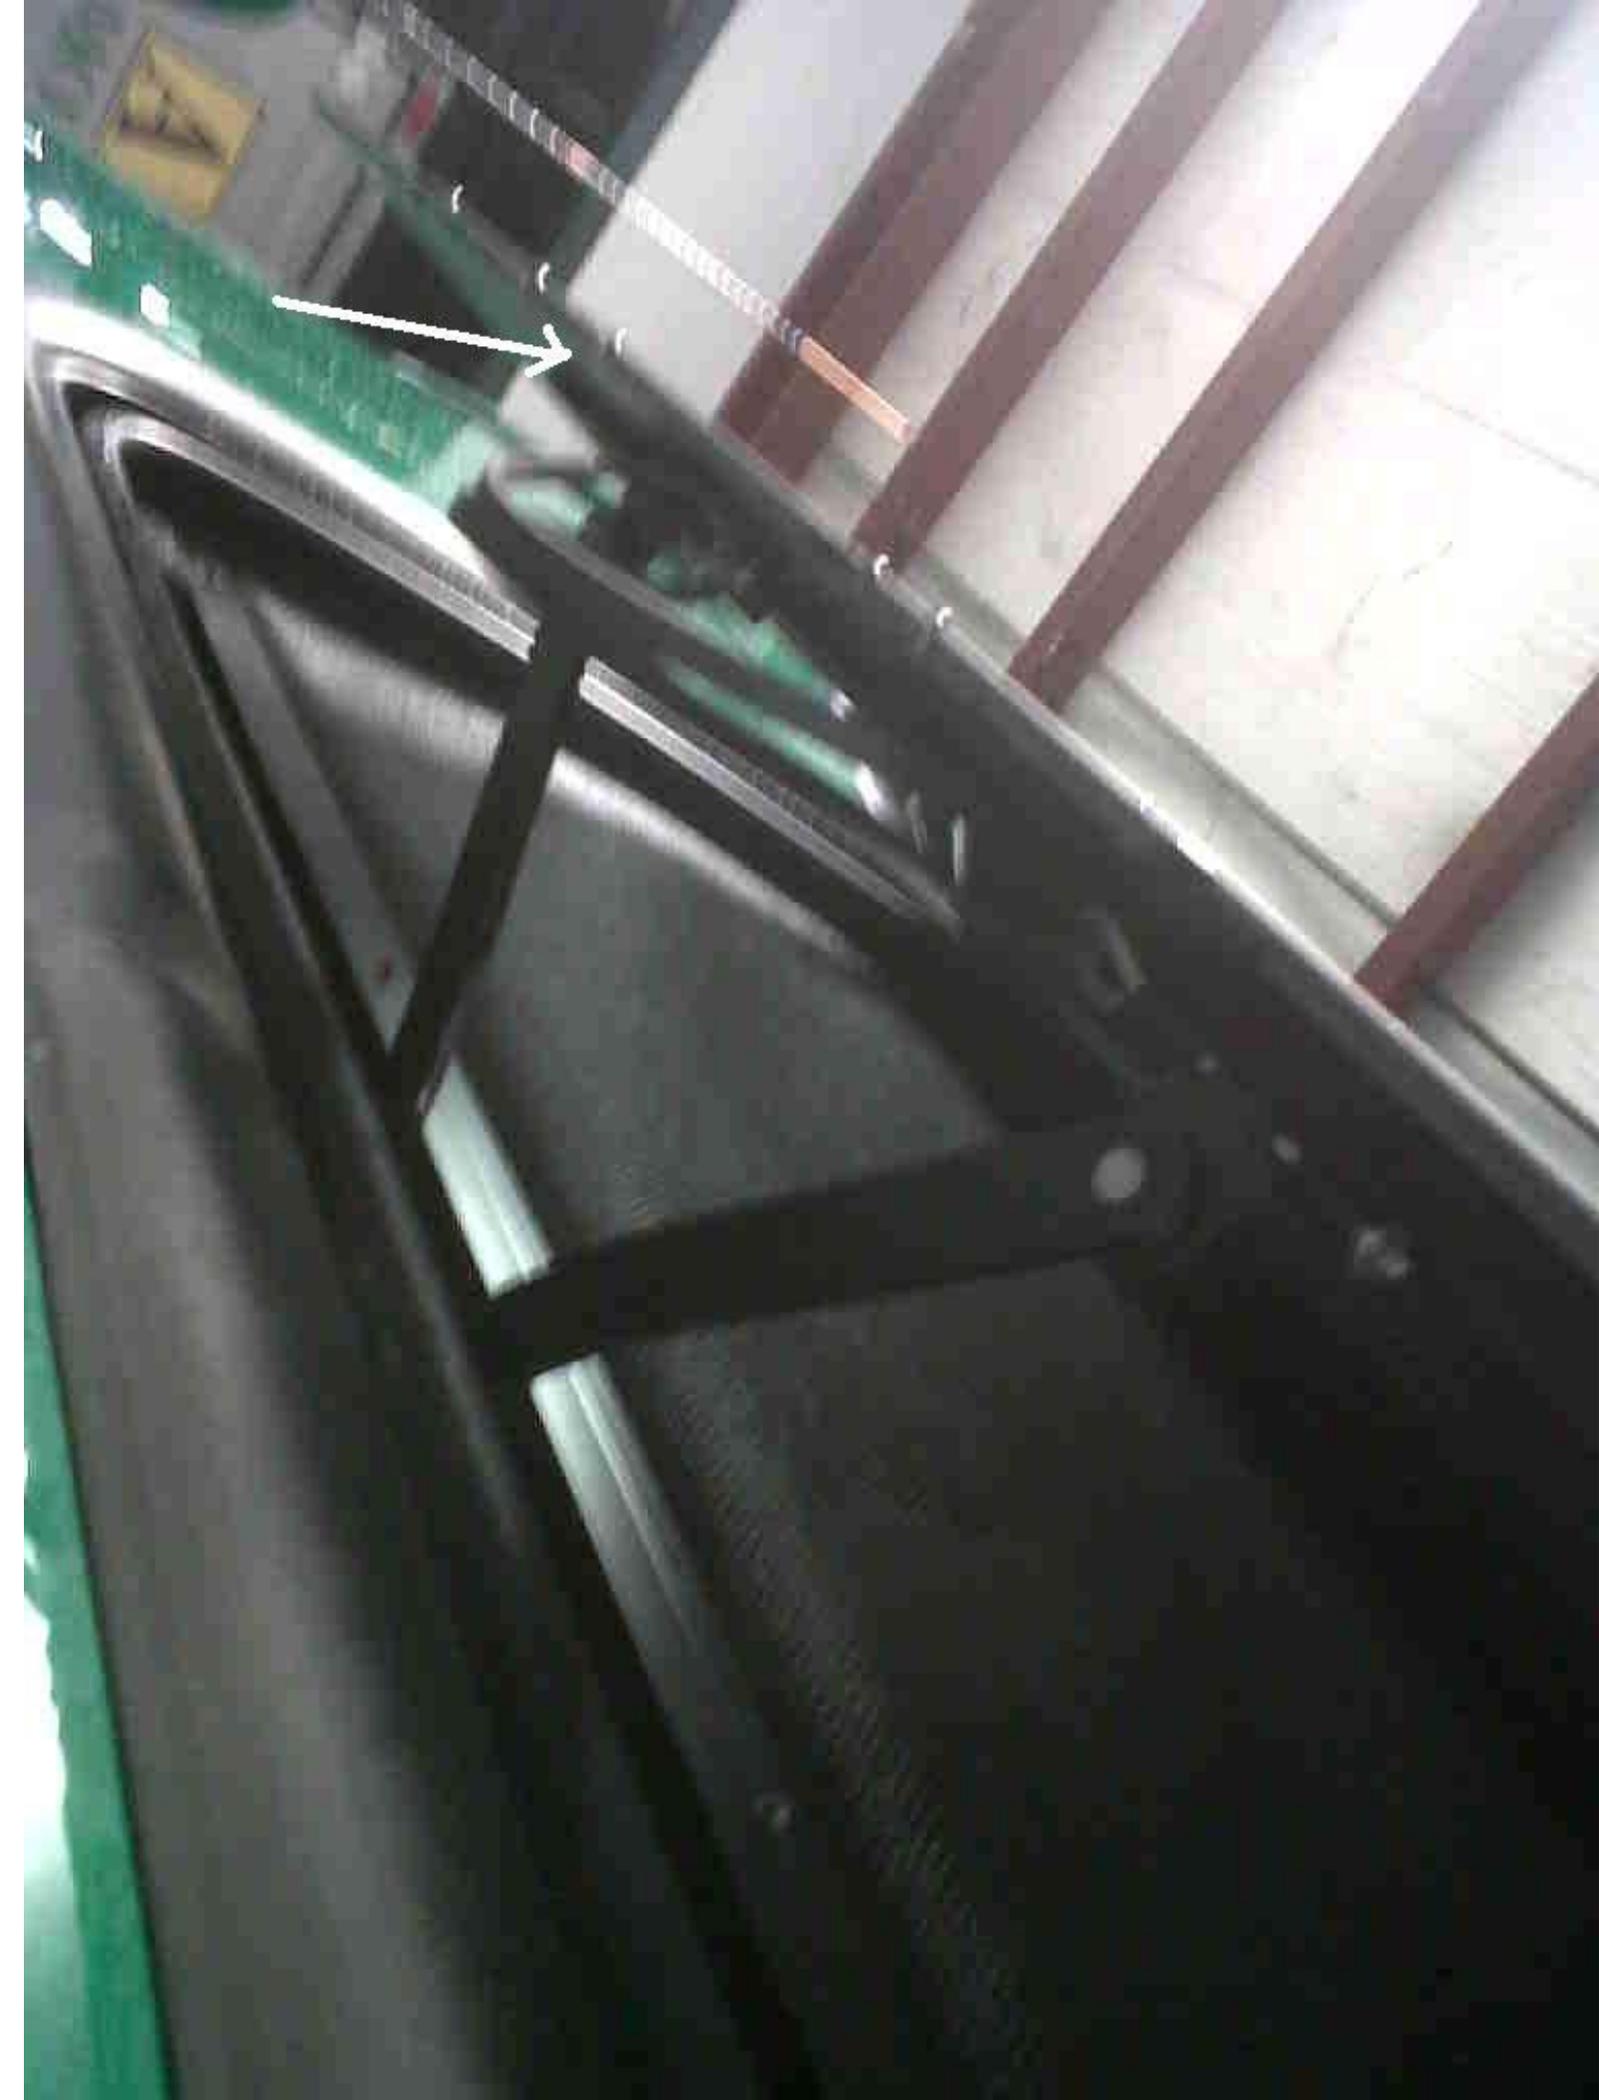
Created	Created By	Activity Type	Description
05/21/2010 13:04:45	TONY AKERS	Follow Up Information	Supplier issues addressed concerning adhesive thickness, bonding time and pull testing.
03/08/2010 08:26:51	TONY AKERS	Response	Replace the complete lower bunk window assembly. Investigating window supplier processes. Please return original windows to TMAC for review. Technical Material Analysis Center, 4100 Bob White Blvd., Pulaski, VA 24301. Send to attention of Tony Akers.
03/05/2010 13:34:39	CAROL WHITLEY	Email - Outbound	Hi Tony, Getting repaorts from the customer the lower adjustable windows are breaking loose from the glass. Also same glass is leaking water past the seals I cannot confirm. Regards, Carol Please, do not change the Subject line if you want to reply to this email. The following service request has been assigned to you: Service Request Number: 1-1391843341 Date Opened : 2010-03-05 13:30:51 Severity : 2-High Product : VNL64T Chassis Id : N VIN/Serial #: 4V4NC9EJXBN Summary : Lower side windows Description : lower side window adjusters breaking loose from window. Driver are duct taping the glass closed. custoemr called today said he cannot confirm at this time but drives are also complaning of water leaks see attached windows ---SR Activities--- Comment: An attachment with filename 'side window2' has been added. Status: Done Creator: SIEBEL ADMINISTRATOR Created: 2010-03-05 13:32:31 ---SR Activities--- Comment: An attachment with filename 'side windows' has been added. Status: Done Creator: SIEBEL ADMINISTRATOR Created: 2010-03-05 13:31:30

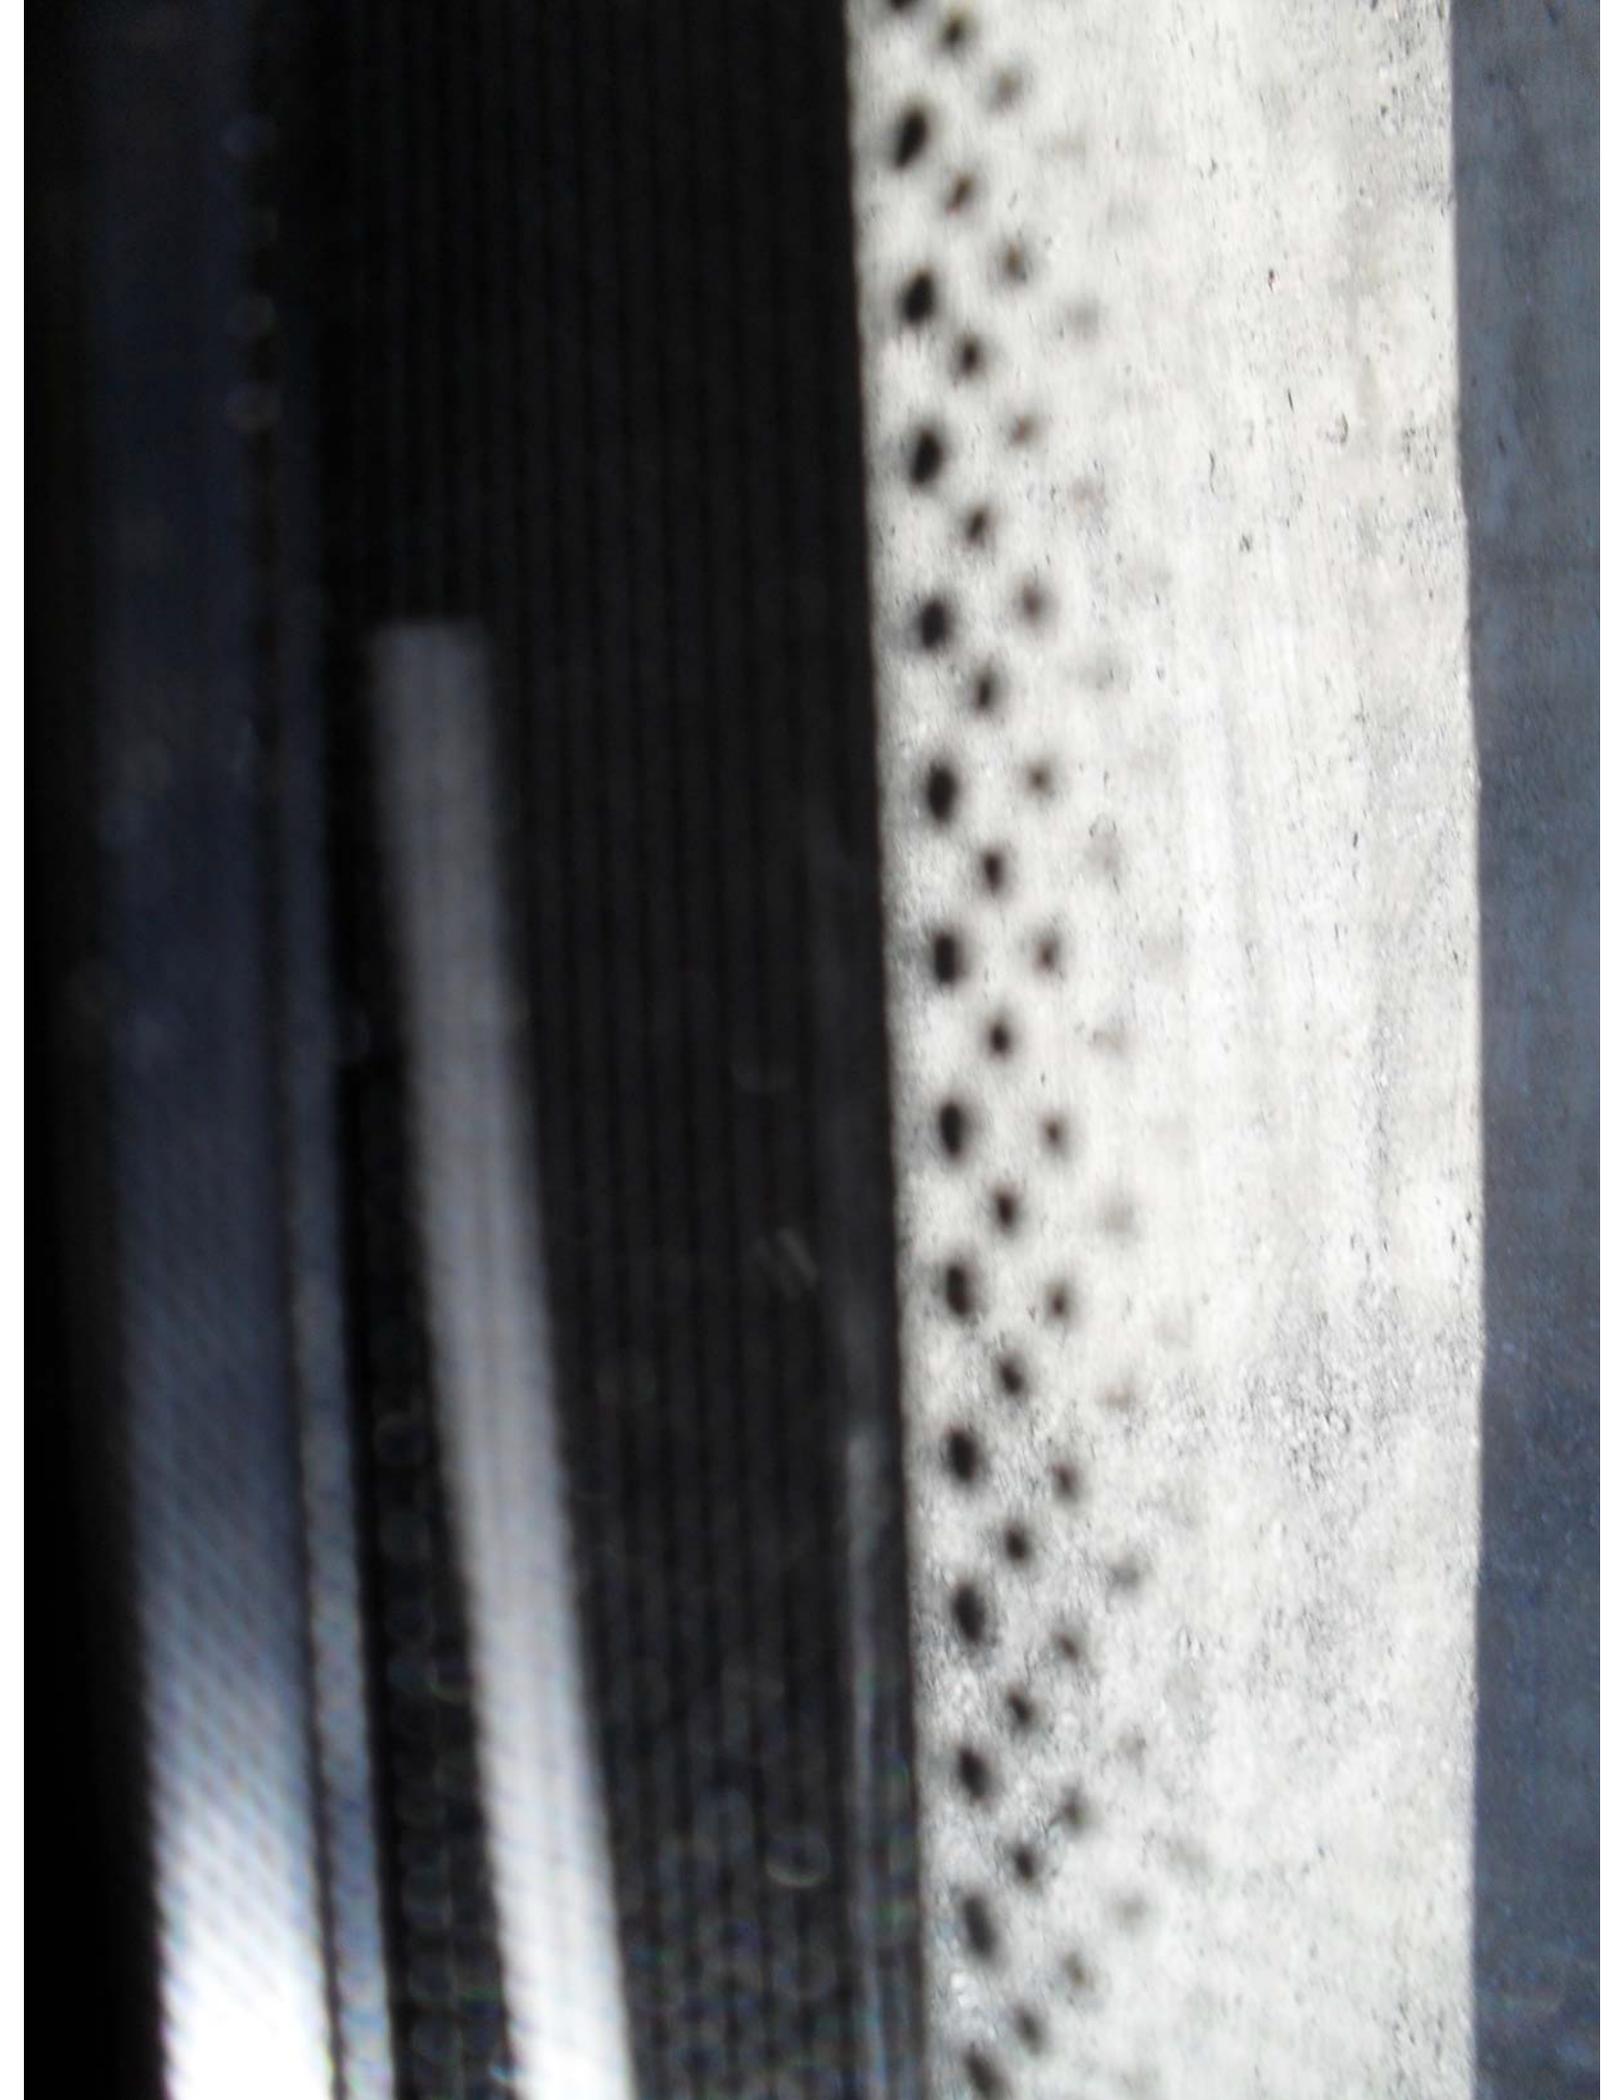
Just received this a.m.....Clean date on the lower bunk window assembly.....

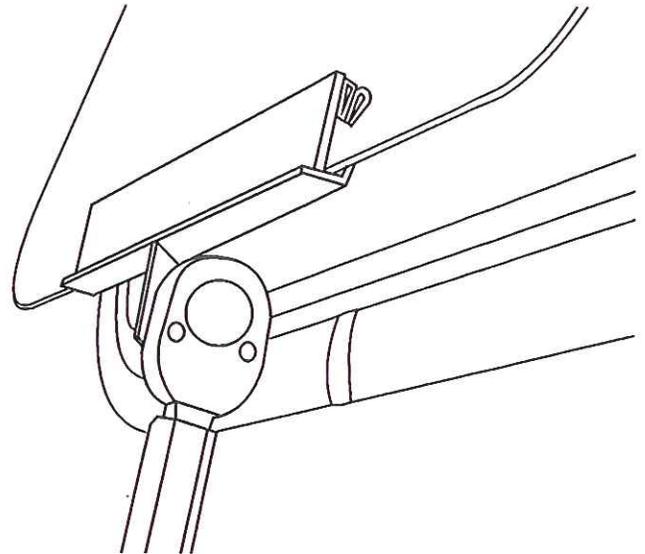
W8003357

1. Open the cab side upper window. From outside the cab install the tool to the window glass as shown above. Apply 20 ft-lb of torque (**Do Not exceed this torque spec as it may damage the window**) to the tool, if the glass separates from the slide track the window must be replaced (replace a failed window glass before inspecting the other side). If no separation occurs not further repair is required.

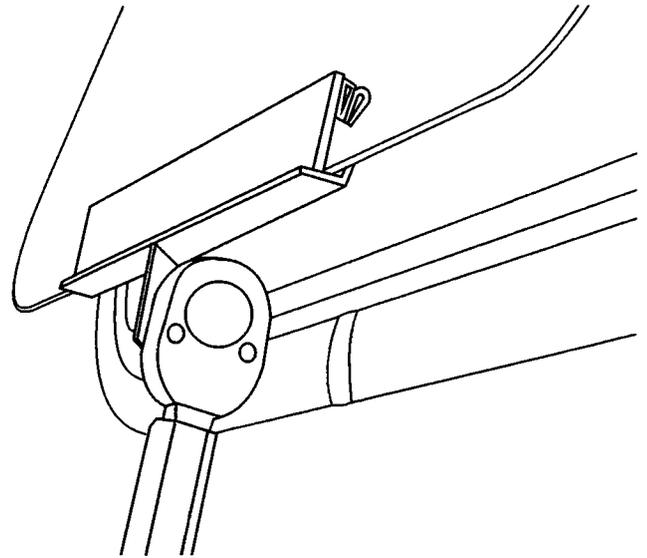
W8003357

1. Open the cab side upper window. From outside the cab install the tool to the window glass as shown above. Apply 20 ft-lb of torque (**Do Not exceed this torque spec as it may damage the window**) to the tool, if the glass separates from the slide track the window must be replaced (replace a failed window glass before inspecting the other side). If no separation occurs not further repair is required.

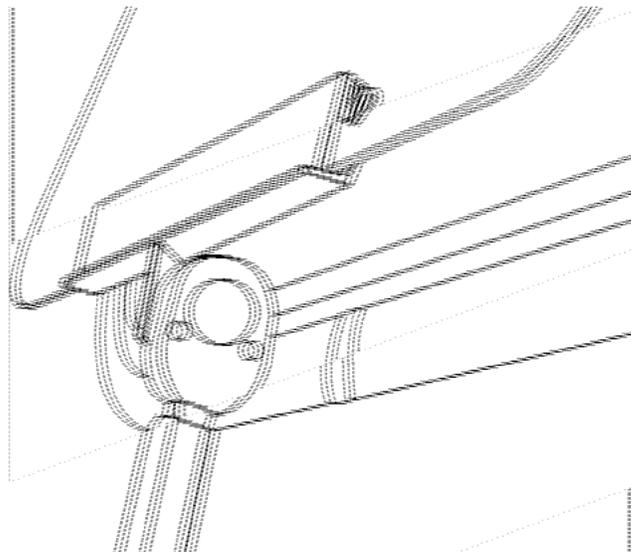
W8003357

1. Open the cab side upper window. From outside the cab install the tool (85129124) to the window glass as shown above. Apply 20 ft-lb of torque (**Do Not exceed this torque spec as it may damage the window**) to the tool, if the glass separates from the slide track the window must be replaced (replace a failed window glass before inspecting the other side). If no separation occurs, no further repair is required.
