ITB11-039e

June 8, 2012

VOLUNTARY SAFETY RECALL CAMPAIGN 1997-2003 QX4 IN SALT STATES FRONT STRUT HOUSING CORROSION

CAMPAIGN ID #: R1109
NHTSA #: 11V-244
APPLIED VEHICLES: 1997- 2003 QX4 (JR50)

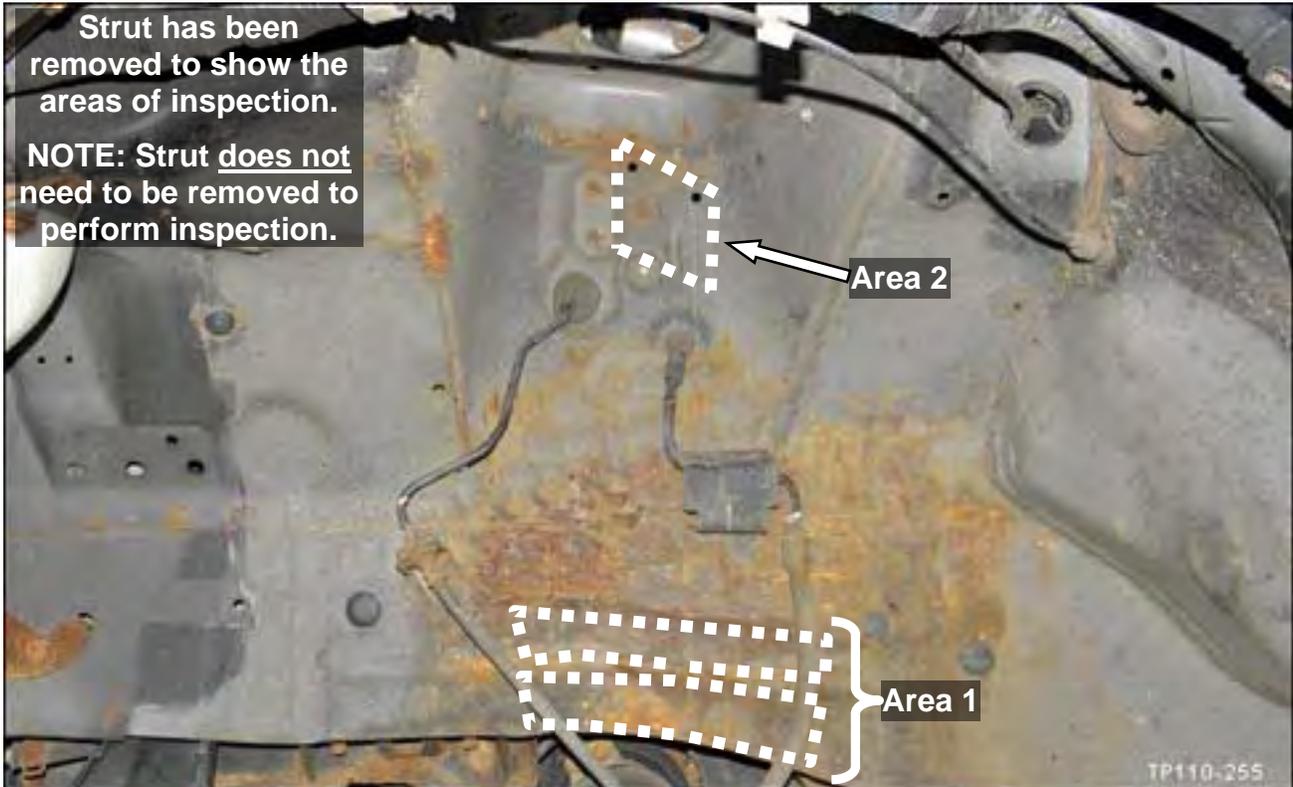
Figure 2

This example photo shows the inspection areas in relation to the repair bracket installation.

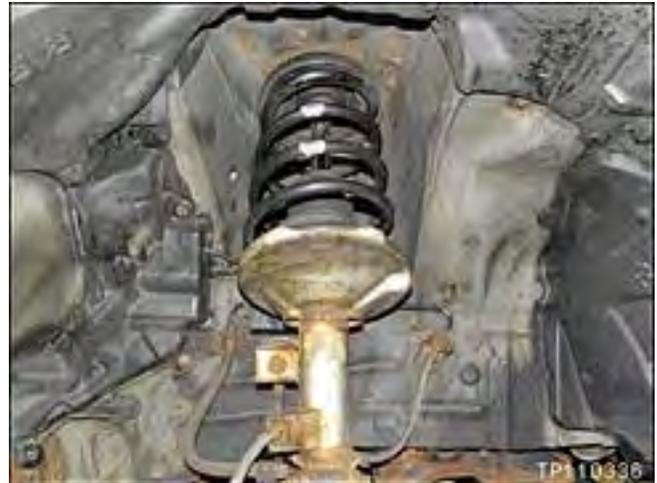
2. Visually inspect for corrosion and rust on the wheel housing panel and the strut housing panel (driver and passenger side).
 - Inspect for corrosion and rust on the panels only.

1. Use mild soap, water, and a brush to **thoroughly wash** the strut housing and the wheel housing in the area shown in Figure 6 (**both sides**).

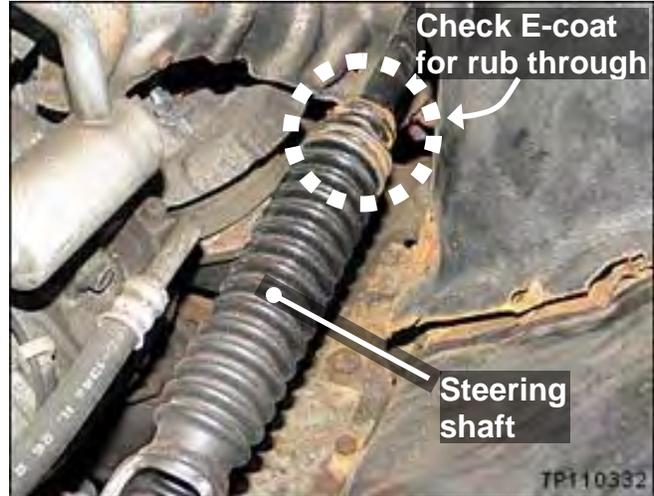
Figure RB5

Contact may have occurred if the strut housing separated from the wheel house.

- **ONLY if the E-coat has been rubbed through to bare metal**, the steering shaft will need to be replaced.
- If the steering shaft needs replacement, you will be instructed to replace it later in this procedure.

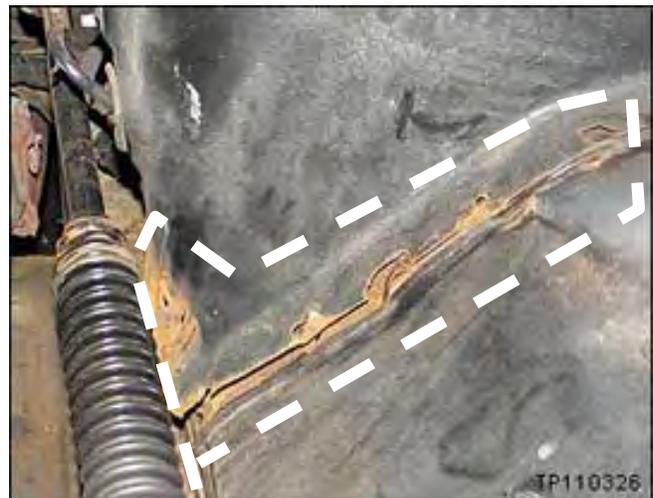
Figure RB6

7a. Only if the strut housing panel is separated as shown in Figure RB6:

Use a wire brush to clean any loose rust, paint, or other debris from the area shown with dashed line.

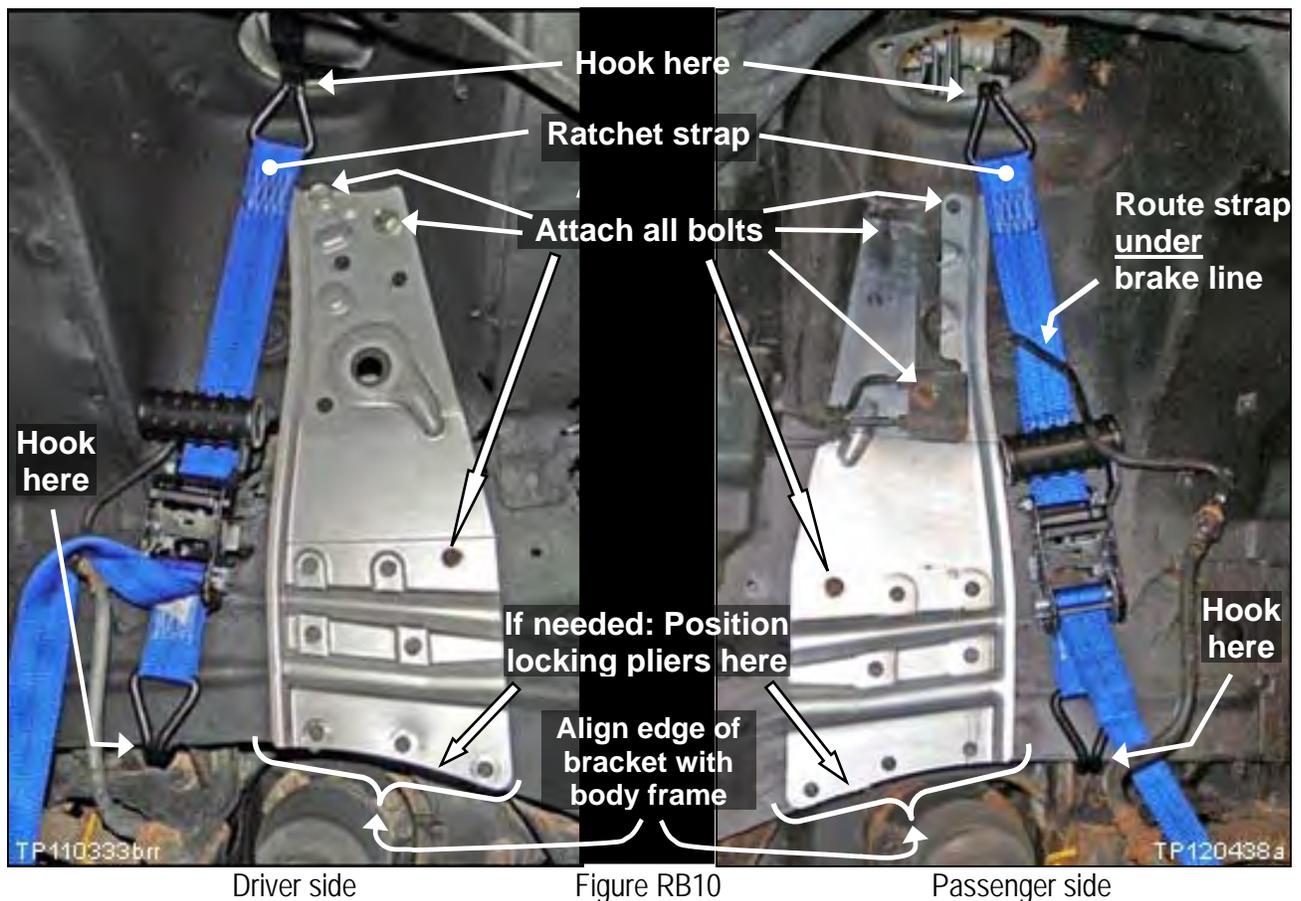
- a. Attach the ratchet strap as shown in Figure RB10.
- b. Use the ratchet strap to pull the strut housing panel down until the existing threaded hole(s) is aligned with the matching hole in the repair bracket (see Figure RB10).

18. Once the bottom edge is aligned, securely tighten all bolts (see Figure RB10).

- At this time, a pair of locking pliers or equivalent tool may be used to further support the repair bracket (see Figure RB10).
- Bolts need to be tight enough to hold the bracket in place while center punching and drilling holes in the next step.

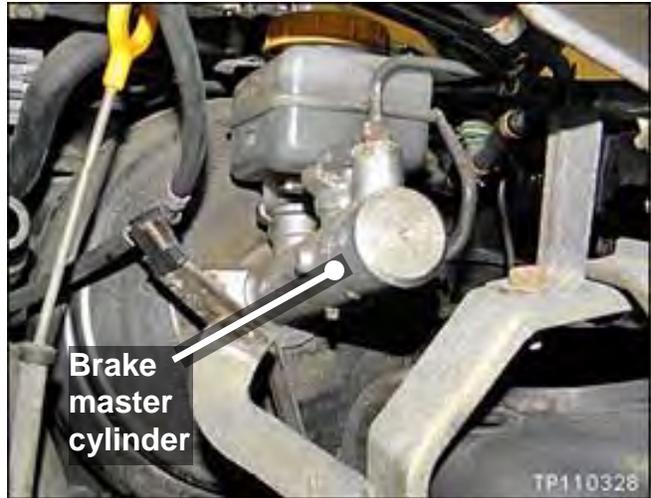
Figure RB28

Contact with the strut housing may have occurred if the strut housing separated from the wheel house.

32. Driver side: Inspect the brake master cylinder for damage due to contact with the separated strut housing.

- If there is damage, replace the master cylinder.
- Refer to the appropriate Service Manual for brake master cylinder replacement information.
