Subject: Chrysler Group LLC Assertions - Karco ZJ-Body Impact Test of 16 May 2011
Reference: EA12-005 File Update (Chrysler Jeep Fuel Tank System Defect)

Jeep Vehicle Fuel Tank Breach: Source Documents History and Background

In April 2011 my expertise was solicited by Mr. Clarence Ditlow, Director for the Washington D.C. based Center for Auto Safety (CAS), regarding a planned real world crash test of a 1996 ZJ-Body Jeep Grand Cherokee fuel system. My role as representative for CAS also included confirmation of test vehicle (Jeep Grand Cherokee) condition as competent, representative and authentic for the stated test purpose(s).

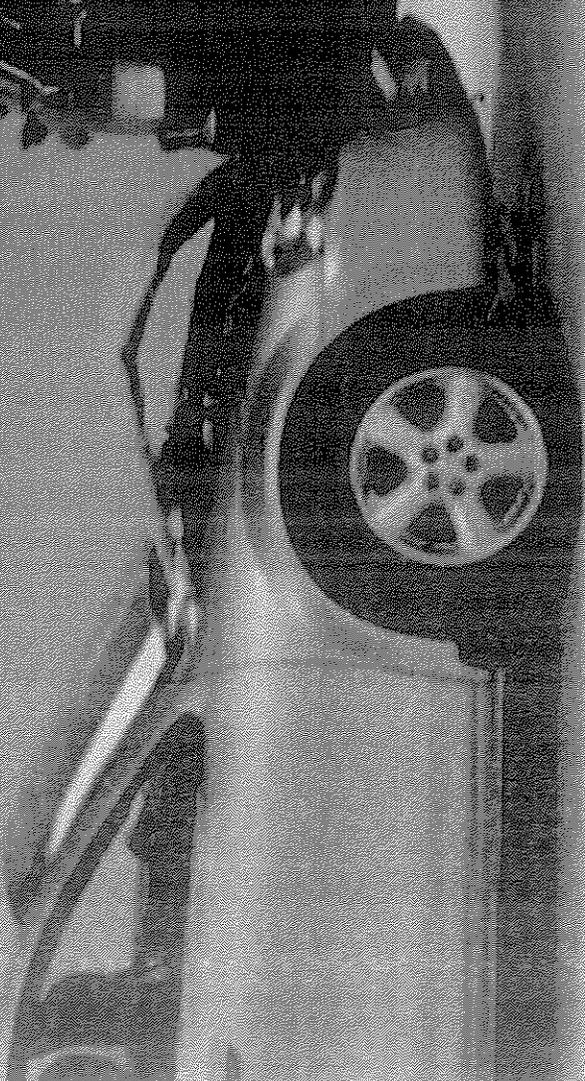
Underride Mode Caused by
10 mph Bumper Test:
Dodge Stratus into rear of Jeep
Grand Cherokee
WJ-Body "Brush Guard"
Damaged, had to be Replaced

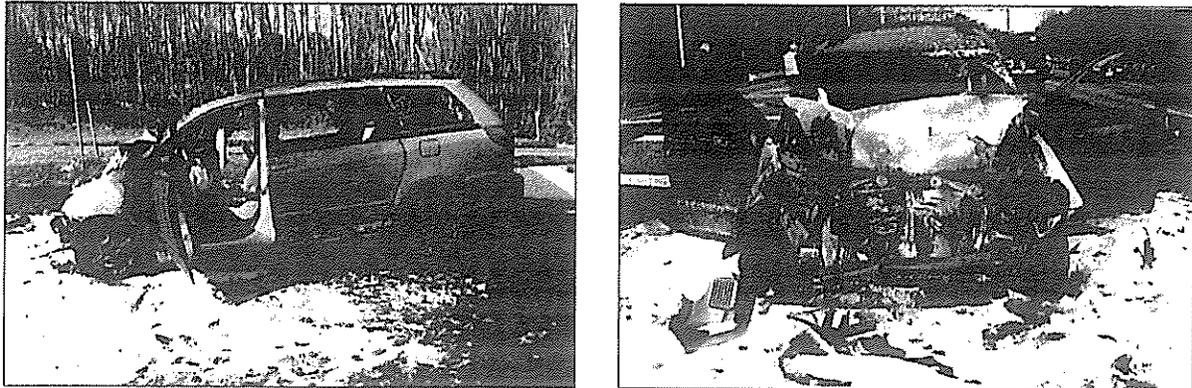
2004 Toyota: The Toyota involved in this crash was a 2004 model year Sienna XLE (VIN - 5TDZA22C34S█). This vehicle was equipped with a 3.3-liter 6-cylinder gasoline engine and an automatic transmission. Figure 2 shows the Toyota at the accident scene. As can be seen in the figure, the Toyota shows signs of frontal impact and fire damage. The Toyota was not available for Kineticorp’s inspection.

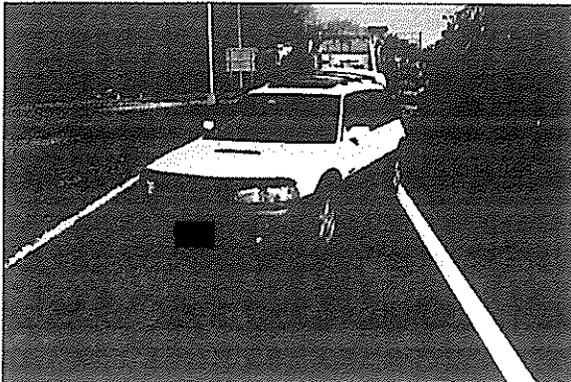
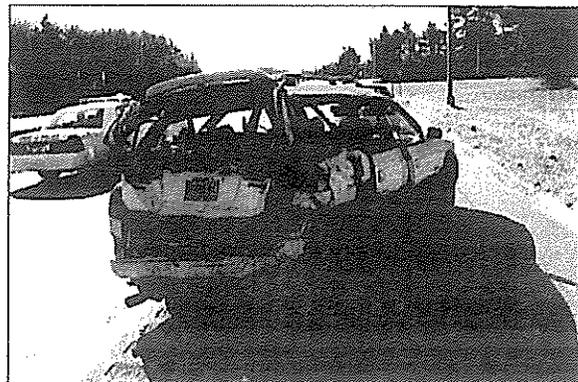
Figure42

1998 Subaru: The Subaru involved in this accident was a 1998 model year Legacy, Outback Edition (VIN - 4S3BG6852W7 ██████████). This 4-door wagon was equipped with a 2.5-liter, 4-cylinder gasoline engine and an automatic transmission. Figure 4 shows the Subaru at the time of the accident. As can be seen in the figure, the Subaru sustained damage to the rear of the vehicle. The Subaru was not available for Kineticorp's inspection.

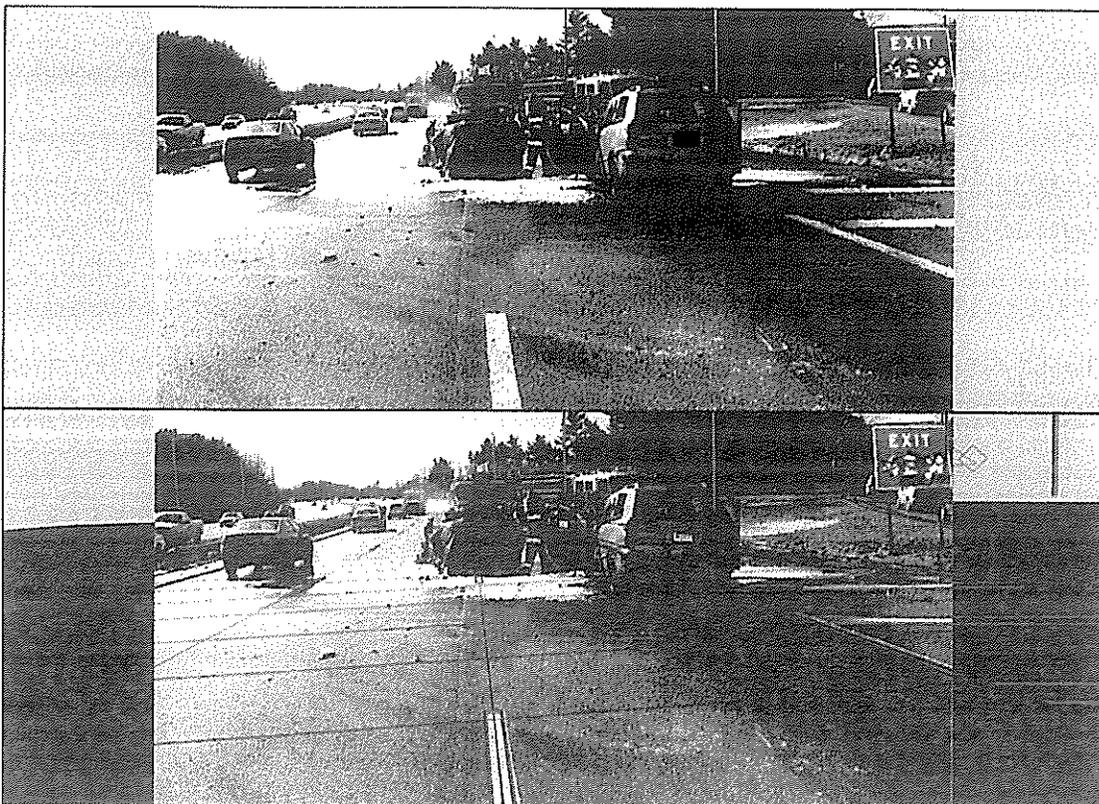
Figure 5 depicts a sampling of our photogrammetry analysis. The first image of the figure is a photograph taken by police. In the second image of the figure, the accident scene photograph has been aligned with the computer model which is visible as an overlay of lines. The third image of Figure 5 ((continued on following page), shows the aligned computer model with the physical evidence traced. Additionally, vehicle models have been positioned to locate the involved vehicles points of rest. In the bottom image of Figure 5-continued, the photograph has been removed leaving the geometry from the computer model.

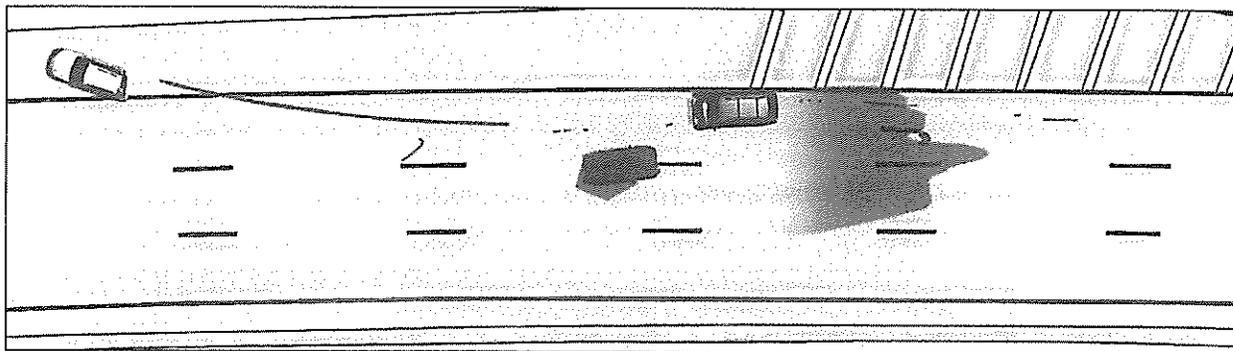
Figure 6 depicts our accident scene diagram, including the rest positions of the vehicles that were located using photogrammetry. Glass, gouge marks and tire marks are indicated in blue. Fluid and burn areas are shown in orange.

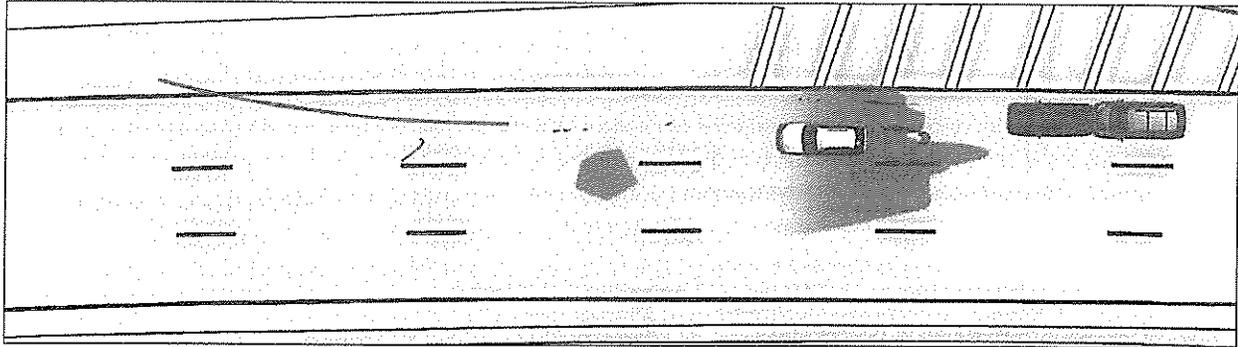
Analysis: Gouge and tire mark evidence were used to locate the points of impact on the roadway. Figure 7 depicts the location of the vehicles at first impact as dictated by the physical evidence.

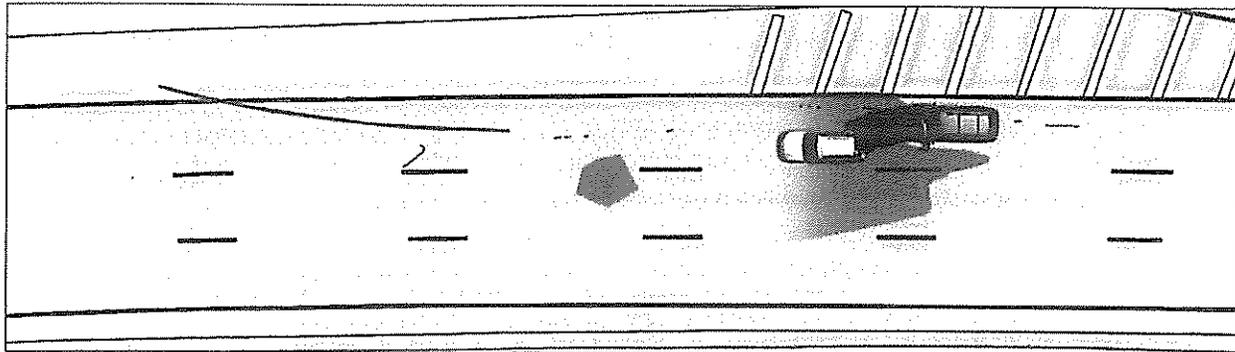
After the initial impact, the Jeep and Toyota traveled approximately 30 feet before impacting the rear of the Subaru. Figure 8 depicts the position of the vehicles at the second impact. As seen in the figure, the Jeep is crushed between the Toyota and Subaru. During impact two, the Jeep and Toyota were both damaged more extensively, as evidenced by the glass deposit at the location of the impact. As the Jeep was crushed, it rolled towards the passenger side and the Toyota under-rod the rear of the Jeep as depicted in Figure 9. The Jeep rolled approximately 25 degrees based on the damage pattern to the rear lift gates of the Jeep and the Subaru. Specifically, the window opening of the Jeep's rear lift gate exhibits more damage to the right side than the left, consistent with the Jeep being rolled to the right as the Toyota penetrated underneath the rear on the Jeep. Also, the rear lift gate of the Subaru exhibits damage consistent with the front of the Jeep being lifted up above the Subaru's rear bumper. Additionally, the right rear wheel of the Jeep gouged the pavement as it rolled to the right.

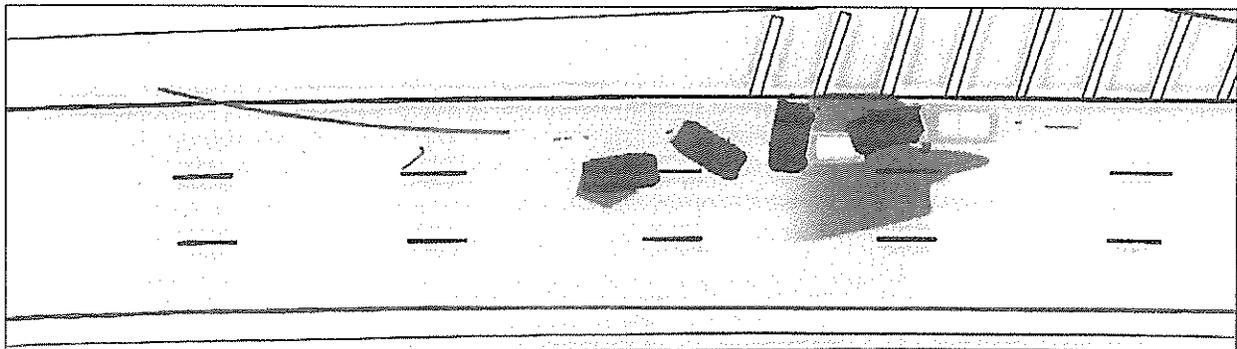
Figure 10

The vehicles then traveled to rest. The collision locked the rear right tire of the Subaru, causing it to leave a dark tire mark that led to its rest position. The Subaru traveled approximately 130 feet after the impact and came to rest on the shoulder. The Toyota traveled approximately 40 feet before coming to rest in the right lane. As the Jeep was crushed between the Subaru and the Toyota, it began to rotate counter-clockwise. The Jeep traveled approximately 50 feet, and rotated approximately 180 degrees before coming to rest straddling the right and middle lanes. The motion of the Jeep as it traveled to rest is depicted in Figure 10.

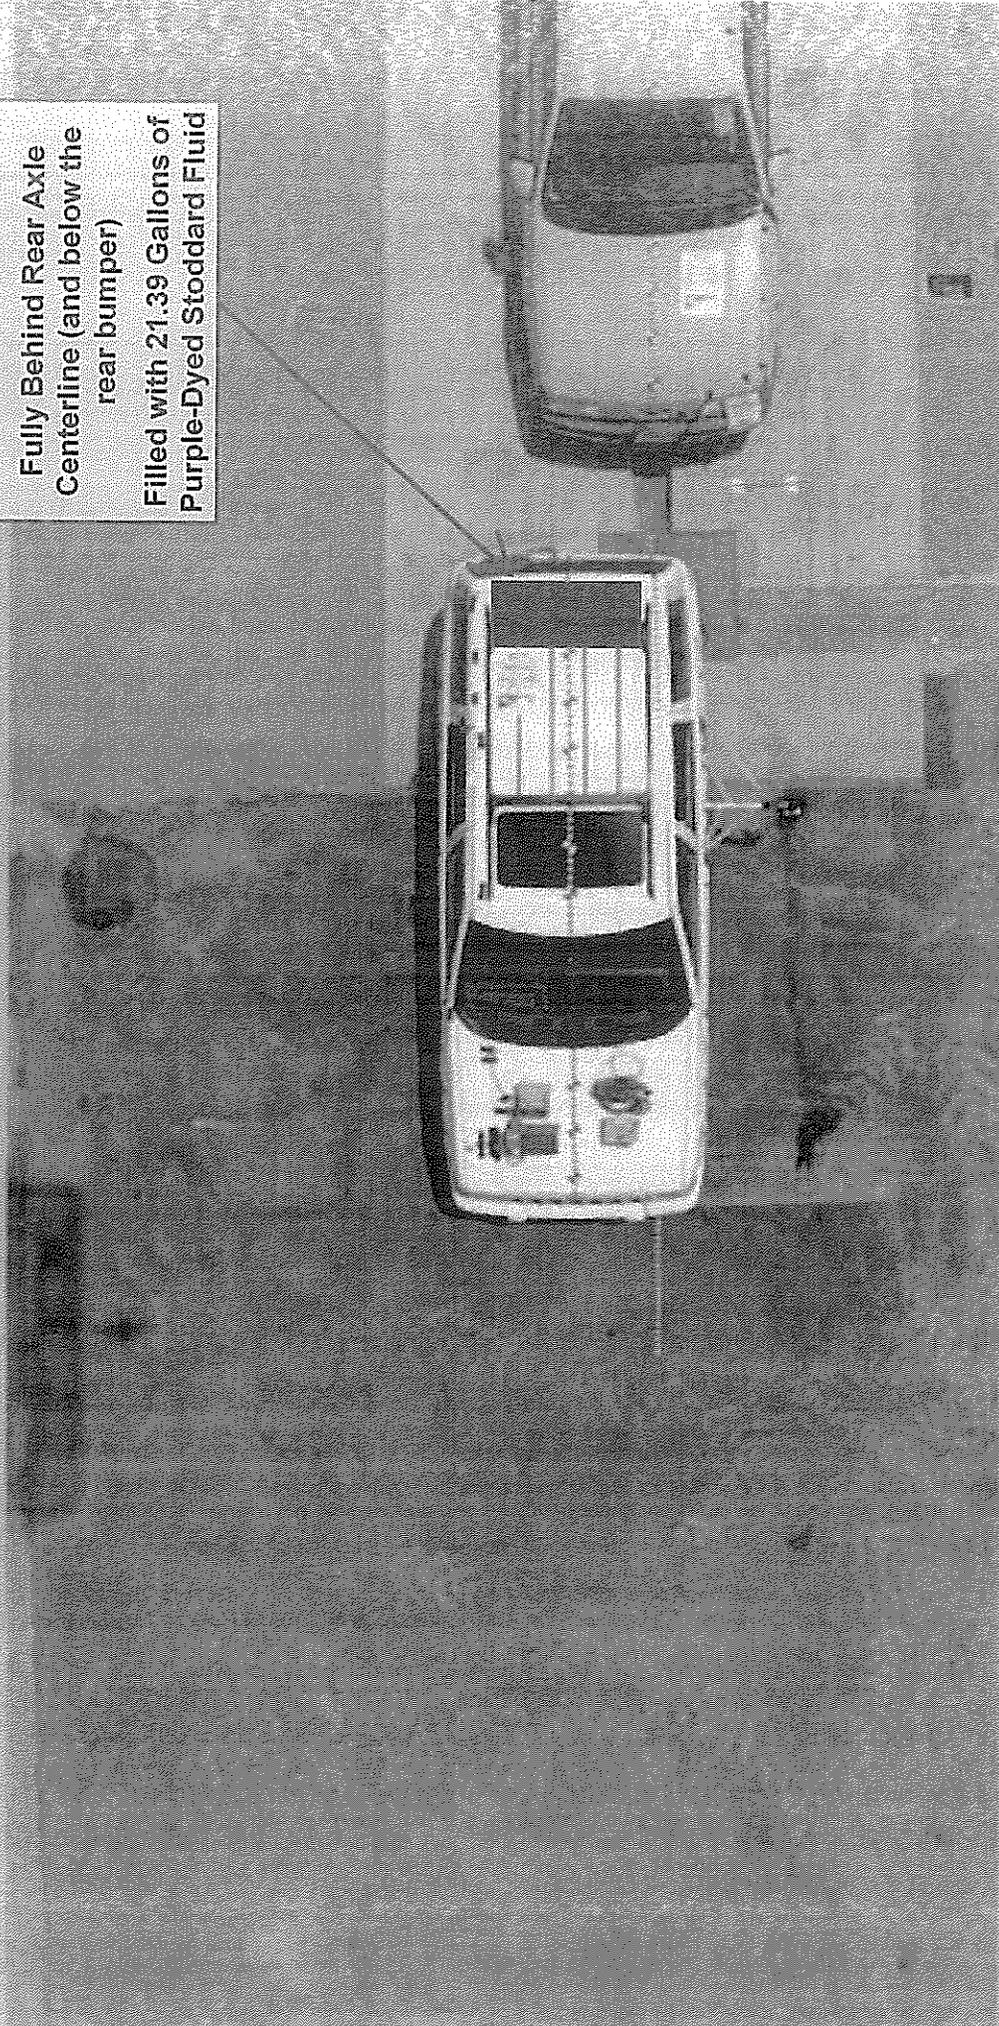
Camera View-02

Purple Rectangle Shows
Approximate Position of
Polyethylene Fuel Tank:
Fully Behind Rear Axle
Centerline (and below the
rear bumper)
Filled with 21.39 Gallons of
Purple-Dyed Stoddard Fluid

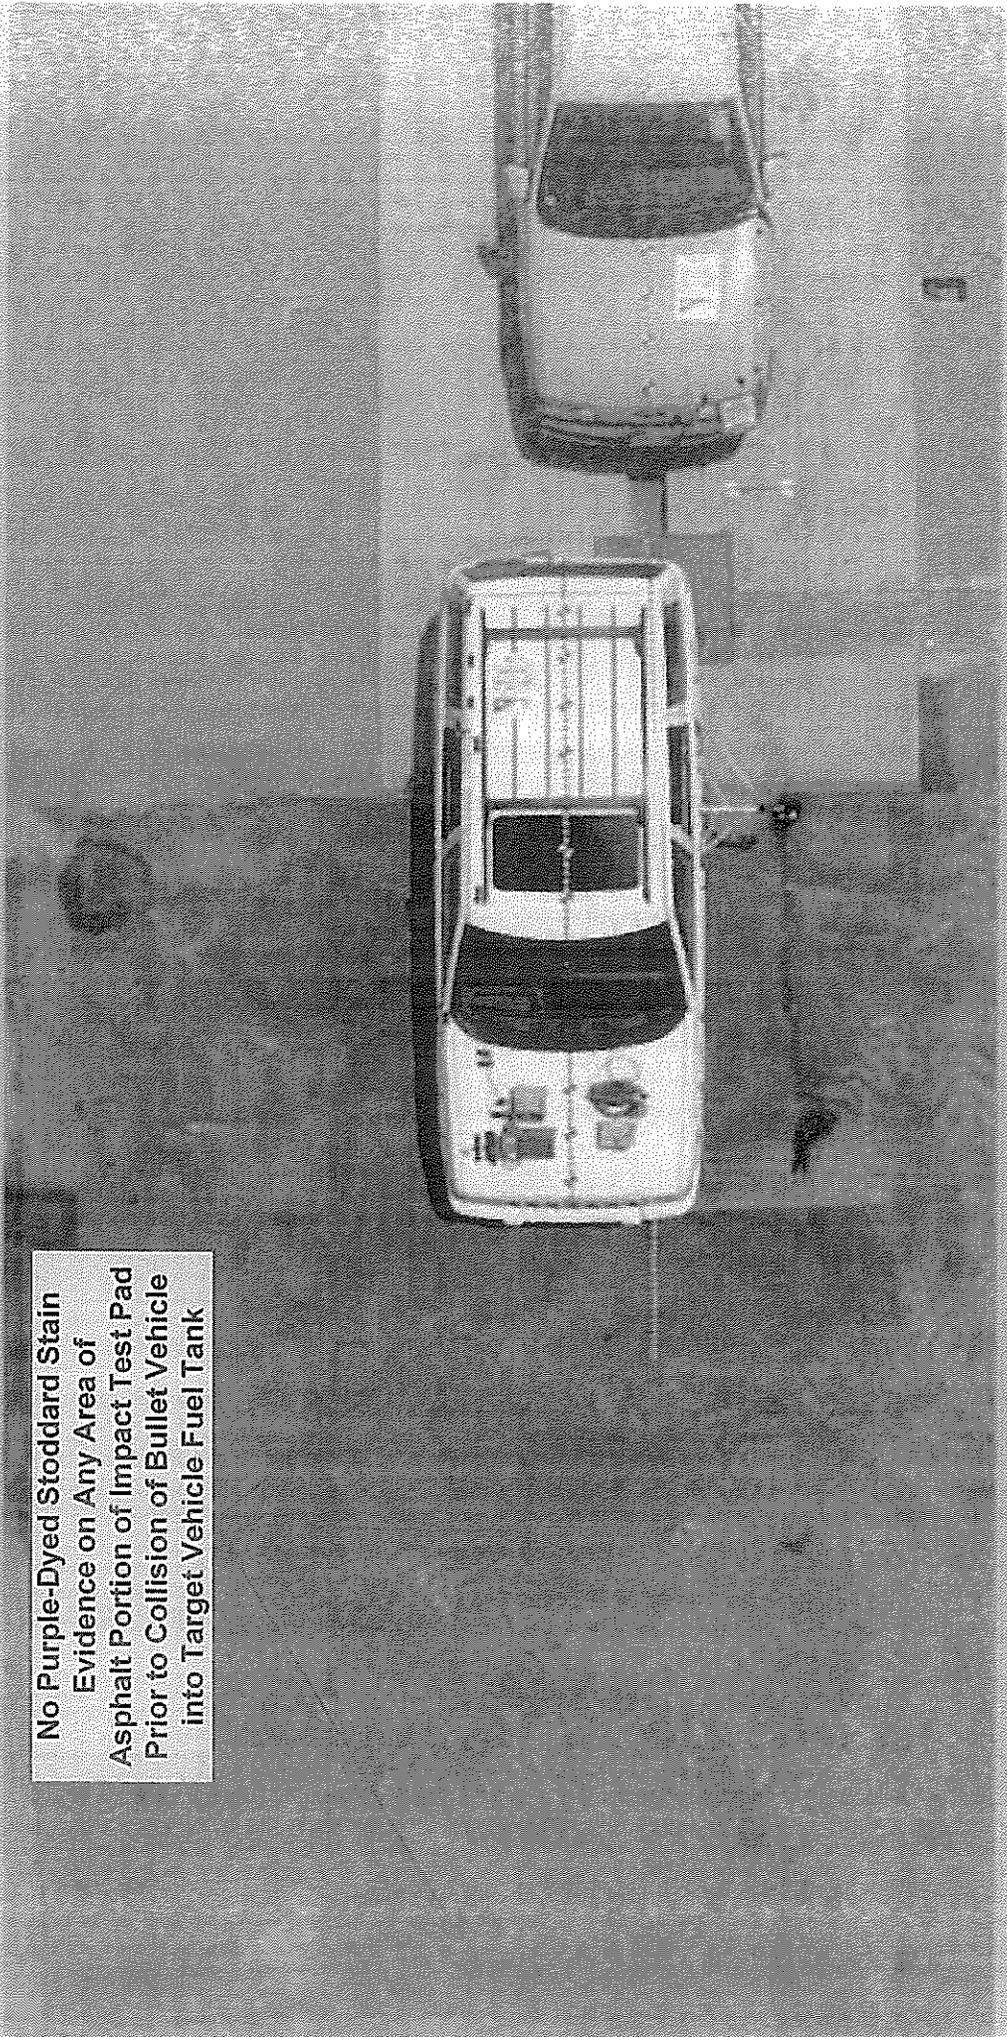
Camera View-02

No Purple-Dyed Stoddard Stain
Evidence on Any Area of
Asphalt Portion of Impact Test Pad
Prior to Collision of Bullet Vehicle
into Target Vehicle Fuel Tank

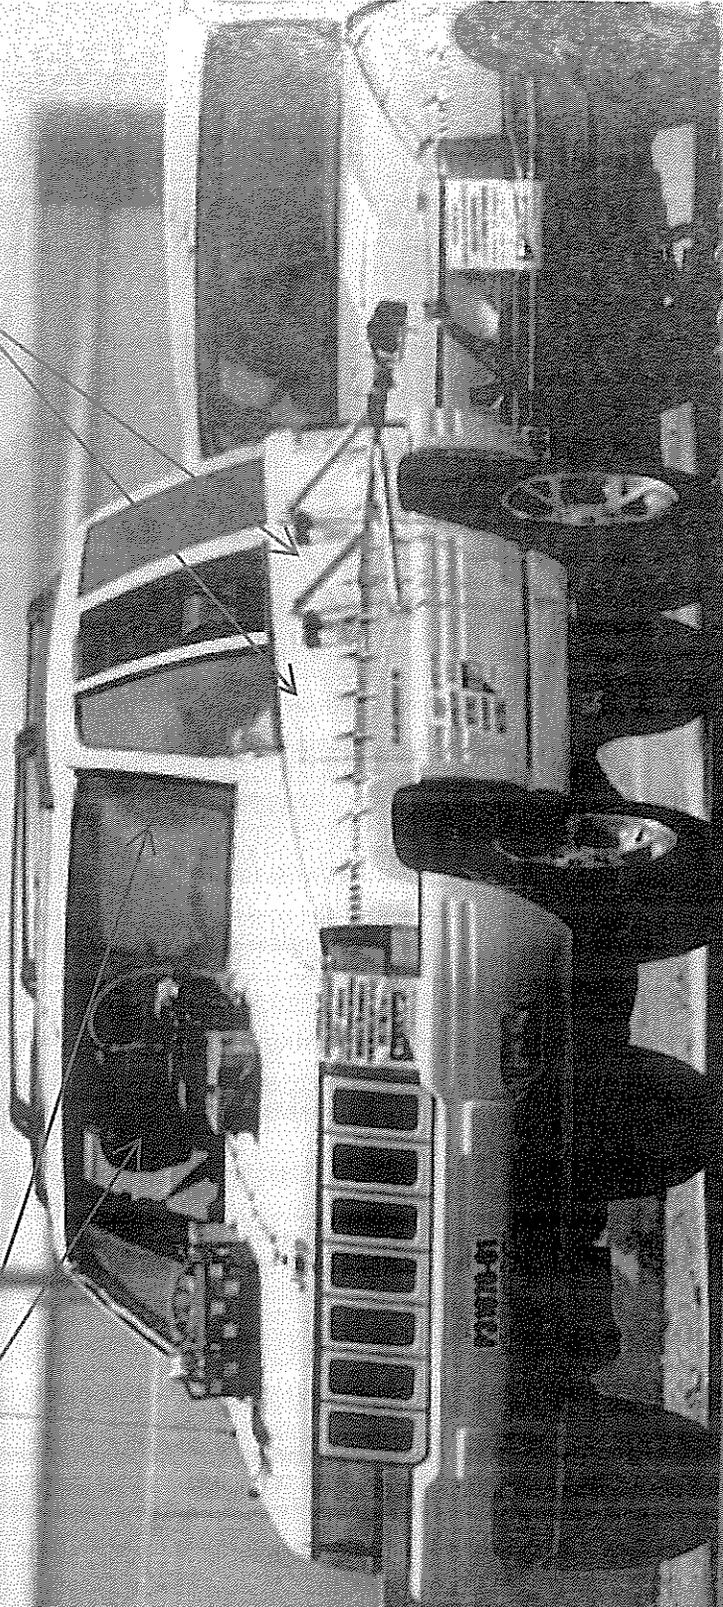
Camera View-03

Prior to Impact Both Test
Dummies are Upright

All Four Doors Operative
Allowing for Emergency Egress

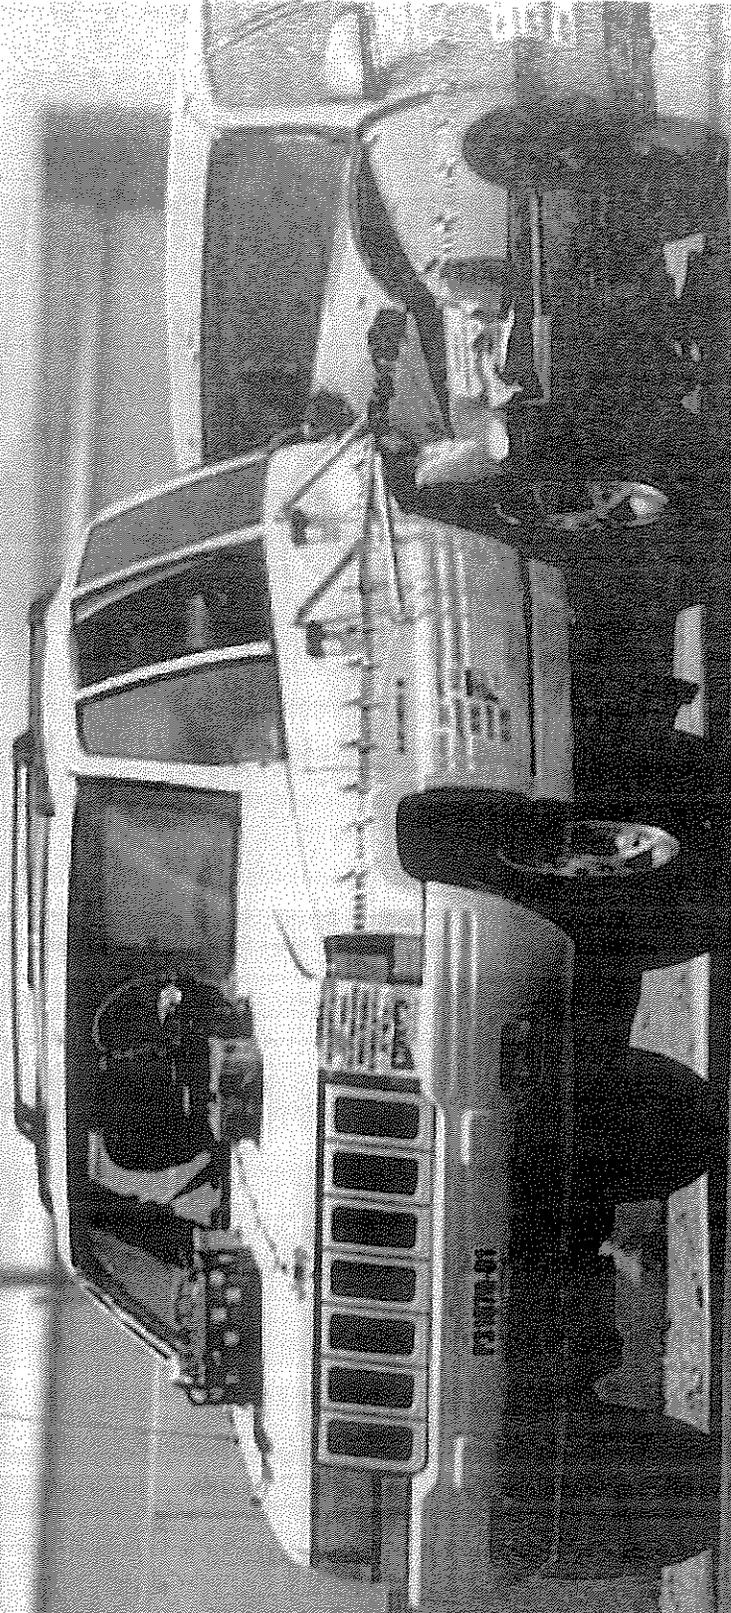
Camera View-03

T = 0.052 Represents Maximum Deceleration and Acceleration of Bullet and Target Vehicles Respectively. However, Target Vehicle Movement in X-axis direction has not yet commenced.

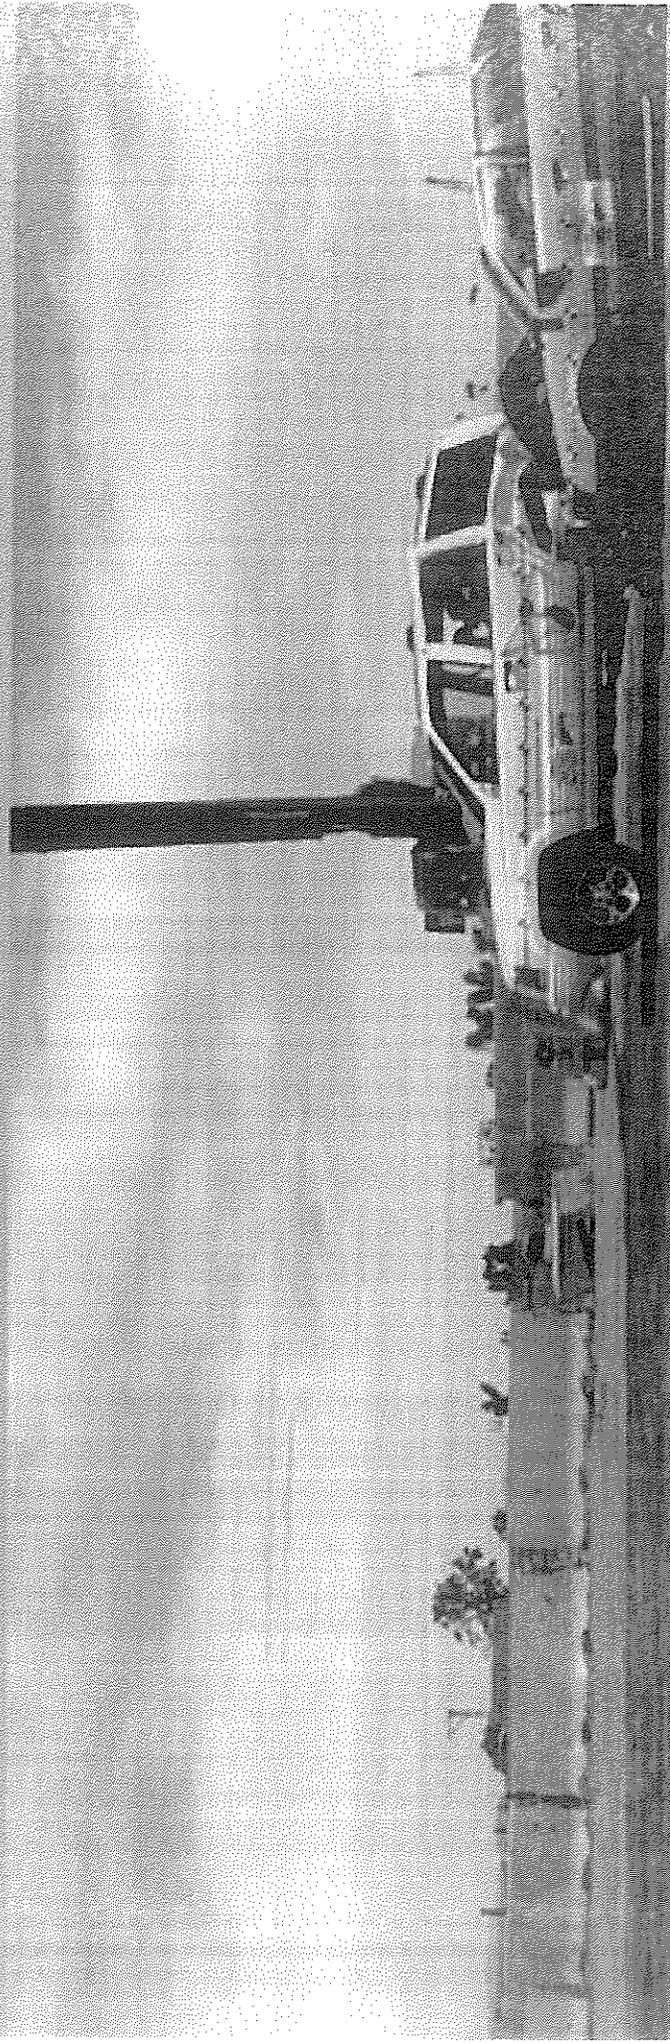
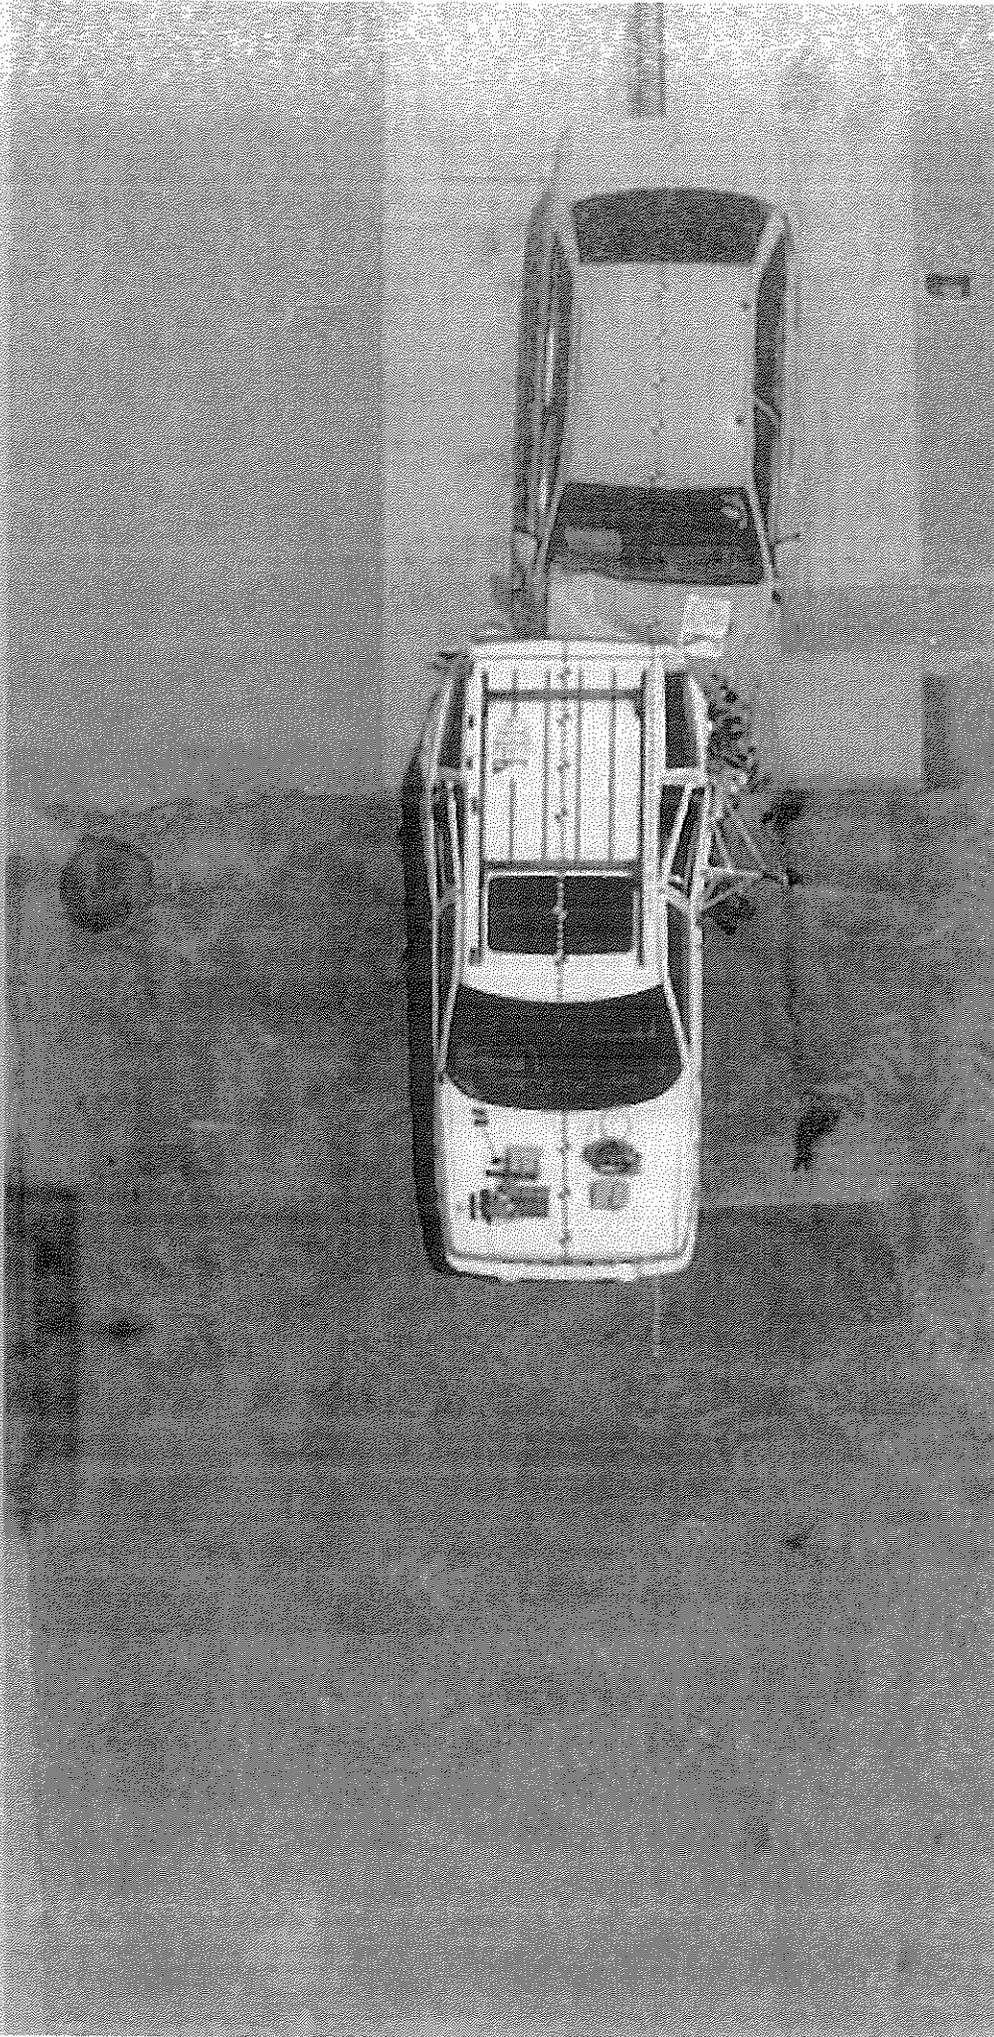
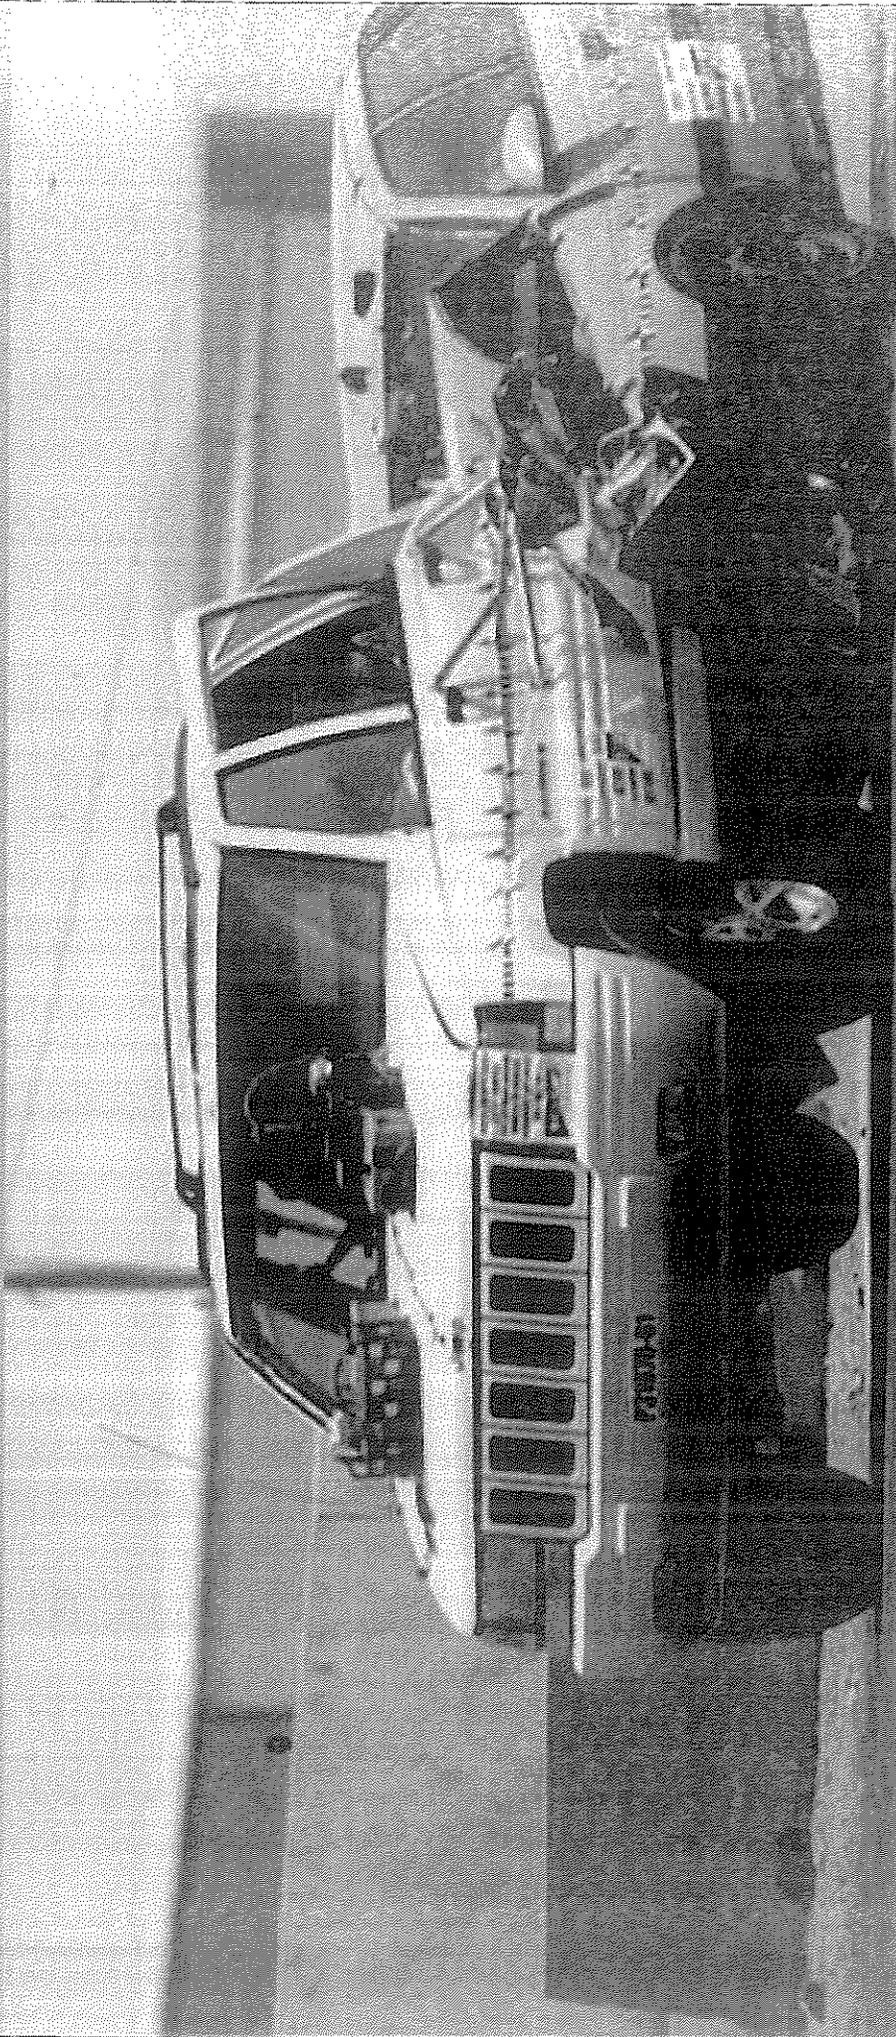
At T = +0.119, the target vehicle has commenced appreciable movement in the X-axis direction. This separation sequence, which moves the target /bullet vehicles off the impact pad, exposes the surface, and accommodates viewing of the stoddard evidence of a fuel tank breach which I assert occurred back at T = +0.052.

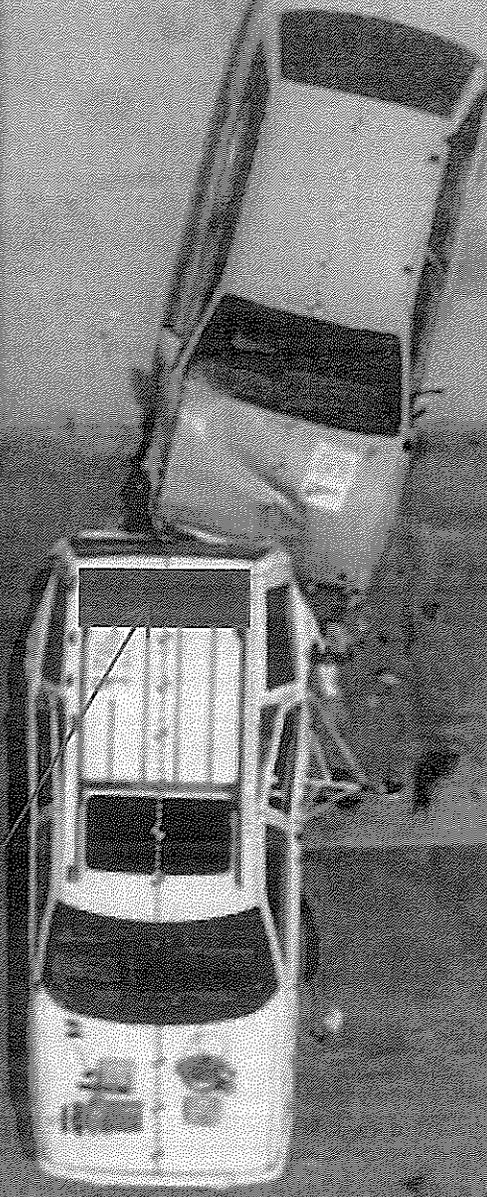
315

Evidence of Stoddard Leakage on Impact Pad Begins Approximately 6 Feet from Original Fuel Tank Position
This Leakage Evidence Begins at Not-Later Than T = +0.315

Purple Rectangle Shows Position of Polyethylene Fuel Tank Behind Rear Axle Centerline and below the rear bumper Filled with 21.39 Gallons of Purple-Dyed Stoddard Fluid

Position of Target Vehicle Fuel Tank Relative to Impact Pad Where Initial Evidence of Stoddard Staining of Pad Occurs Target Vehicle and Its Fuel Tank Reach this Specific Pad Location at T = +0.315

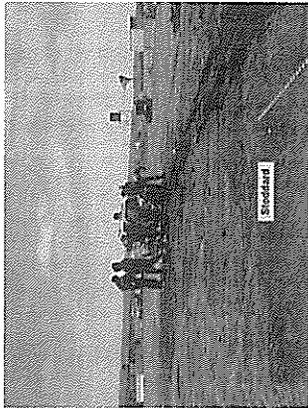
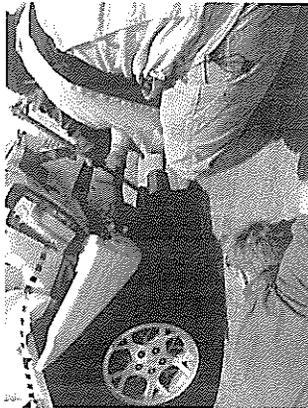
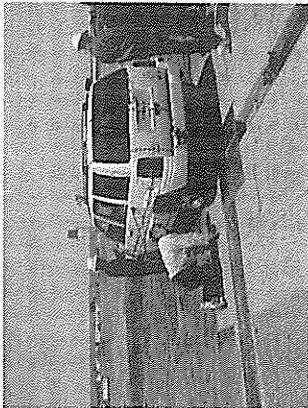
These photographs are part of my expert reports to the exemplar accident. The breaches to the unprotected Jeep Grand Cherokee fuel tank did not result in minor leakage; it was so severe that, as the person representing CAS at this test, I recommended that time/resources not be wasted on the FMVSS-301 rollover protocols (last page).

Stoddard Evidence Trail
from Two Breaches in
Jeep Grand Cherokee
Target Vehicle Fuel Tank
Two Breaches Occur at
Not Later Than $T = 0.052$
