13E-005  
(16 pages)

Re: Notification of Defect Affecting Motor Vehicle Safety

FRAM Group Operations, LLC ("FRAM") has determined that a limited number of replacement oil filters it manufactured and sold to Subaru of Indiana Automotive, Inc. ("SIA") for distribution to the Subaru of America ("SOA") dealer network have a manufacturing defect related to motor vehicle safety. SOA and SIA may be referred to collectively and generally as "Subaru". No motor vehicle accidents or personal injuries have been reported. The following information is submitted pursuant to the motor vehicle equipment defect and non-compliance reporting regulations of the National Highway Traffic Safety Act (49 CFR Part 573). Based upon reported data from the field, the defect resulted in a leaking filter that, shortly after installation, could have resulted in a loss of motor oil. That loss of motor oil could, in certain circumstances, result in a fire and engine shut down. As further set forth below, five incidents impacting motor vehicle safety have been reported to FRAM.

This notice relates to FRAM's model 15208AA12A filter (the "filter") which is sold exclusively to SIA for OES applications. The filters s

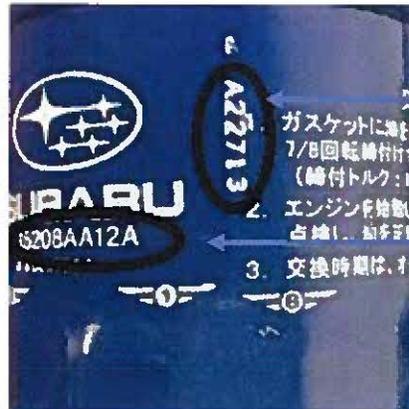
The filter (shown below) is a spin-on filter.

Date Code: [single digit year]  
[three digit date of assembly]  
[single digit shift]

Model Number

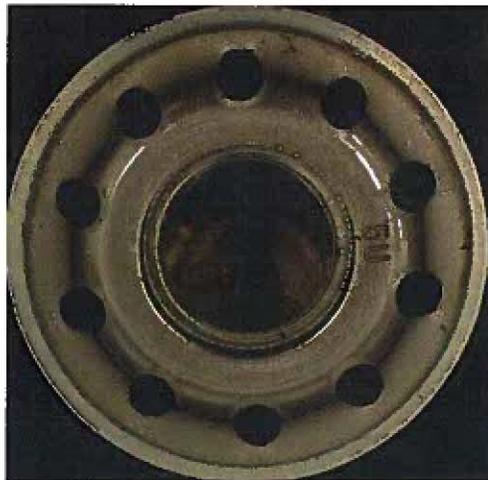
The filter media is contained in a housing that prior to assembly is open on one end. During assembly, the open end is capped with a tap plate (shown below):

The tap plate has a female threaded portion that is concentric to the outer diameter of and perpendicular to the plate. The tap plate also has a channel that holds a "P" ring gasket that is inserted during manufacture.

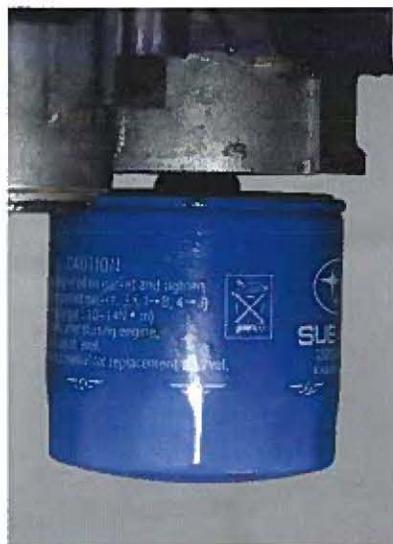
This threaded portion is intended to mate with a corresponding, hollow and threaded spud that is connected to the engine (shown below).

When the filter is screwed onto the engine spud, the gasket compresses against the engine mounting surface and forms an oil tight seal.
