Technical Service Bulletin

GROUP RECALL	NUMBER 13-01-033-1
DATE AUGUST 2013	MODEL(S) Azera (HG)

SUBJECT: AZERA PODS UPDATE (RECALL 111)

Description: This bulletin describes the service procedure to update or replace the PODS (Passive Occupant Detection System).

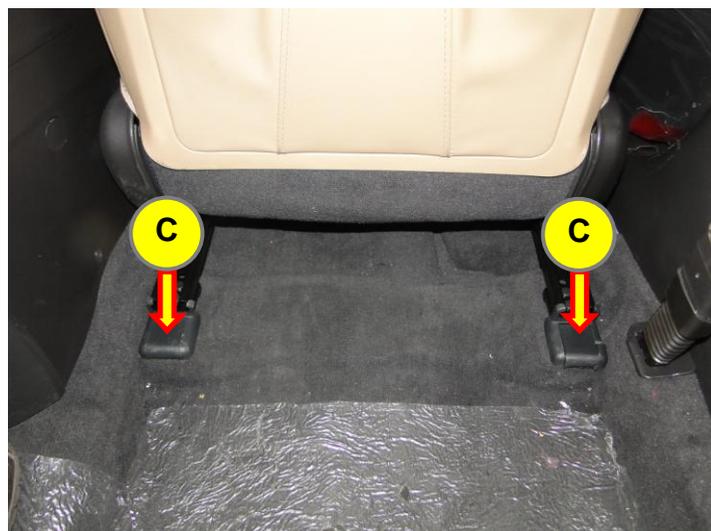
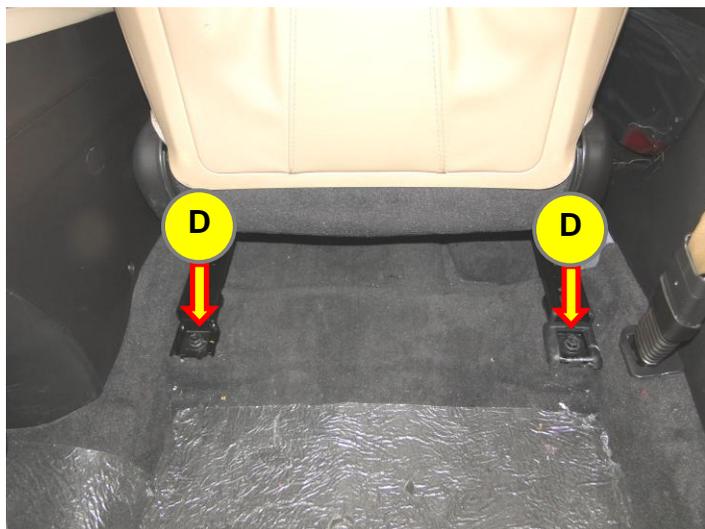
4. Move the front passenger seat to the most forward position.
5. Open the covers (C), and then remove the rear mounting bolts (D) of the front passenger seat.

Tightening torque :**49.0~63.7 N.m (5.0~6.5 kgf.m, 36.2~47.0 lb-ft)**

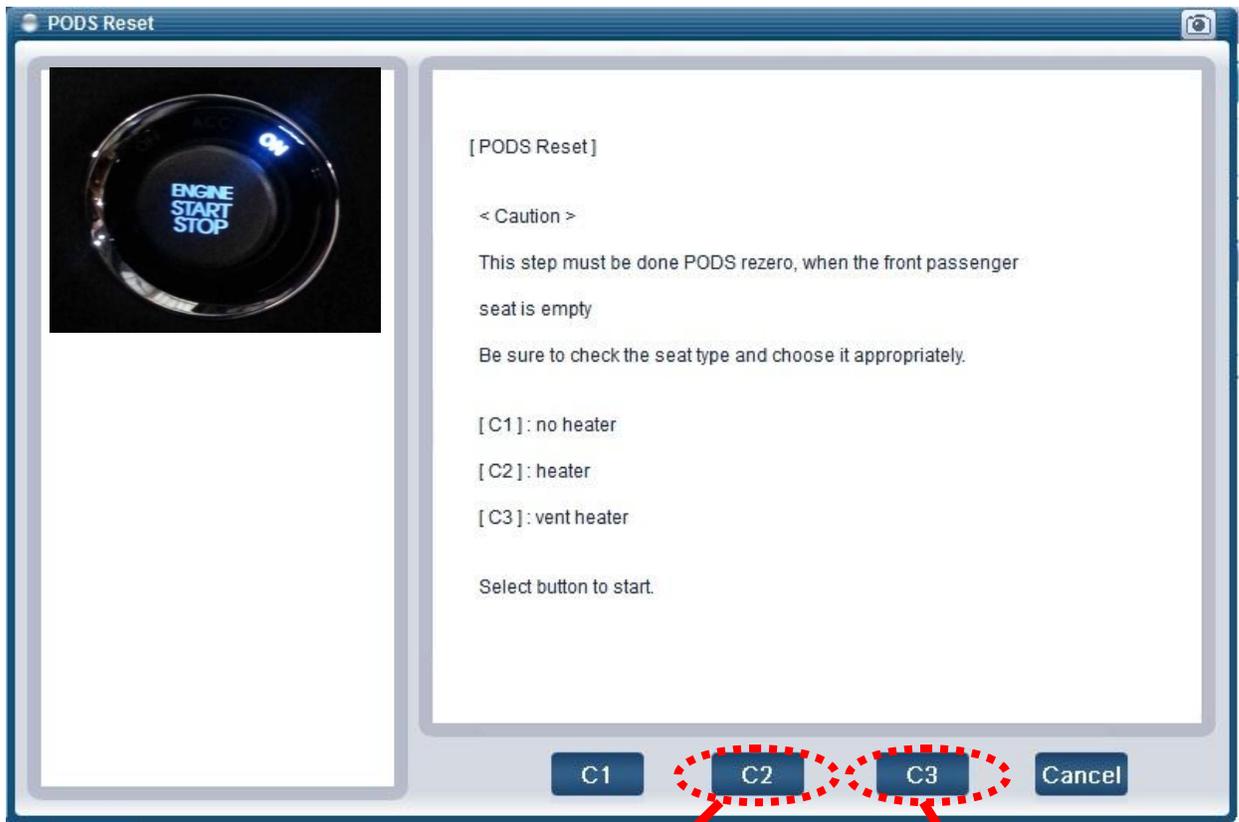
30) On the PODS reset screen below select; **C2 for Heating** only and **C3 for Heating and Cooling**.
