**Subject: NHTSA Campaign Number 13V-340/Jaguar Safety Recall J030 – XK Convertible Switch – Dealer Communications**

## **SUPPLEMENTARY INFORMATION**

**Publication Part No. JSA 18 02 30 991**

## Non-Compliance Recall J030 - Update

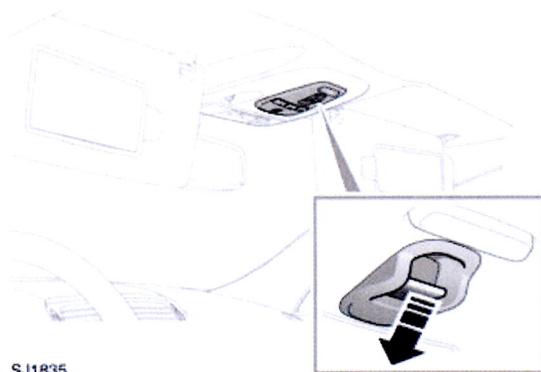
## CLOSING THE CONVERTIBLE ROOF

**Note:** If at any period during the convertible top closure sequence, the switch is released, all movement of the convertible top will cease.

In order to rectify this non-compliance, the convertible roof switch will be replaced with a revised design. This convertible top switch is mounted in the overhead console. The rectification process will include replacement of this overhead console / convertible roof switch assembly.
