**Subject:** 2100 Plus Muncie CS10 & CS11 PTOs

**Number:** SB 265A **DATE:** 12/04/2013

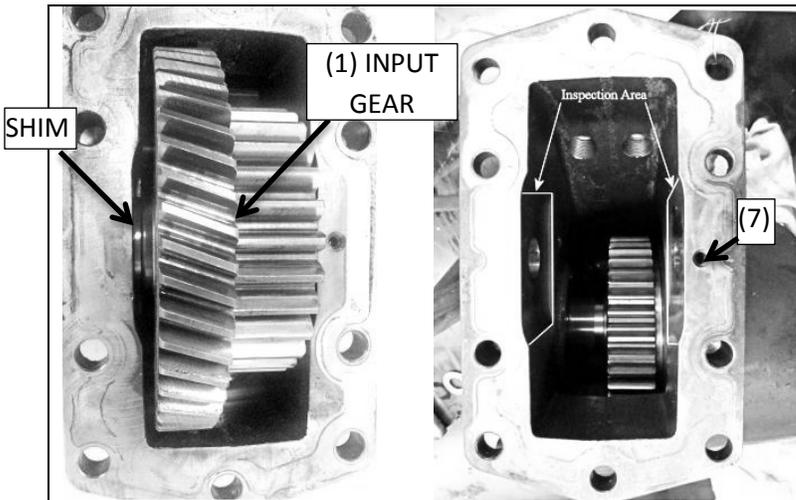
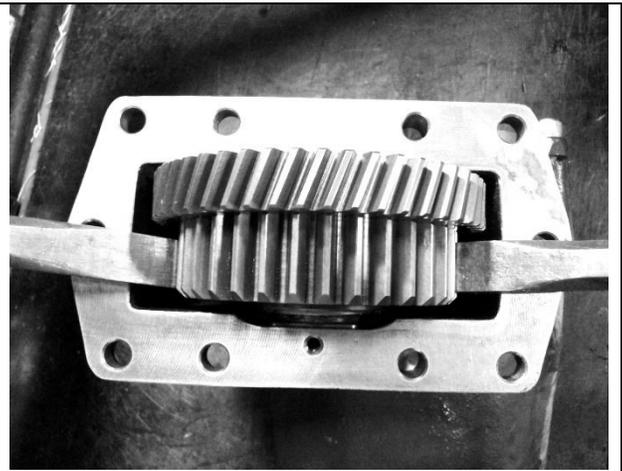
- A. Make a note of the position of the input gear within the housing and the bearing shim next to the gear. Remove the CS10/11 input gear (1) by removing the set screw (7) in the mounting pad and driving the idler shaft (4) from the housing.

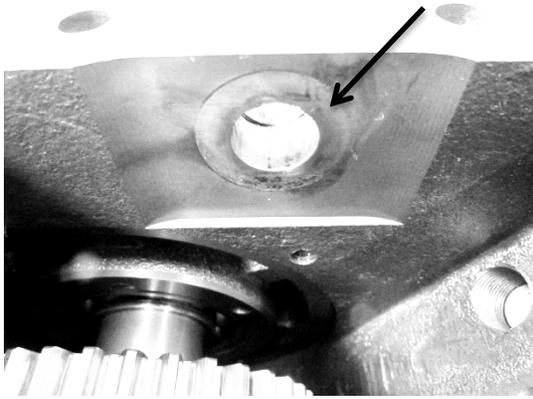
Inspection of the Housing. The area around the idler shaft shows little to no wear. This is an example of no wear.

If the Area around idler shafts shows wear, then the unit needs replacing.
